August 5, 2021

RE: #9 Beecher Park, AP 8-120  
VLS&E Job 698-3

The following is a report regarding the condition of the single family dwelling located at your above referenced property. On July 30, 2021 our office visited the property to inspect the following systems in order to evaluate the structural integrity of the components as well as the code-compliance and potential code-upgrade requirement associated with any significant renovation.

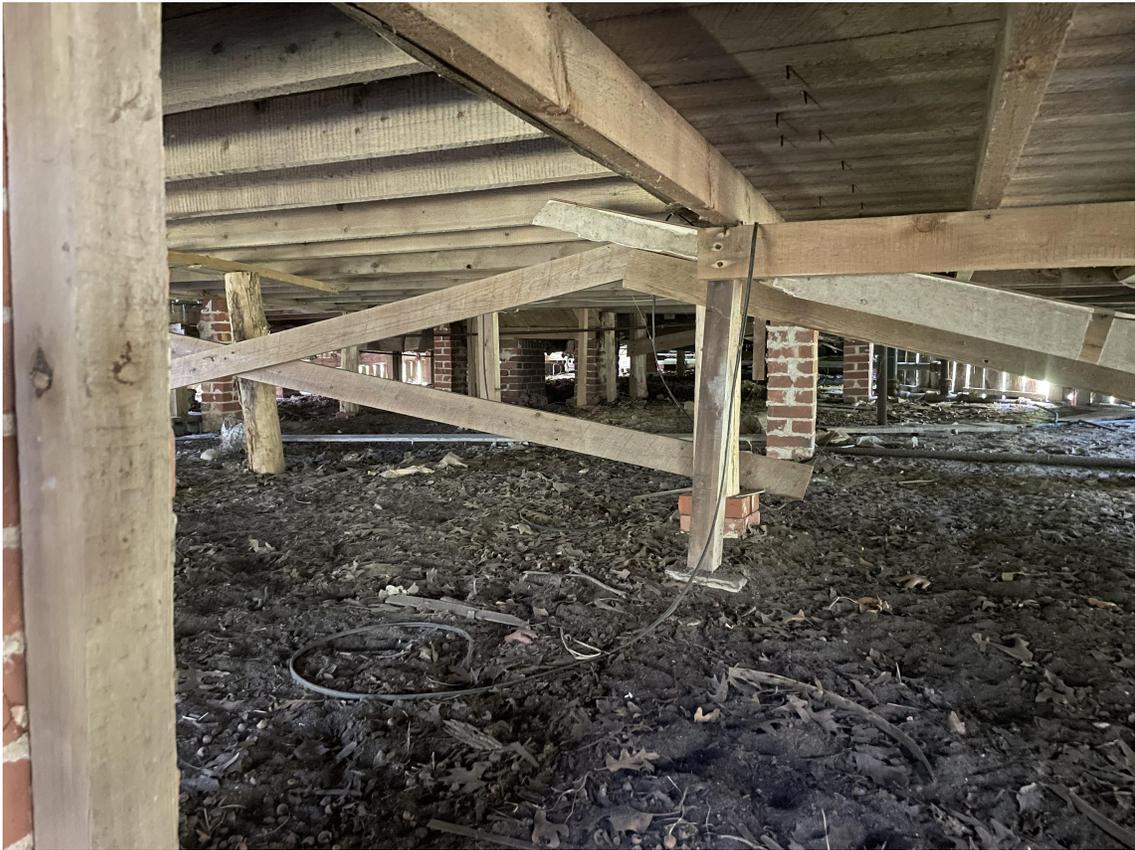
**1. Foundation system:** The foundation consists of timber and brick pilings. It appears that the brick piles are original and the timber piles were added in later years to add support. The brick piles are in sound condition with no signs of cracking or deterioration. The wood piles, though not failing are not supported on stable bases and do not have adequate connections to the floor frame of the dwelling. Cross-brace members have been added to indicate potential lateral strength issues as well. The dwelling is relatively stable on the existing foundation, however the foundation should not be relied upon for any reconstruction or major remodeling.

Foundation area - pilings and first floor framing

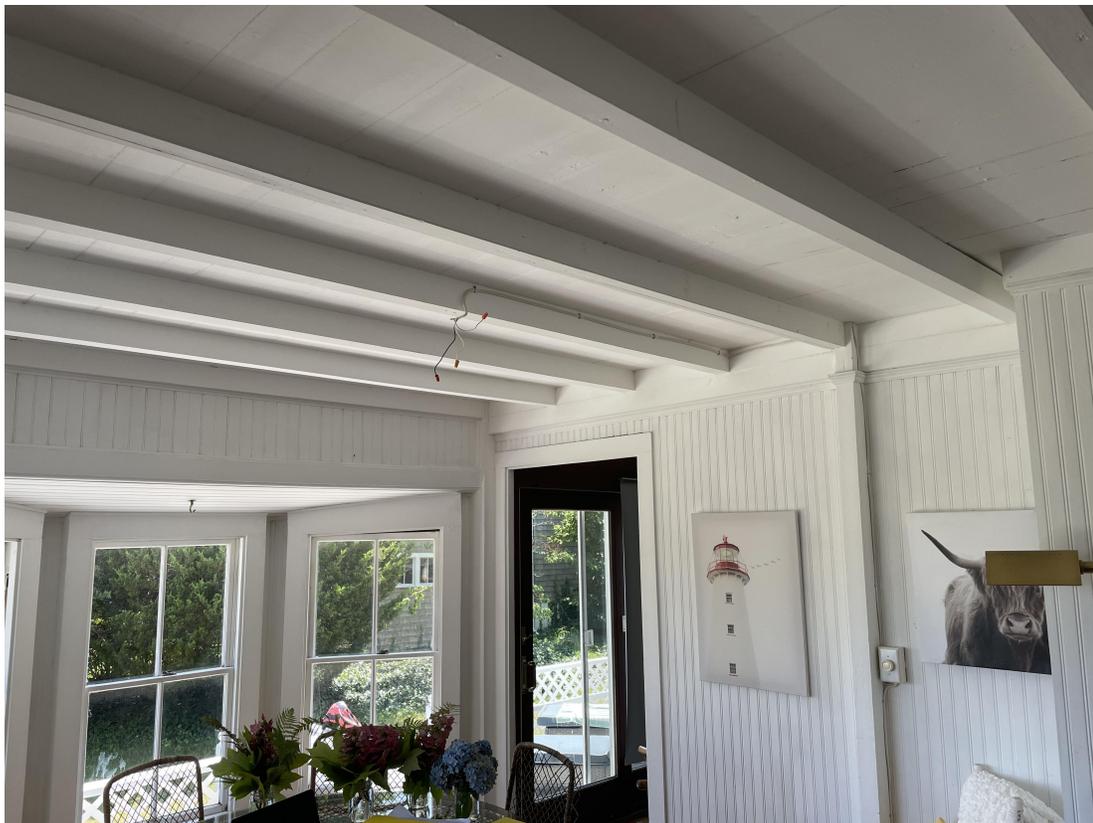
**2. First and second floor framing:** The primary support beams consist of approximately 2 x 6 (dimensional) fir with 2 x 6 fir floor joists. The joists and beam have all deflected significantly contributing to unlevel floors and cielings. Though a catastrophic failure has not occurred yet, the beams are undersized for the current loading and would need replacement and reinforcing with any significant remodeling.

Second Floor framing

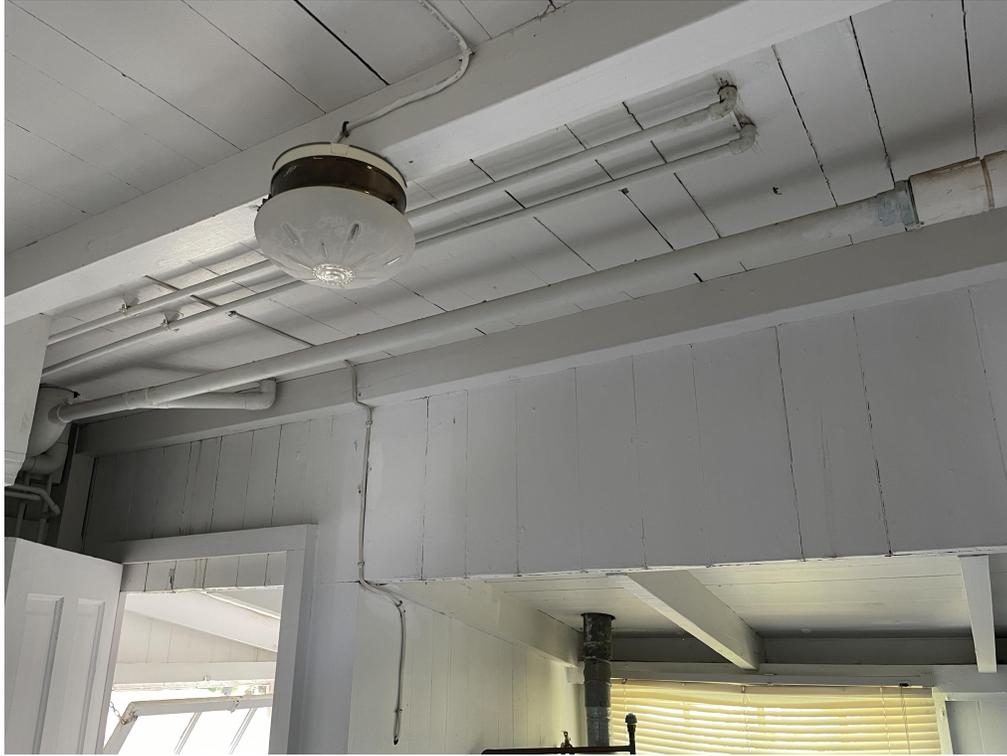
Second floor framing examples

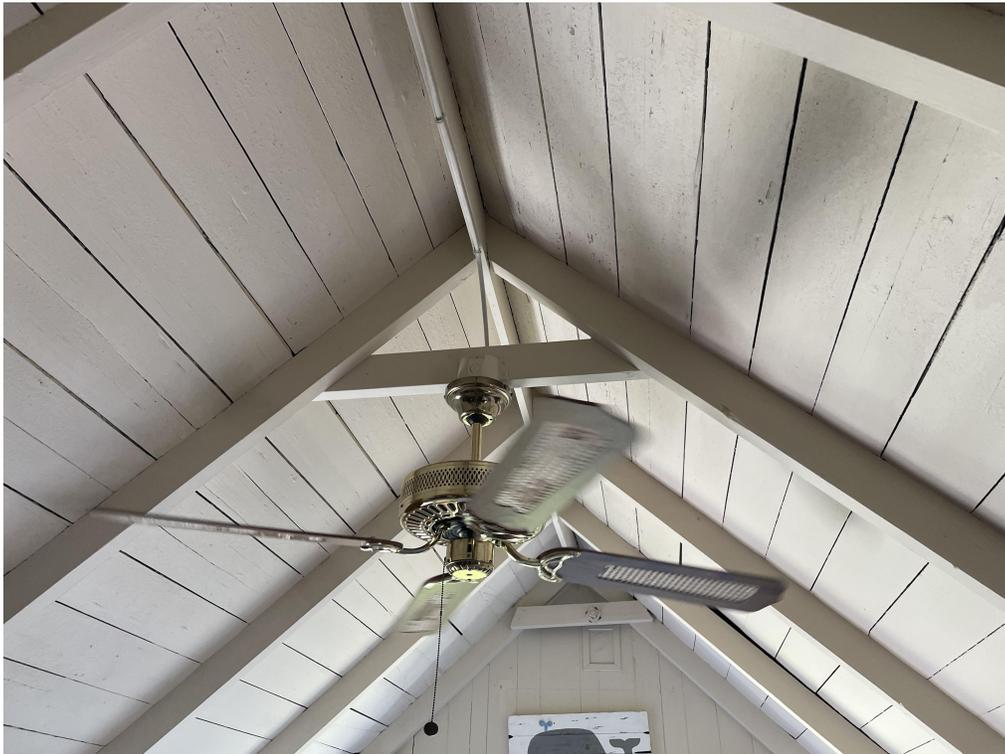
The roof framing consists of 2 x 6 (dimensional) roof rafters spaced approximately 30 inches on center. The framing is well below current loading and strength requirements. As with the wall system, the lack of depth of the rafters and roof cavity would make insulating difficult. The rafters would need to be reinforced with any code-upgrade.

Roof framing
