# JOHN LOLLEY, PE

November 4, 2021

At the request of Chris Alley of Schofield, Barbini & Hoehn, I inspected the property at 22 Hatch Road in Vineyard Haven, MA. on 11/1/2021. The property is a two-story, single-family dwelling built around 1900 according to the Tisbury Assessors office. The original structure has been added onto over the years. The following is a structural evaluation of the property.

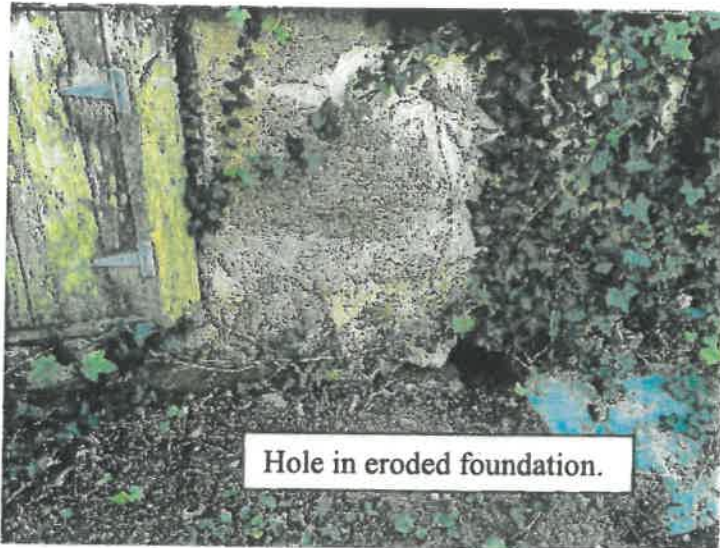
Hole in eroded foundation.

The building's original foundation consists of field stones cemented together with lime mortar of the 1875/ 1900 era. I noted significant foundation wall deterioration inside and outside the stone foundation wall most likely due to stormwater draining toward and into the foundation over the years. Lime mortar is permeable and in the subject house the mortar at grade level has deteriorated and been washed away leaving open holes between the existing basement stones. This in turn causes the interior foundation to be damp, weakens the supporting capacity of the existing foundation wall and provides an entry for

Overall, the house is in average condition for its age. It is recommended that the structural and dampness issues be addressed if continued to be used as a residence.

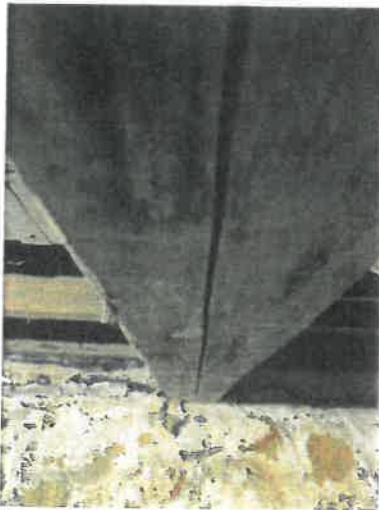
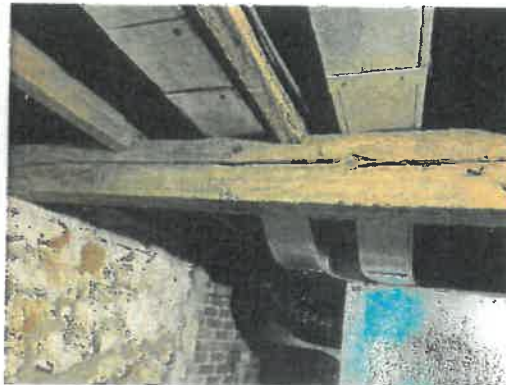
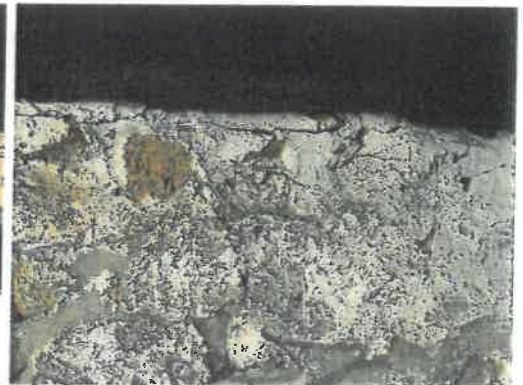
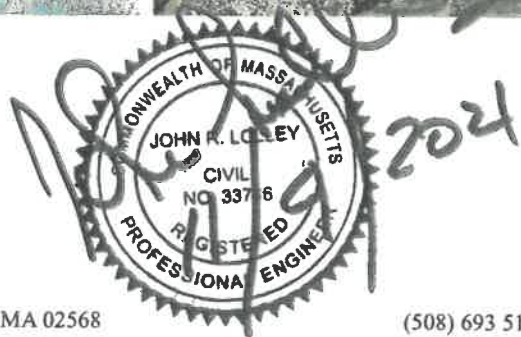
animals into the basement. The basement supporting timbers are rough sawn and exhibited some bowing.
