7 Arlington Ave Existing Conditions Letter For Partial Demolition Request

Prepared for the MV Commission

July 21, 2022

7 Arlington Ave, Oak Bluffs
Parcel ID: 3-15-0

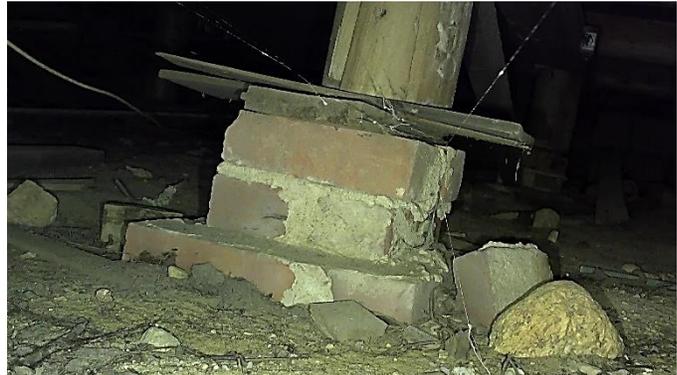
The CMU and brick piers do not show signs of substantial deterioration or imminent failure; although the bricks are of the age where beach sand mortar was used and those do deteriorate over time and need replacement. That being said, the brick/timber piers would not be capable of supporting a major renovation/addition or any additional weight/load applied to them. The timber piers do not show signs of rot or decay but are not adequately held down or fastened to the framing to prevent uplift as current code requires. All footings/piers are supported by inadequate (were visible) footings/bases and would need to be replaced to carry additional load. There are no "hurricane holdowns" or lateral support systems visible in the basement/crawl space or throughout the home, common for this era of construction.

Inadequately supported timber pier with brick footing/wooden shims

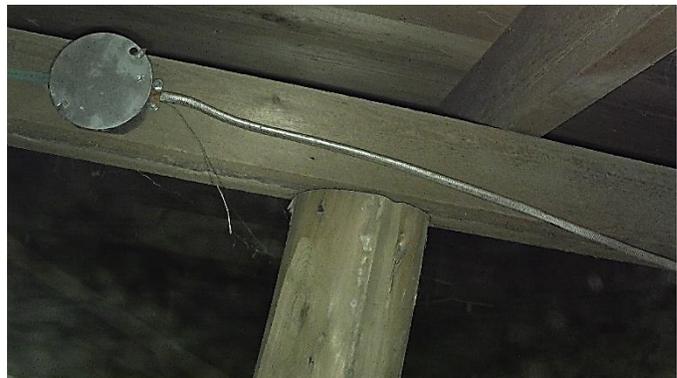
Inadequate connection between top of timber pier & girder

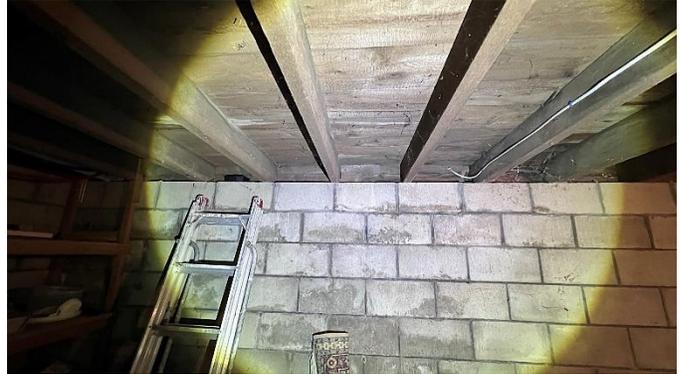
The existing building consists of under-framed floor joists on all 3 levels that far exceed their span ratings under current building codes and show significant deflection and over-stressing. The 1st level joists are true 2x6s @ 24" OC and are supported by 4x6 carrying sticks/girders located below bearing walls or equally spaced along the floor mass. In my professional opinion, the 1st level joists are not original to the 1875 construction due to their size and the fact the same joists/carrying sticks run throughout the entire 1st level, both under the "new" construction and original "Palmer Villa" building. The joist size in this building indicate they were installed sometime after 1900. Campground homes from the mid-late 1800s are usually framed with 2"+ wide x 4"+ deep joists/rafters or "half-cut" circular timbers. Also observed was the lack of foundation anchorage and a mud sill; this ensures the building is fastened to the foundation and will prevent the building from shearing (or sliding) off its foundation.

True 2x4 joists indicate construction of entire 1st level floor was after 1900

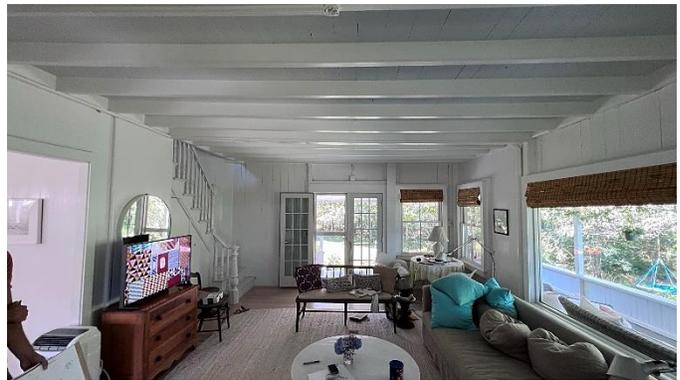
The 2nd level floor framing in the original Palmer Villa structure consists of 3x6s @ 24" OC and have a beveled edge detail along the base of the joist which was common for this era. These joists show a significant deflection and are spanning 14'-6" between supports. Using current code loading (15 lb/ft² dead load & 40 lb/ft² live load) the joists fail in bending stress and deflection by 157% & 396% respectively. This calculation only accounts for open bedroom/hallways; the additional 3rd level and interior bearing walls were not considered. Although no catastrophic event has occurred because of the inadequate floor joists, they are severely undersized and cannot support code loads and would need significant reinforcement during the renovation.

3x6 joists showing significant deflection and over stressing

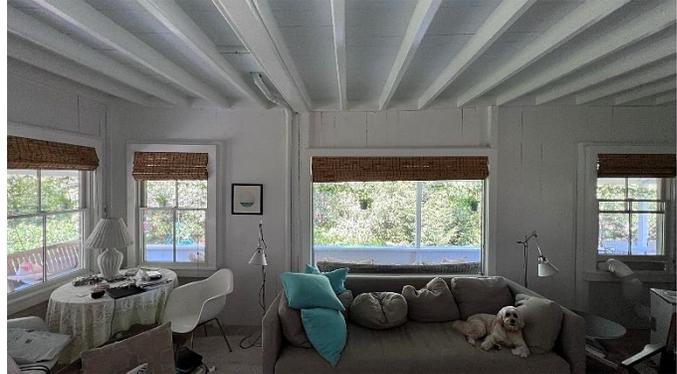
Like most campground style homes and those built around the late 1800s, the exterior walls are constructed with 4x4 posts spaced 4ft - 8ft or greater with vertical 1x boards acting as the shear diaphragm and load carrying support. This practice is far from code compliant and infilling between posts with new 2x studs @ 16" or 24" OC and re-sheathing the exterior of the building with structural grade plywood would be necessary to adequately resist the code-compliant wind shear. This building would be considered Exposure D (worst case scenario as per ASCE 7-16) with 140mph wind gusts @ 3-second intervals, this equates to a wind pressure of 27.79 lb/ft² and a load along the face of the exterior walls of 292 lb/ft. For reference, if you were holding a piece of plywood (4ft x 8ft sheet) the wind pressure felt would be nearly 900 lbs.

Load bearing wall showing 4x4 posts spaced far apart with minimum exterior shear capacity. Deflecting rim joist/header is also evident from this photo.
