# Bristol Structural Letter

Prepared for the MV Commission

May 20, 2022

1133 Main St. Tisbury  
Parcel ID: 29-B-12

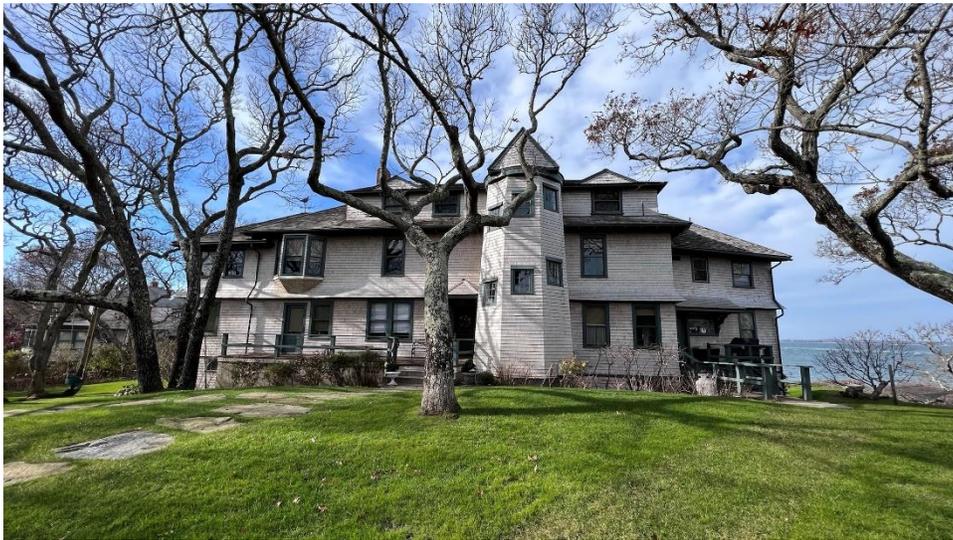
The existing stair tower, shown from the exterior in the cover photo, is showing significant signs of deflection and settlement, from the 1<sup>st</sup> level to the 3<sup>rd</sup> level the treads and risers are pulling away from the exterior wall which supports them; if this stair was original to the house, in my experience, it is under framed and needs full replacement to fix the associated issue(s).

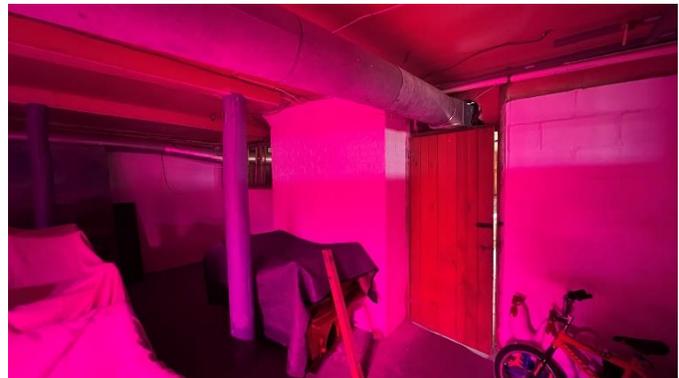
The foundation consists of partial CMU (concrete masonry units) foundation walls with 2x6 exterior studs extending to the bottom of the 1<sup>st</sup> level deck, slender unreinforced CIP (cast in place) piers/ cedar tree trunks supporting the carrying sticks/ point loads from above, full height CMU block foundation in a few locations, and new CIP foundation below the recent addition toward the north. Below slab insulation and footing depth/size is unknown. The current HVAC system that runs in the basement is uninsulated and has considerable energy loss.

*Interior of basement showing uninsulated duct work, CMU walls and tree trunk support posts*

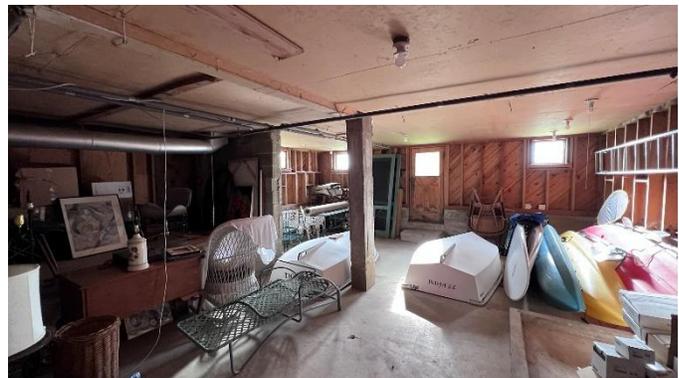
*Interior of basement showing slender CIP support posts and CMU foundation walls beyond*

- The necessary re-framing to bring the entire building up to energy and structural code requirements would be extensive and costly:
  - New frost protected foundation and interior footings as well as new support posts

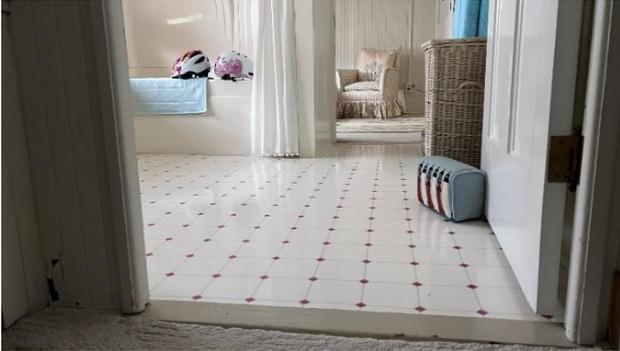
*3<sup>rd</sup> level: large humps and dips are visible throughout the upper and lower levels of the home*

The upper level (3<sup>rd</sup> floor) shows significant signs of deflection and over stressed floor framing which could be caused by either excessive roof loads or MEP penetrations in the existing joists/structure. For example, current code compliant P traps require a minimum of 8" between top of sub floor to bottom of joist to fit the assembly and piping; a complete removal and reframe would be necessary throughout the entire 3<sup>rd</sup> level to allow for this retrofit.

- 1<sup>st</sup>, 2<sup>nd</sup>, and 3<sup>rd</sup> level deck framing would need to be completely removed and reframed with i-joists or deep 2x joists to properly span between supports

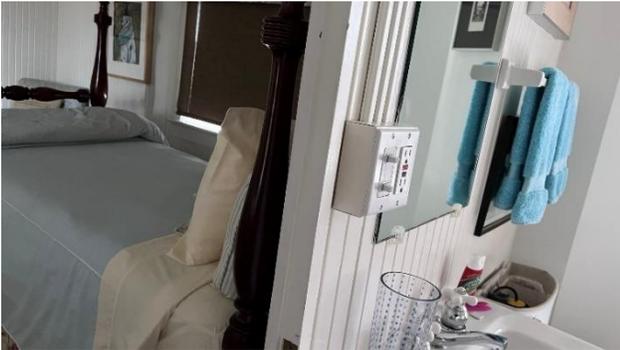
*1" thick 3<sup>rd</sup> level interior wall showing exposed wire runs*

SIPs as the additional weight would be too much for the existing rafters to support. Additionally, the 3<sup>rd</sup> level interior walls consist of solid boards (no 2x studs or top/ bottom plates) so there is no room to hide the MEPs behind the sheetrock; all wires, switches and plumbing are exposed and could pose a safety concern.

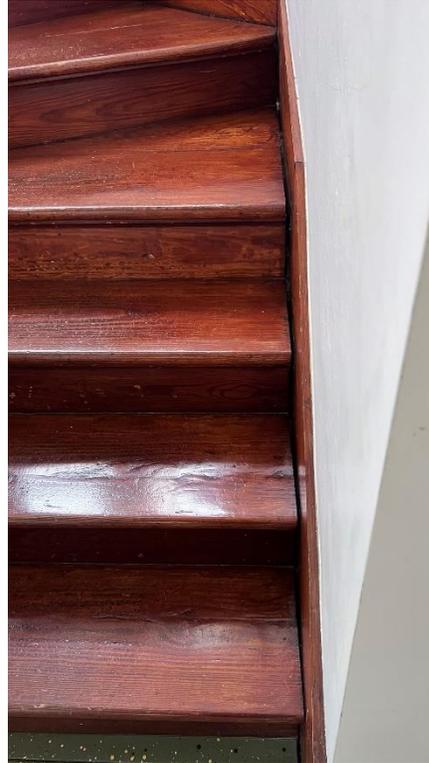
*Staircase showing signs of separation from support wall*

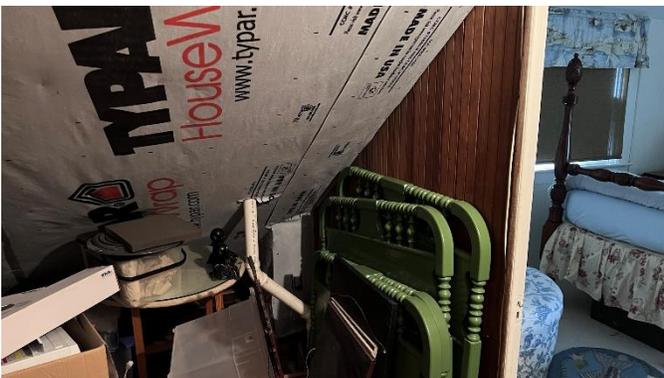
*View in storage room on 3<sup>rd</sup> level showing house wrap hiding rigid insulation and undersized rafters*

The existing roof framing consists of 2x6 full sawn rafters, well below the necessary depth for code compliant R-values, even with the use of exterior

- New roof framing and structural ridges would be necessary to both transfer the loading away from the insufficiently supported interior walls and undersized joists, and to increase the R-value whether with spray foam or SIPs.
