340 Boothby Rd
Limington, ME 04049
(860) 338-1702
www.souzastructural.com

August 1, 2023

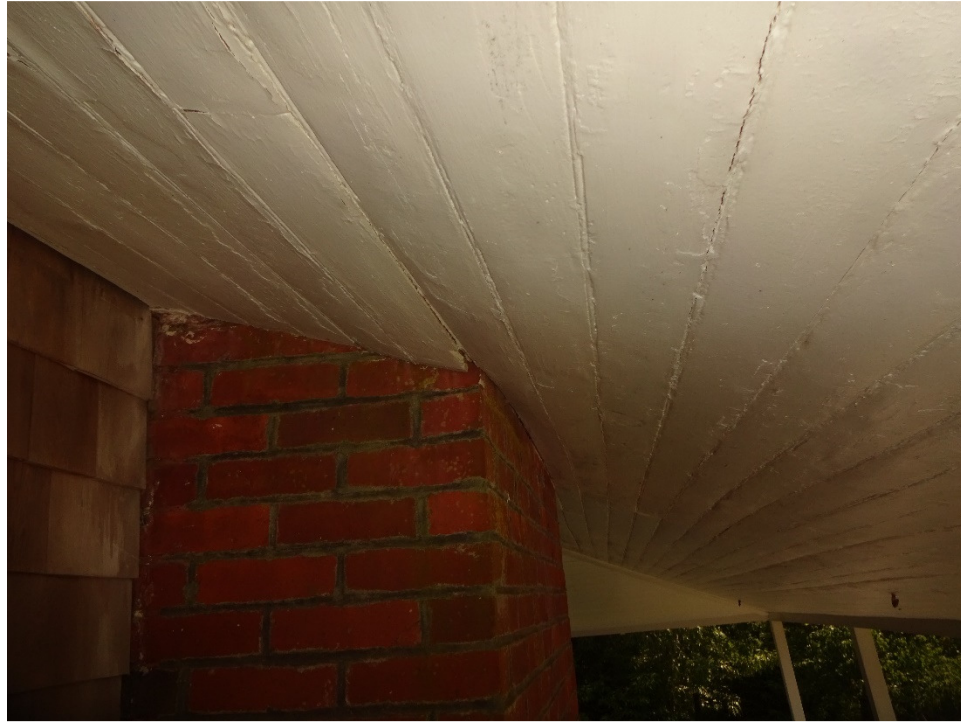
Figure 1: Porch Ceiling Sagging Around South Chimney

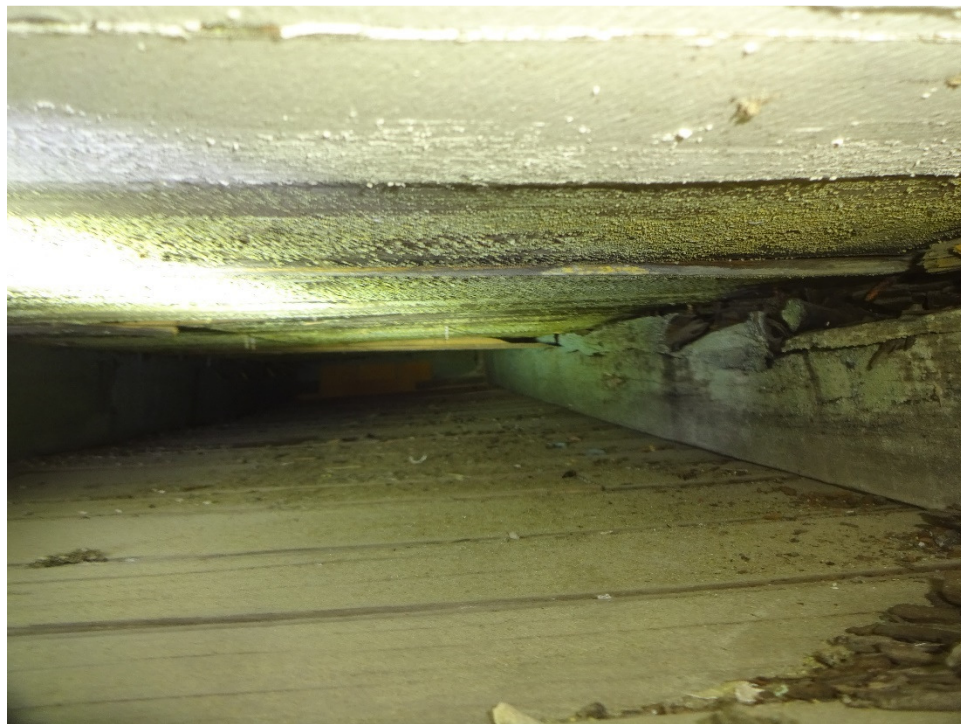
Figure 2: Damaged Rafter Adjacent to South Chimney

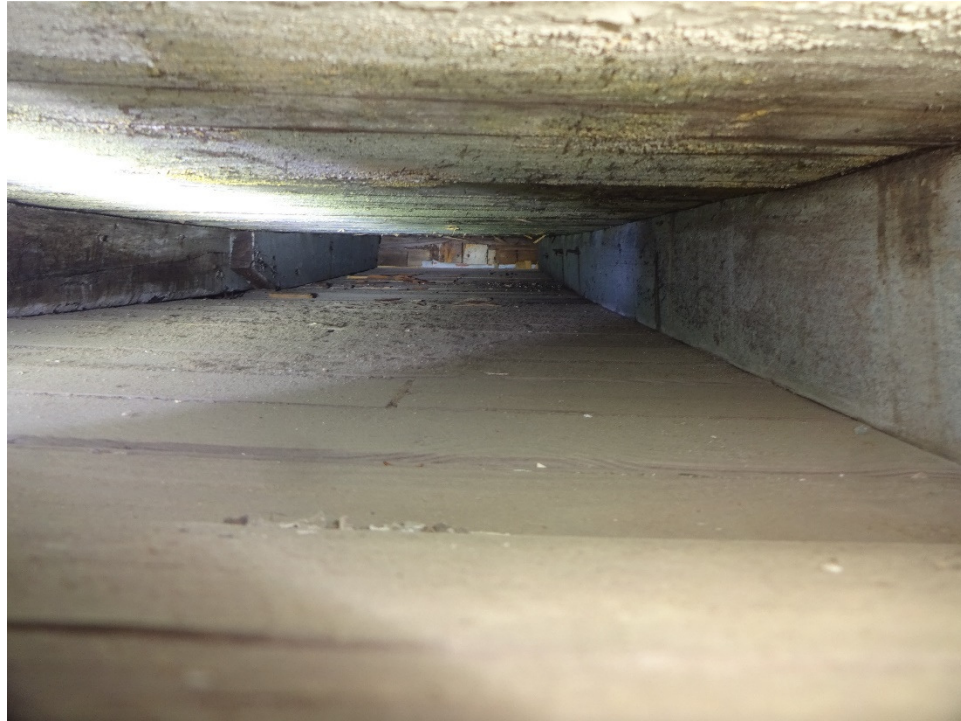
Figure 3: Sagging Rafters Below East Dormer

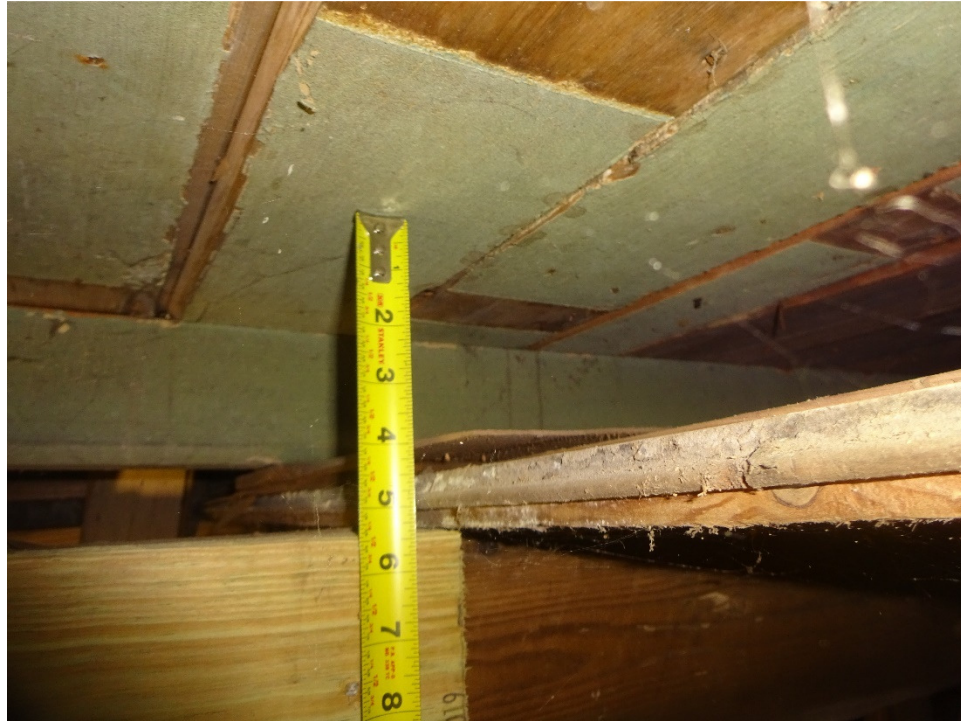
Figure 4: 3x4 Shims over 2x6 Floor Joists @ NE Corner of Main Structure

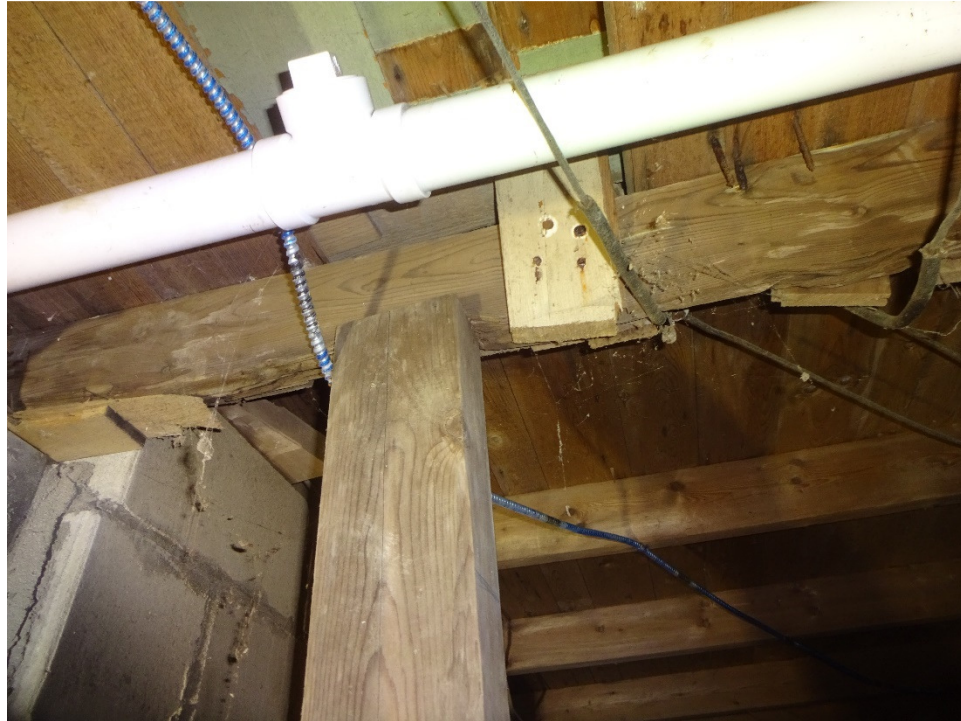
Figure 6: Deteriorated Floor Framing and Temporary Support Post

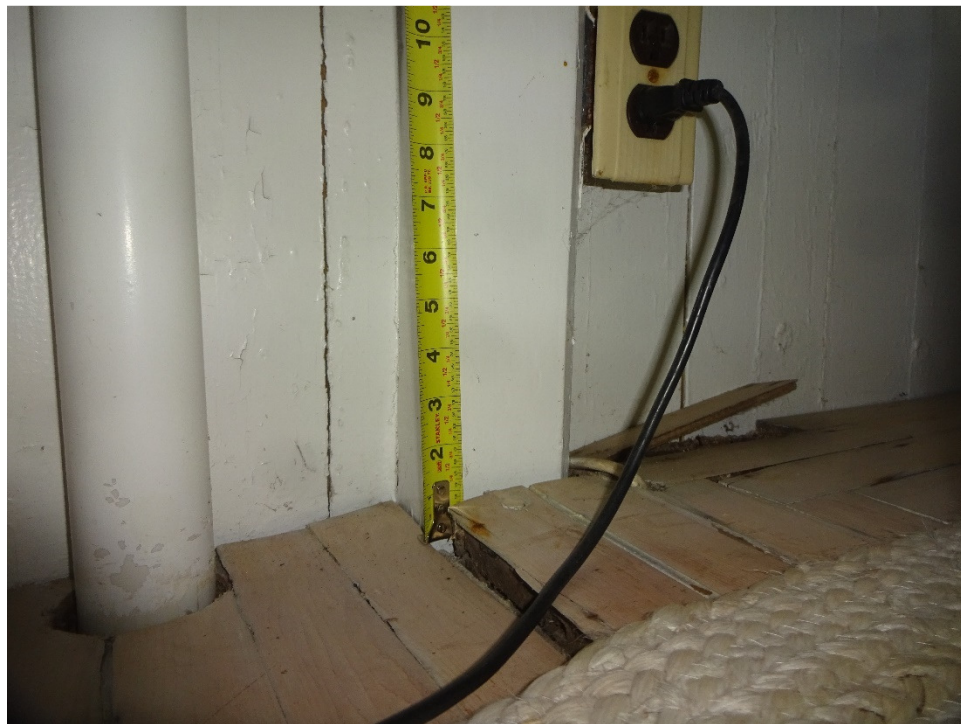
Figure 7: Step in First-Floor @ NE Corner of Main Structure

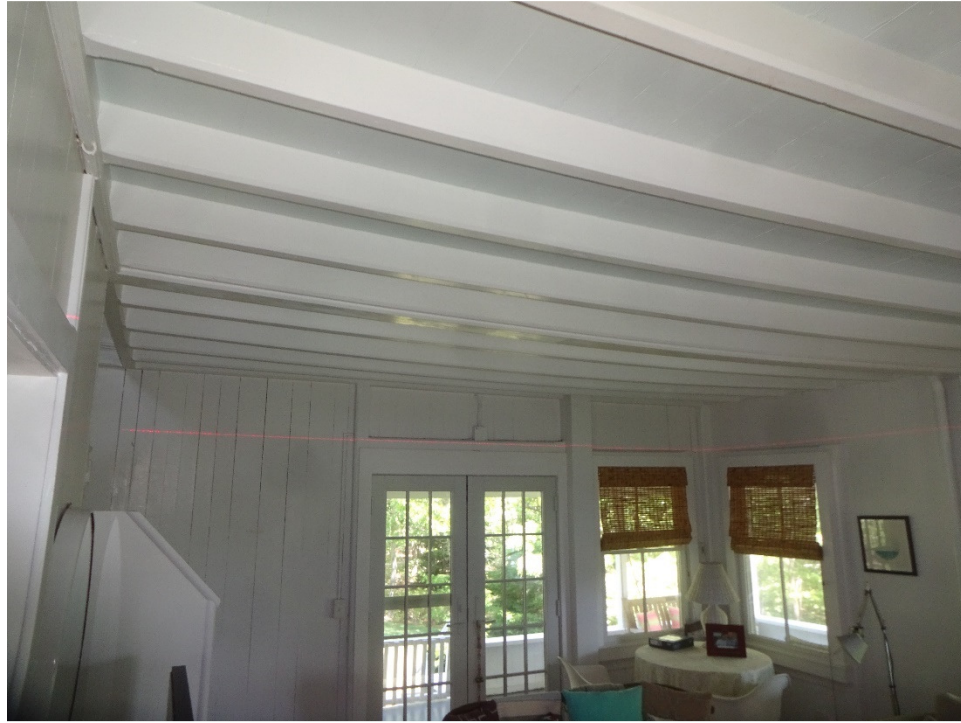
Figure 9: Northeast Corner Wall Framing

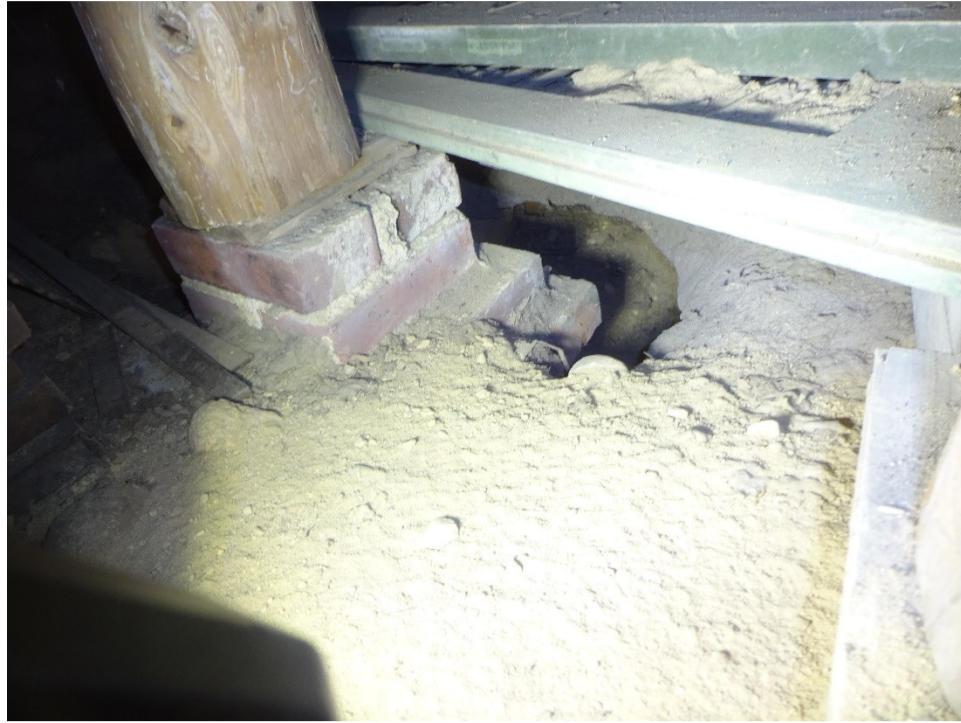
Figure 10: Undermined Brick Pier

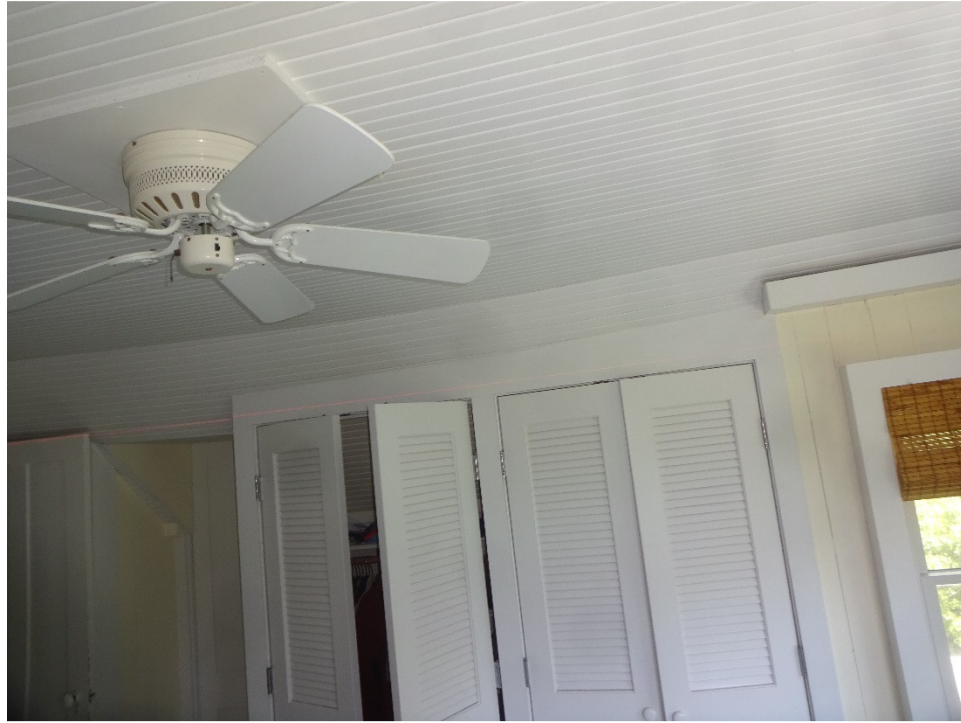
Figure 13: Second-Floor Roof Sagging along the Master Bedroom Closet Wall

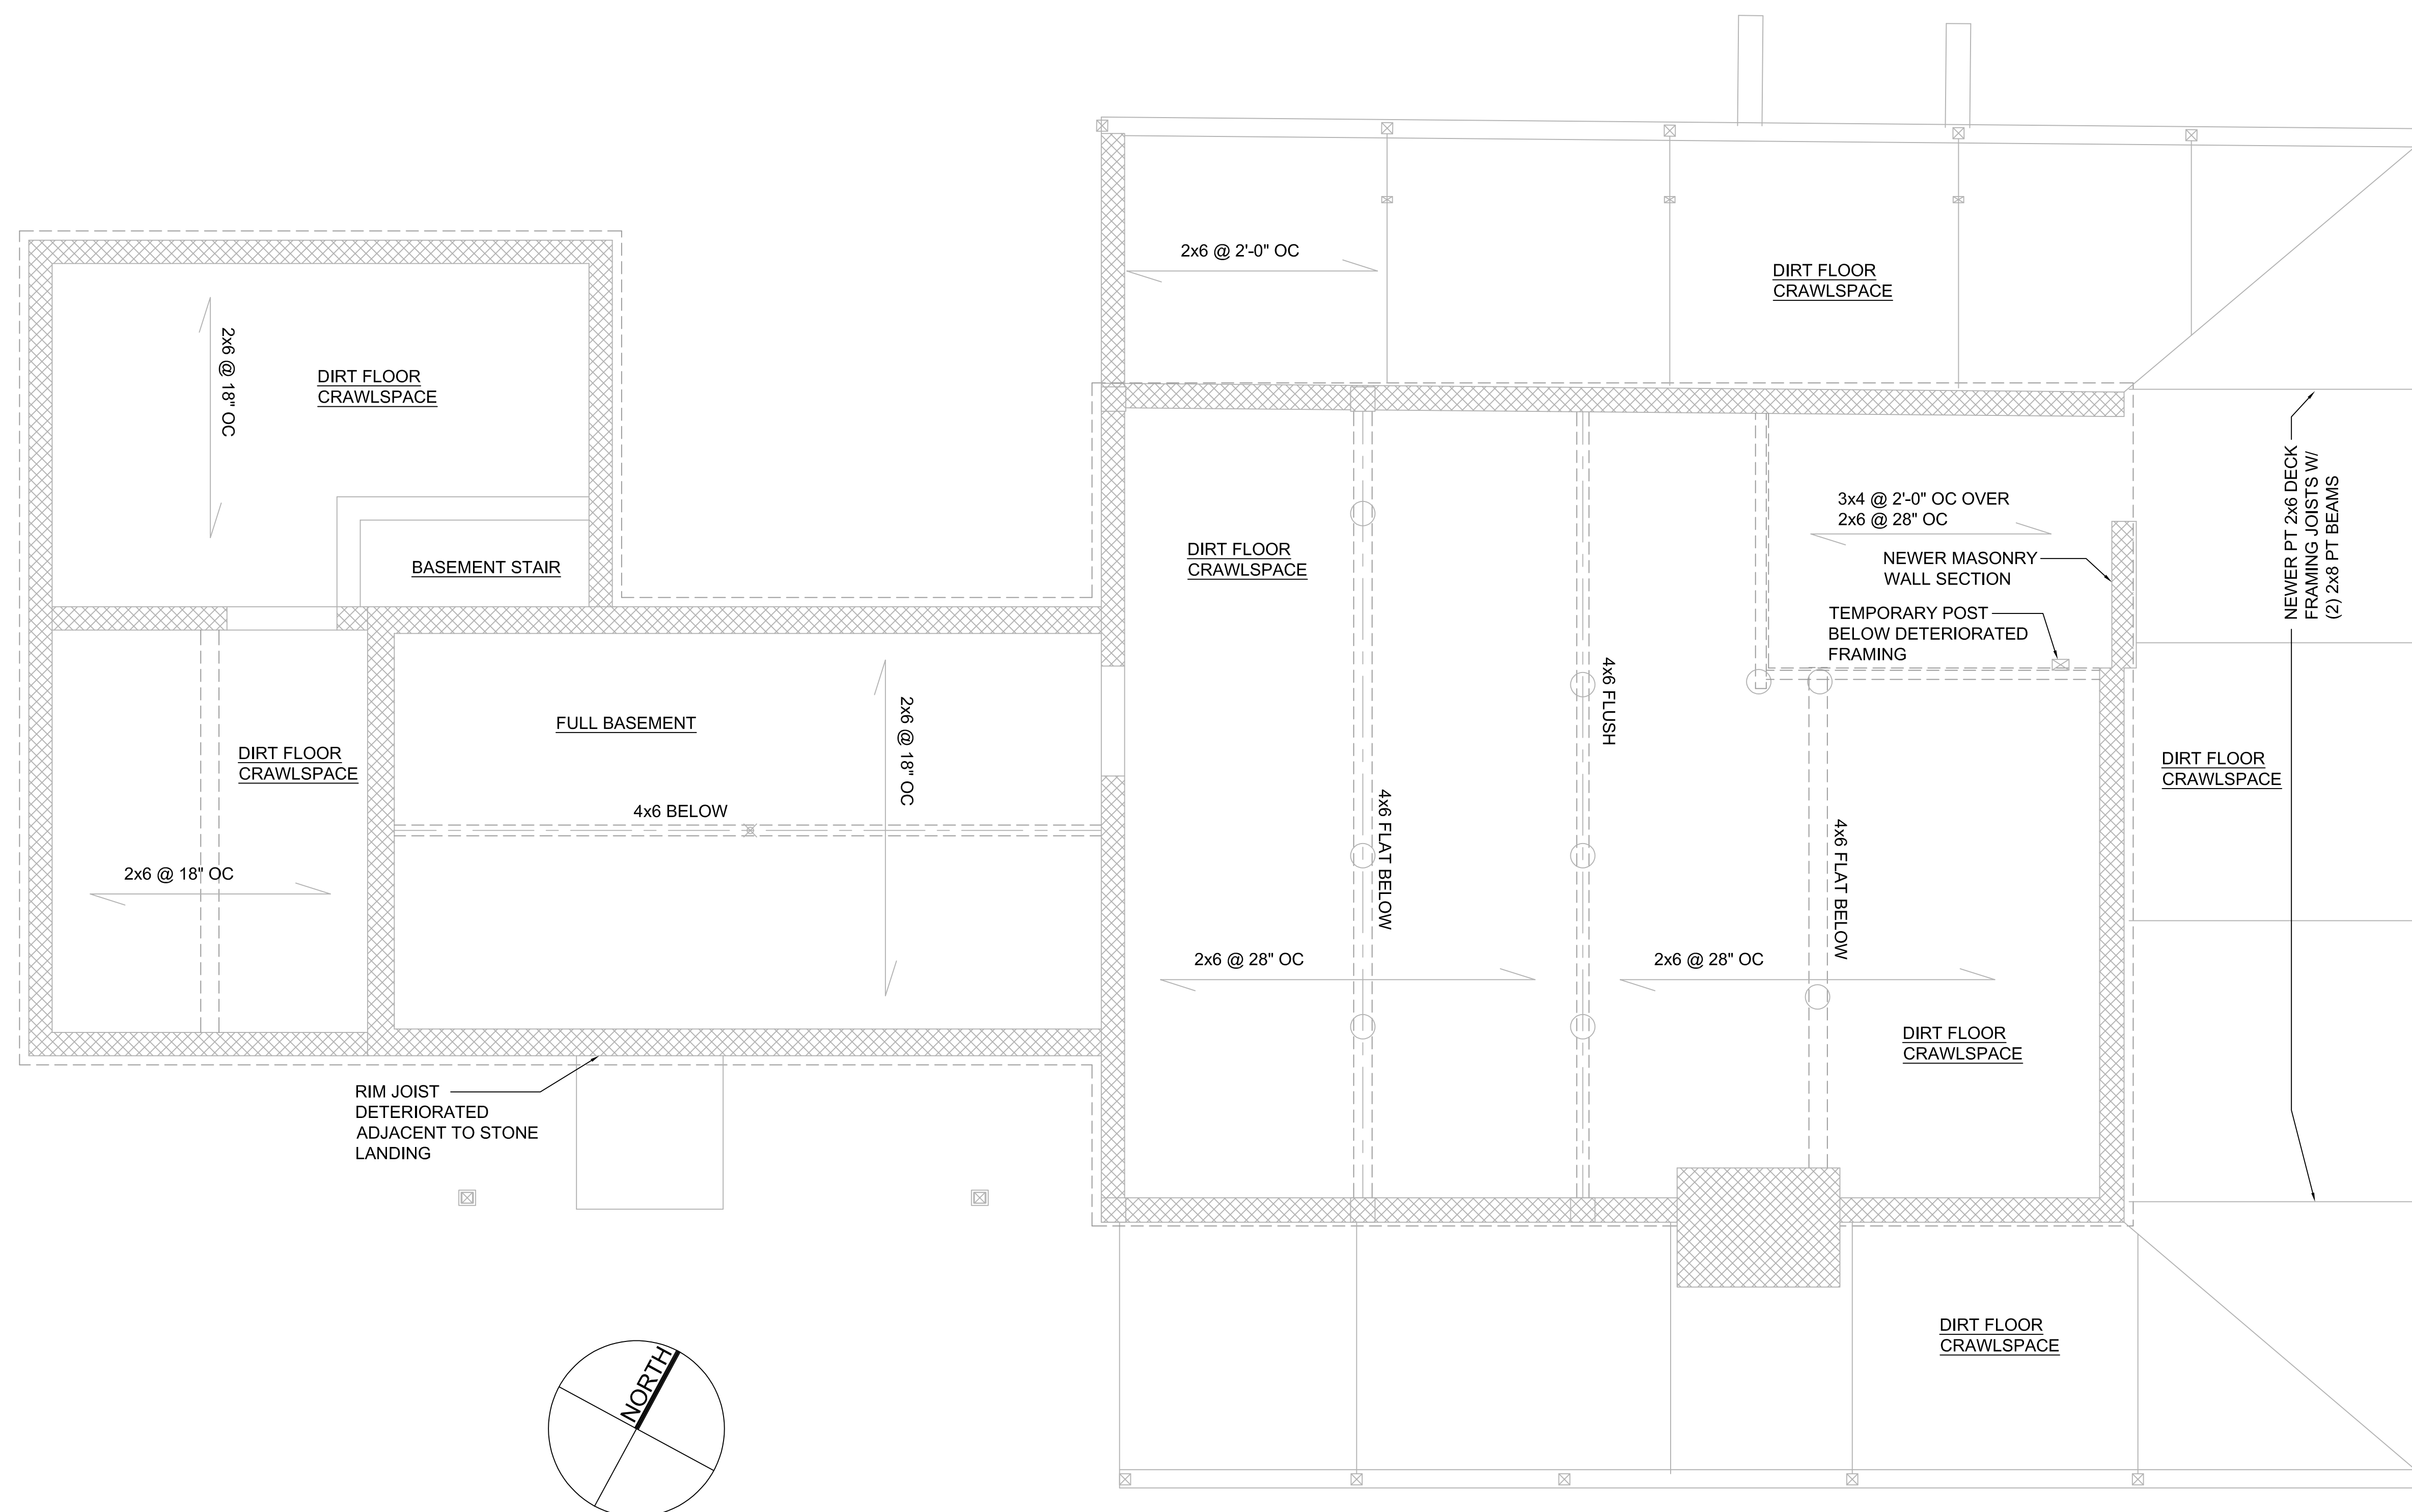
1 EX FOUNDATION PLAN
 SK-1 SCALE: NOT TO SCALE
