# Nauset Environmental Services, Inc.

NES Job # 2-473  
Report No. NES/ASB-19/2363

Re: Pre-demolition asbestos inspection & sampling  
at 38 Wing Road (Oak Bluffs)

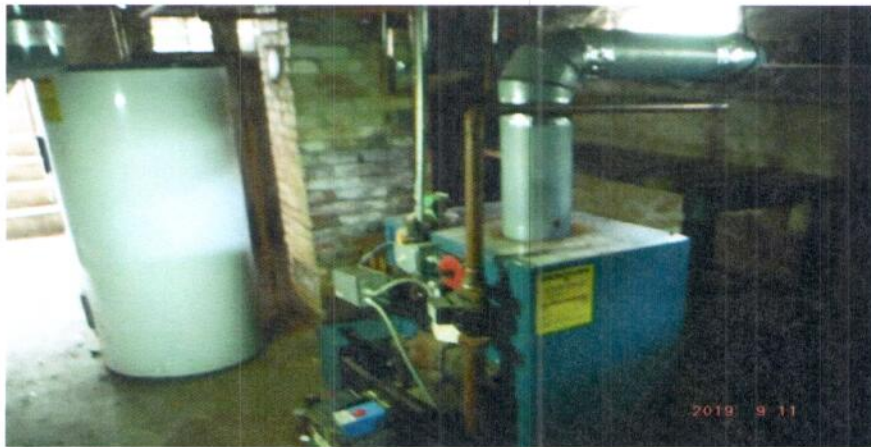
1) **Thermal Systems:** There was no insulation on the piping on the oil heat thermal system (see photo) hence it was NOT sampled for suspect ACBMs.

There was an oil burner for heating and NO suspect ACBM's associated with the thermal system.

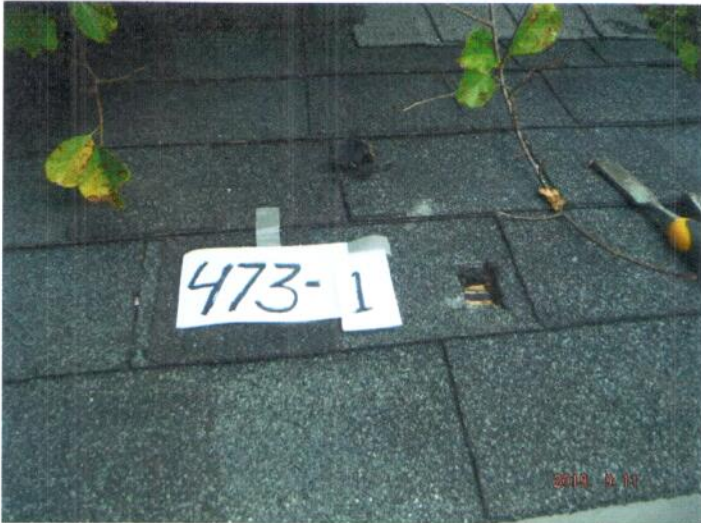
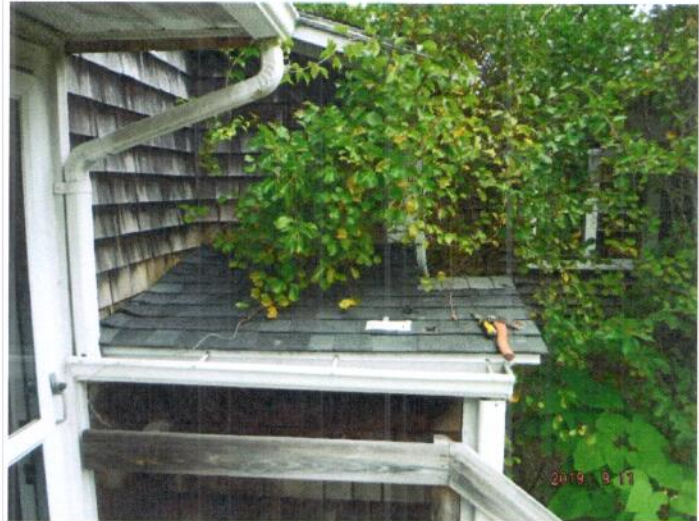
Samle 473-1 Shed roof Asphalt Shingle

<u>Sample #</u>	<u>Location</u>	<u>Analytical results</u>
<b>Roof</b>		
#473-1	Shed - roofing	Grey/Black Shingle – <b>NO ASBESTOS DETECTED</b> Black Tar - <b>NO ASBESTOS DETECTED</b>
#473-2	Right side 1 <sup>st</sup> fl. – window	Off White Caulk - <b>NO ASBESTOS DETECTED</b>
#473-3	Left side 1 <sup>st</sup> fl. - window	White Caulk - <b>NO ASBESTOS DETECTED</b>
#473-4	Middle rear 1 <sup>st</sup> fl. – window	Off White Caulk <b>NO ASBESTOS DETECTED</b>
#473-5	Back entrance– wall	Off White Plaster <b>NO ASBESTOS DETECTED</b>

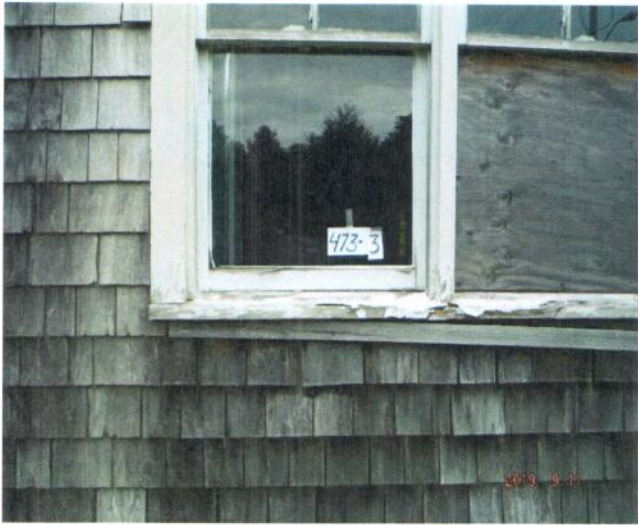
Sample 473-3 Left side window Caulking

<b>Lab No.:</b> 6876872 <b>Client No.:</b> 473-3 <u>Percent Asbestos:</u> <i>None Detected</i>	<b>Analyst Observation:</b> White Caulk <b>Client Description:</b> Window Caulk <u>Percent Non-Asbestos Fibrous Material:</u> None Detected	<b>Location:</b> Left Side 1st Floor <b>Facility:</b> <u>Percent Non-Fibrous Material:</u> 100
<b>Lab No.:</b> 6876873 <b>Client No.:</b> 473-4 <u>Percent Asbestos:</u> <i>None Detected</i>	<b>Analyst Observation:</b> Off-White Caulk <b>Client Description:</b> Window Caulk <u>Percent Non-Asbestos Fibrous Material:</u> None Detected	<b>Location:</b> Middle Rear <b>Facility:</b> <u>Percent Non-Fibrous Material:</u> 100
<b>Lab No.:</b> 6876874 <b>Client No.:</b> 473-5 <u>Percent Asbestos:</u> <i>None Detected</i>	<b>Analyst Observation:</b> Off-White Plaster <b>Client Description:</b> Wall Plaster <u>Percent Non-Asbestos Fibrous Material:</u> 4 Cellulose	<b>Location:</b> Back Entrance <b>Facility:</b> <u>Percent Non-Fibrous Material:</u> 96

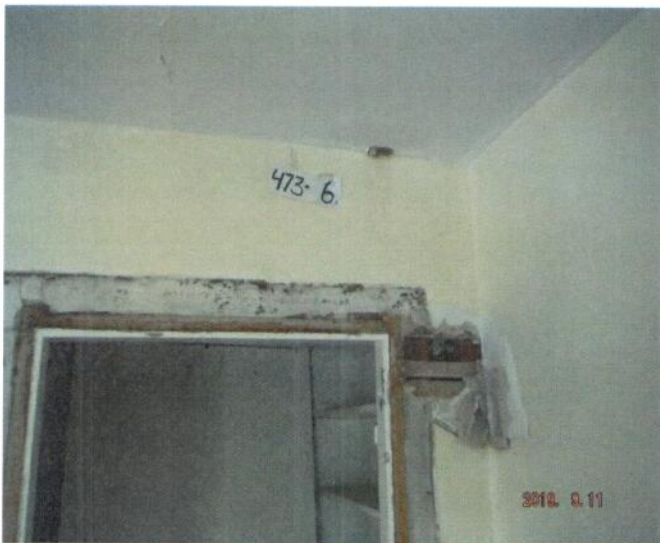
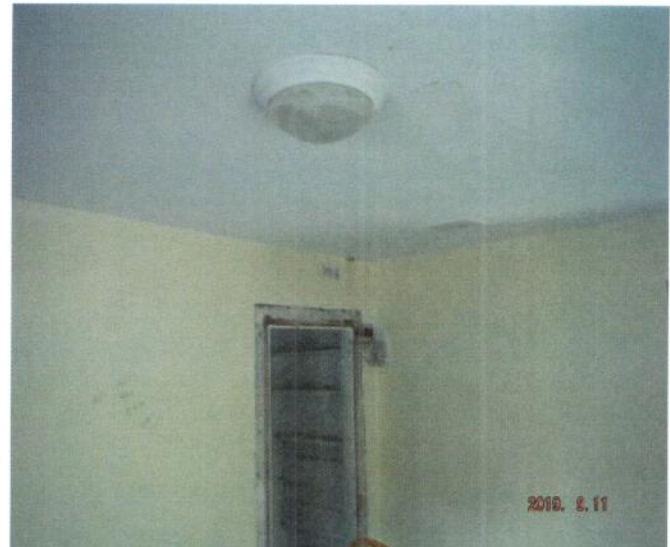
Sample 473-6 Front room ceiling Plaster

Lab No.: 6876875 Client No.: 473-6 <u>Percent Asbestos:</u> <i>None Detected</i>	<b>Analyst Observation:</b> Off-White Plaster <b>Client Description:</b> Ceiling Plaster <u>Percent Non-Asbestos Fibrous Material:</u> 3 Cellulose 2 Hair	<b>Location:</b> Front Room <b>Facility:</b> <u>Percent Non-Fibrous Material:</u> 95
Lab No.: 6876876 Client No.: 473-7 <u>Percent Asbestos:</u> <i>None Detected</i>	<b>Analyst Observation:</b> Off-White Vinyl Sheet Flooring <b>Client Description:</b> Sheet Vinyl Flooring <u>Percent Non-Asbestos Fibrous Material:</u> 25 Cellulose 2 Fibrous Glass	<b>Location:</b> Middle Closet <b>Facility:</b> <u>Percent Non-Fibrous Material:</u> 73
Lab No.: 6876876(I.2) Client No.: 473-7 <u>Percent Asbestos:</u> <i>None Detected</i>	<b>Analyst Observation:</b> Tan Mastic <b>Client Description:</b> Sheet Vinyl Flooring <u>Percent Non-Asbestos Fibrous Material:</u> 1 Cellulose	<b>Location:</b> Middle Closet <b>Facility:</b> <u>Percent Non-Fibrous Material:</u> 99

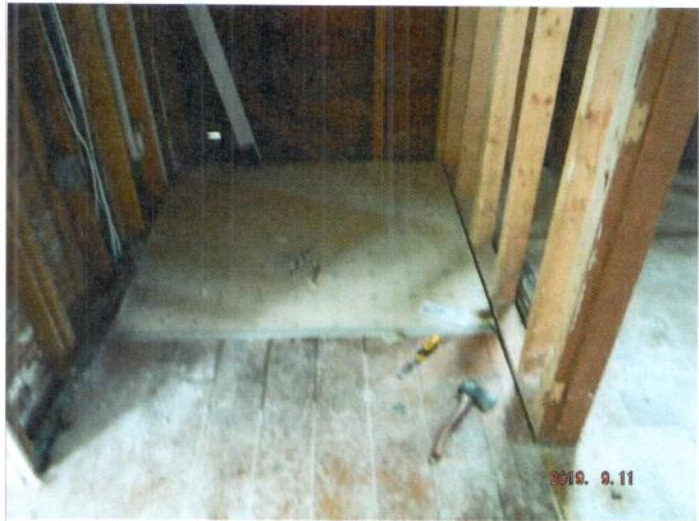
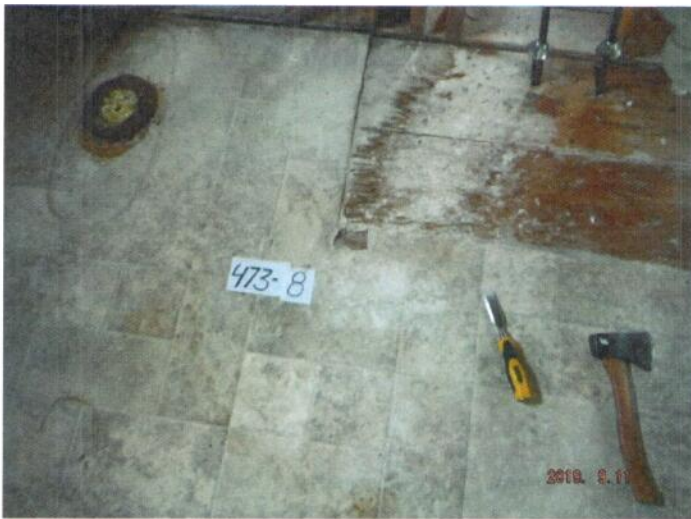
Sample 473-8 Middle bathroom flooring Sheet Vinyl

Lab No.: 6876877 Client No.: 473-8 <u>Percent Asbestos:</u> <i>None Detected</i>	<b>Analyst Observation:</b> Lt Tan Vinyl Sheet Flooring <b>Client Description:</b> Sheet Vinyl Flooring <u>Percent Non-Asbestos Fibrous Material:</u> 13 Cellulose 3 Fibrous Glass	<b>Location:</b> Middle Bathroom <b>Facility:</b> <u>Percent Non-Fibrous Material:</u> 84
Lab No.: 6876877(I.2) Client No.: 473-8 <u>Percent Asbestos:</u> <i>None Detected</i>	<b>Analyst Observation:</b> Off-White Vinyl Sheet Flooring <b>Client Description:</b> Sheet Vinyl Flooring <u>Percent Non-Asbestos Fibrous Material:</u> 2 Fibrous Glass	<b>Location:</b> Middle Bathroom <b>Facility:</b> <u>Percent Non-Fibrous Material:</u> 98
Lab No.: 6876878 Client No.: 473-9 <u>Percent Asbestos:</u> <i>25 Chrysotile</i>	<b>Analyst Observation:</b> Lt Green Vinyl Sheet Flooring <b>Client Description:</b> Sheet Vinyl Flooring <u>Percent Non-Asbestos Fibrous Material:</u> 10 Cellulose	<b>Location:</b> Middle Bathroom Shower <b>Facility:</b> <u>Percent Non-Fibrous Material:</u> 65

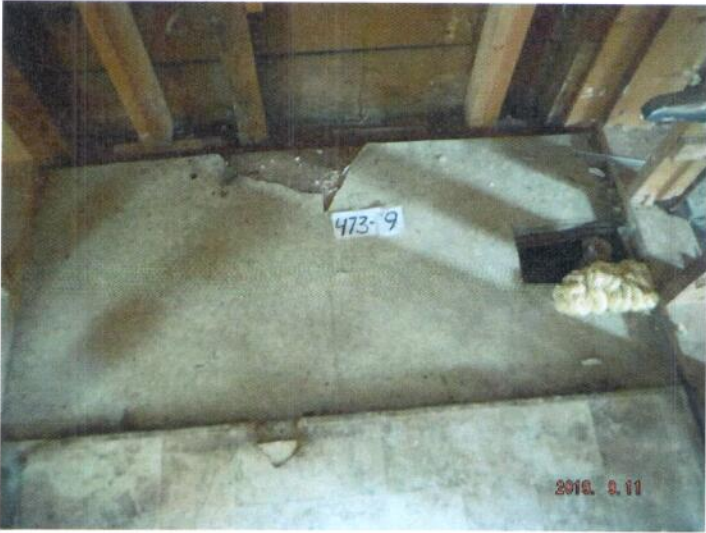
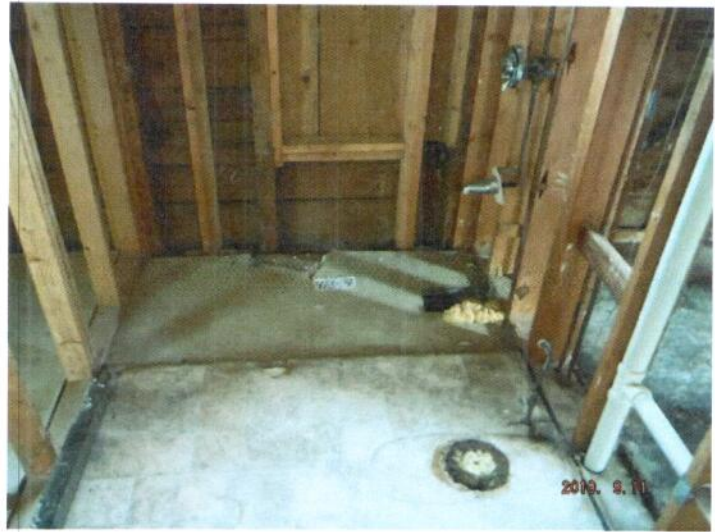
Sample 473-9 Middle bathroom shower flooring Sheet Vinyl

Lab No.: 6876878(L2)  
Client No.: 473-9  
Percent Asbestos:  
**PC Trace Chrysotile**

**Analyst Observation:** Tan Mastic  
**Client Description:** Sheet Vinyl Flooring  
Percent Non-Asbestos Fibrous Material:  
None Detected

**Location:** Middle Bathroom Shower  
**Facility:**  
Percent Non-Fibrous Material:  
100

From the asbestos results of the inspection, THERE WERE ACBMs identified in the house intended for demolition, but only in the shower; hence special handling is calling for a Massachusetts-licensed asbestos abatement contractor to remove the materials identified in Table 1, even though they ae small in area.

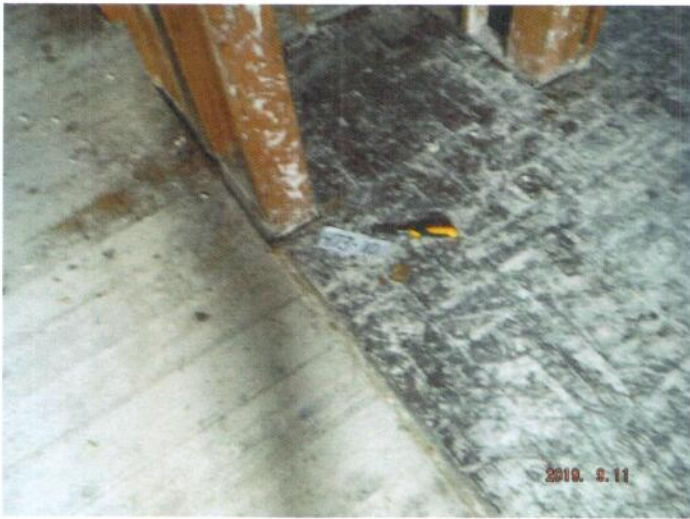
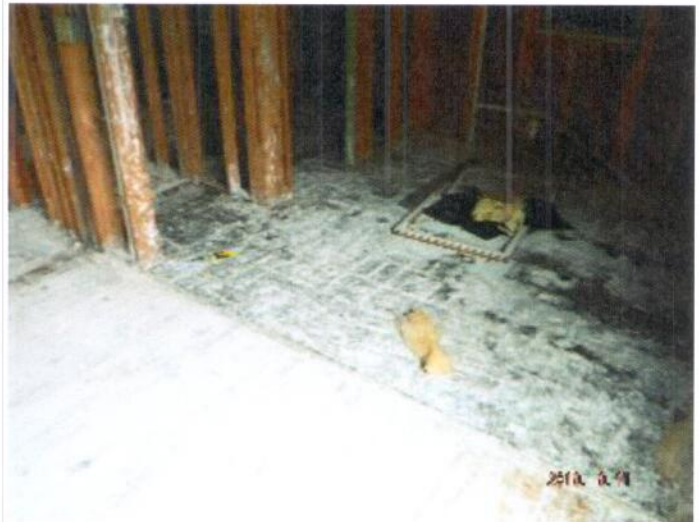
Sample 473-10 Left side kitchen flooring Sheet Vinyl

Lab No.: 6876879  
Client No.: 473-10  
Percent Asbestos:  
**None Detected**

**Analyst Observation:** Brown/Off-White Vinyl Sheet Flooring  
**Client Description:** Sheet Vinyl Flooring  
Percent Non-Asbestos Fibrous Material:  
10 Cellulose  
7 Fibrous Glass

Lab No.: 6876879(L2)  
Client No.: 473-10  
Percent Asbestos:  
**None Detected**

**Analyst Observation:** Tan Mastic  
**Client Description:** Sheet Vinyl Flooring  
Percent Non-Asbestos Fibrous Material:  
None Detected
