Cable exposed near shoreline

Wed, 08/08/2018

Survey conducted of exposed cables at Town Beach

By Cassius Shuman 12/13/2018

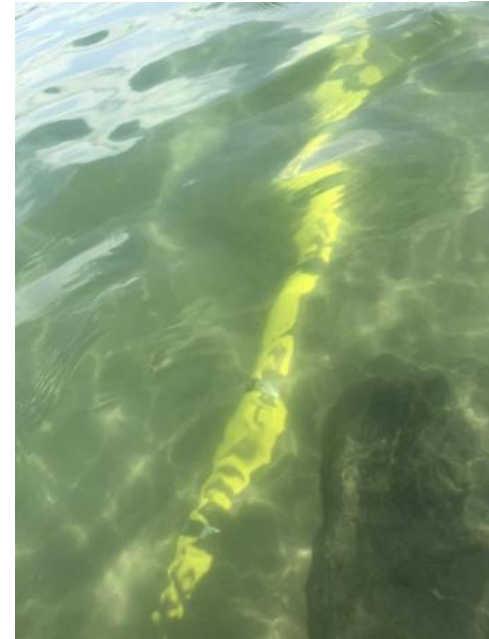
As has been reported by *The Times*, the sea2shore transmission cable, installed by National Grid as part of the Block Island Wind Farm project, can now be seen about 25 feet from Town Beach at low tide. The cable, which is yellow and black, was getting some attention on the morning of Wednesday, Aug. 8. The cable connects Block Island to the mainland.

Beachgoers were floating and swimming above the cable, which at low tide was about three feet below the water. The exposed section of cable is also about 100 feet in front of an area marked by 12 white buoys, which has been designated a “no anchor” zone, to warn boaters not to drop anchor onto the section where the cable is not buried deep enough. — *Lars Trodson & Cassius Shuman*

An exposed section of the cable is seen here about 3' below the water at low tide.

“We will be meeting with them again in two weeks for their solution for immediate resolution, and again in September for proposals on a more permanent solution to this problem,” noted Dwyer. “The CRMC and other permitting agencies are taking this very seriously, and will be pushing National Grid to implement measures, as soon as possible.”

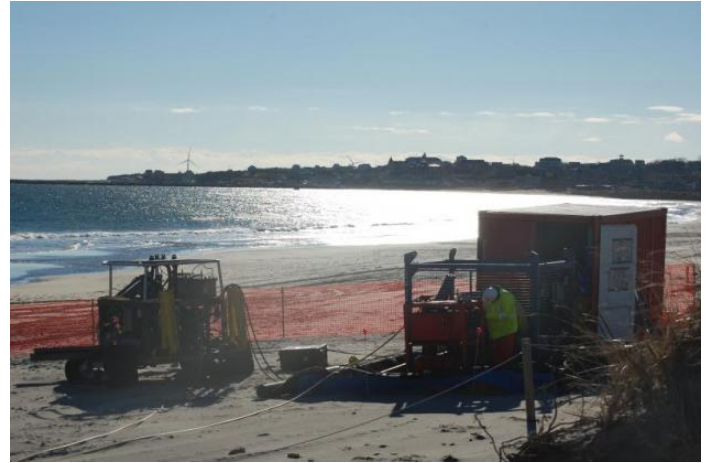
Crews from National Grid and Ørsted U.S. Offshore Wind are surveying the cables at Fred Benson Town Beach to study how best to reach a long-term plan to bury the cables to their appropriate length. Photo by Lars Trodson

There has been an issue of improper burial depth with National Grid's sea2shore cable since it was installed in June of 2016. The subsea cables are heavily armored and were intended to be buried four to six feet beneath the seabed when installed, but after Grid's technicians encountered hard seabed off Town Beach they were unable to meet the burial depth requirement in that locale.

After performing some analysis, the companies learned that shifting sands atop hard bedrock are the reason for the cables becoming exposed. National Grid's sea2shore cable links Block Island to the mainland, while Ørsted's export cable connects the wind farm to the island and its power grid.

New Shoreham town officials have insisted that National Grid and Ørsted implement a long-term solution to mitigate cable exposure at the beach. At a Town Council meeting in June, Town Manager Ed Roberge said that, "The cable needs to be relocated. They did not get their designed depth and they need to." He believes the companies need to provide a long-term solution.
