# ***CHILMARK POND***

## ***Individual System Assessment***

***REVISED: 2/23/2023***

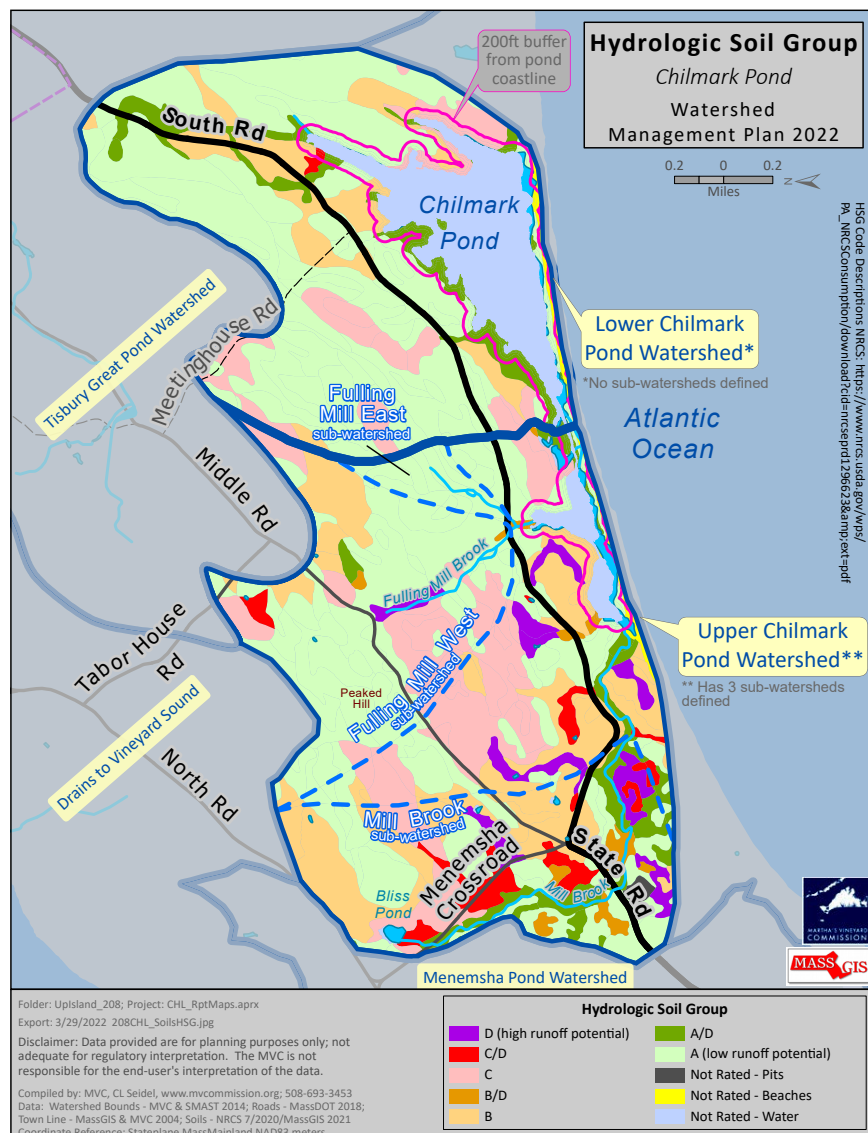
Figure 5. Chilmark Pond Hydrologic Soil Groups

loam, and Pompton sandy loam<sup>13</sup>. Most watershed soils in Chilmark are classified in Hydrologic Soil Groups (HSG) A, A/D, B, and C. HSG A and B are generally suitable for infiltration (Figure 5)<sup>14</sup>. In other words, these soil types are likely to infiltrate (absorb) more rainfall than others. Although the characteristics of these soils may reduce stormwater runoff by filtering stormwater (and wastewater), the characteristics of these soil types can also increase the potential for pollutants to leach into groundwater.

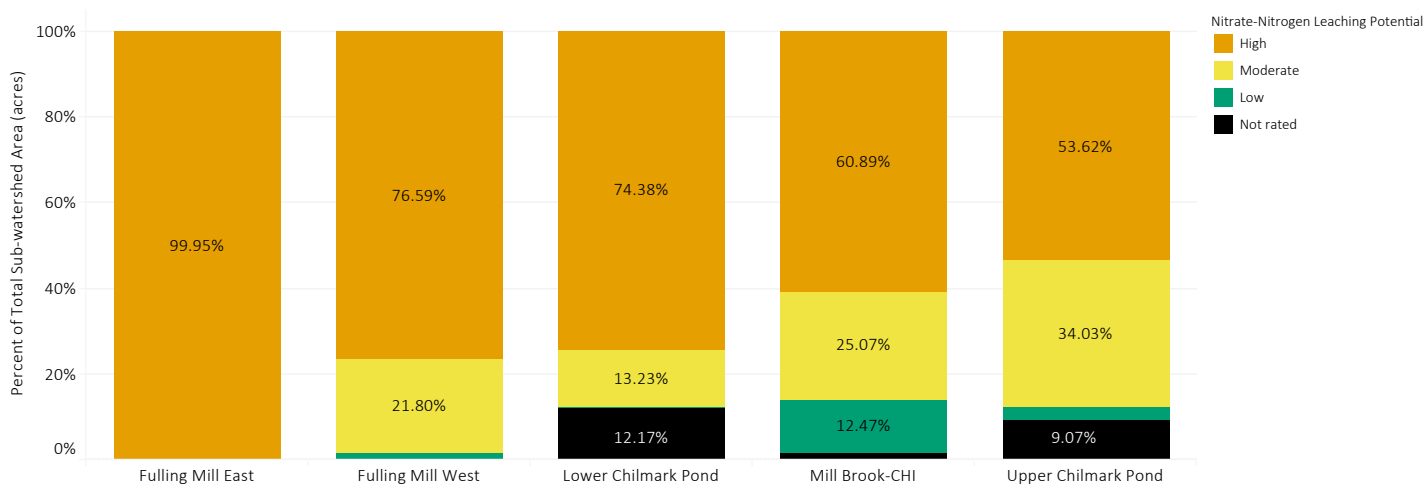
Figure 6. Chilmark Pond Nitrogen Leaching Potential by Sub-watershed

Soluble nitrate is highly mobile and easily moves through the soil profile to groundwater, especially after heavy rainfall or with increased irrigation. The characteristics of soils in the Chilmark watershed are more likely to transport nitrogen to groundwater and are therefore associated with susceptibility to nitrogen pollution. Most (69%) of the Chilmark Pond watershed soils are categorized with a high potential for nitrate-nitrogen leaching<sup>15, 16</sup>. Upper Chilmark Pond and Mill Brook-CHI soil characteristics are less likely to transport pollutants and therefore have lower nitrogen-leaching potential than the watershed as a whole (Figures 6 and 7).

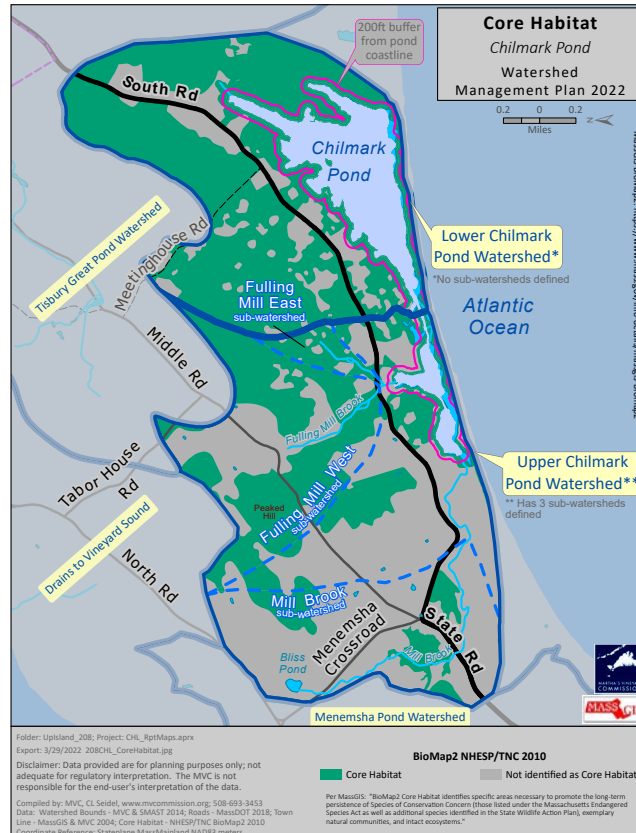
**Figure 17. BioMap2 Core Habitat Landscape (Note Core IDs correspond with elements list)**

Core Habitat (Figure 17) and Critical Natural Landscapes (Figure 18) are intended to protect the state's biodiversity and their habitats in the

face of climate change, these areas are mapped under the BioMap2 (2010) project. Core Habitats include: Aquatic Core, Priority Natural Communities, and Species of Conservation Concern<sup>44</sup>. Critical Natural Landscapes include: Tern Foraging, Coastal Adaptation, Upland Buffer of Aquatic Core, and Landscape Blocks<sup>45</sup>. There are approximately seven endangered species, 21 threatened species, and 27 special concern species listed in the Chilmark Pond watershed in the Core area<sup>46</sup>. The Core area is also home to one imperiled natural community (Estuarine Subtidal: Coastal Salt Pond) and one critically imperiled natural community (Sandplain grassland)<sup>47</sup>.

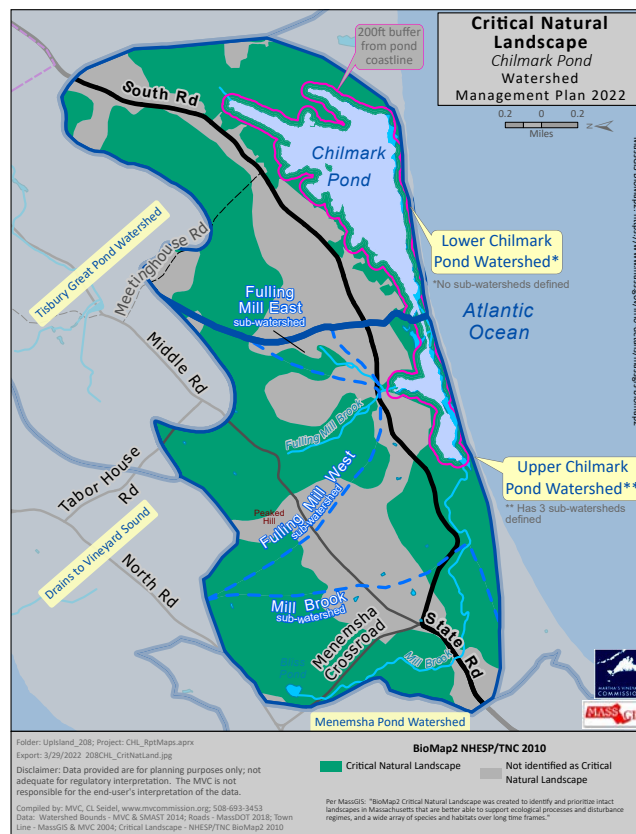
**Figure 18. Critical Natural Landscape Map**

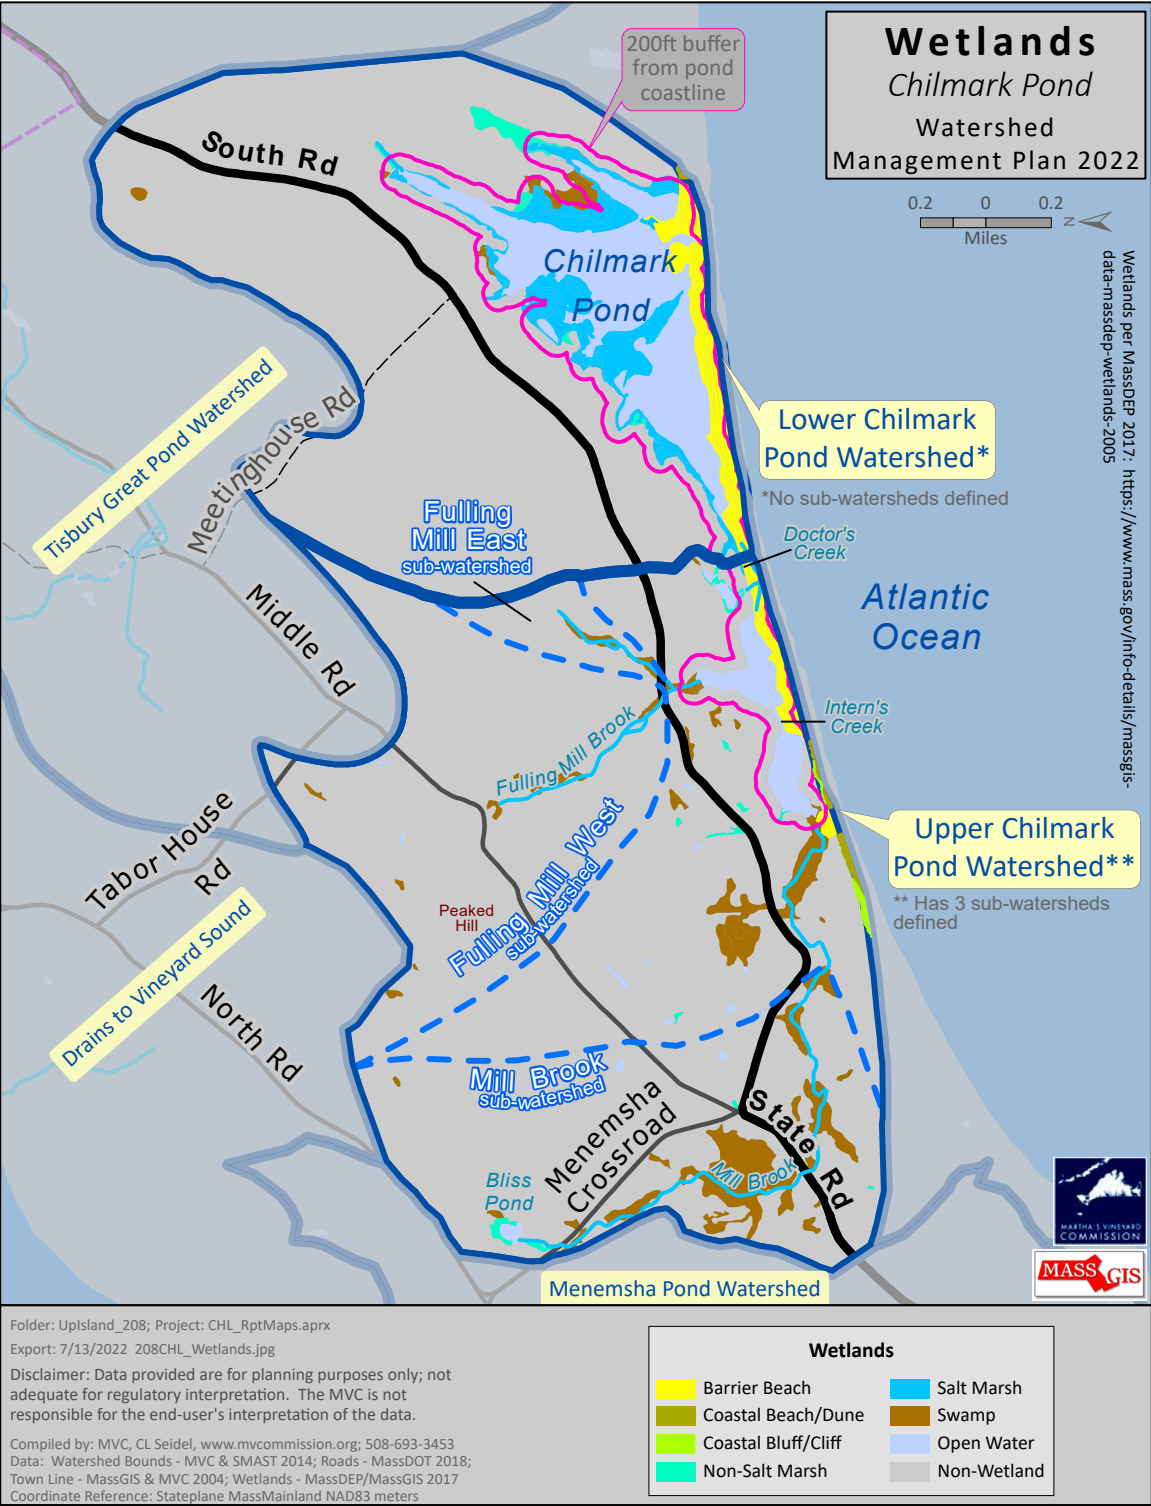
Figure 19. Chilmark Pond Watershed Wetlands Map

Wetlands also provide valuable habitat benefits to a variety of wildlife species and to overall water quality in associated aquatic systems (Figure 19). While areas of the Chilmark watershed

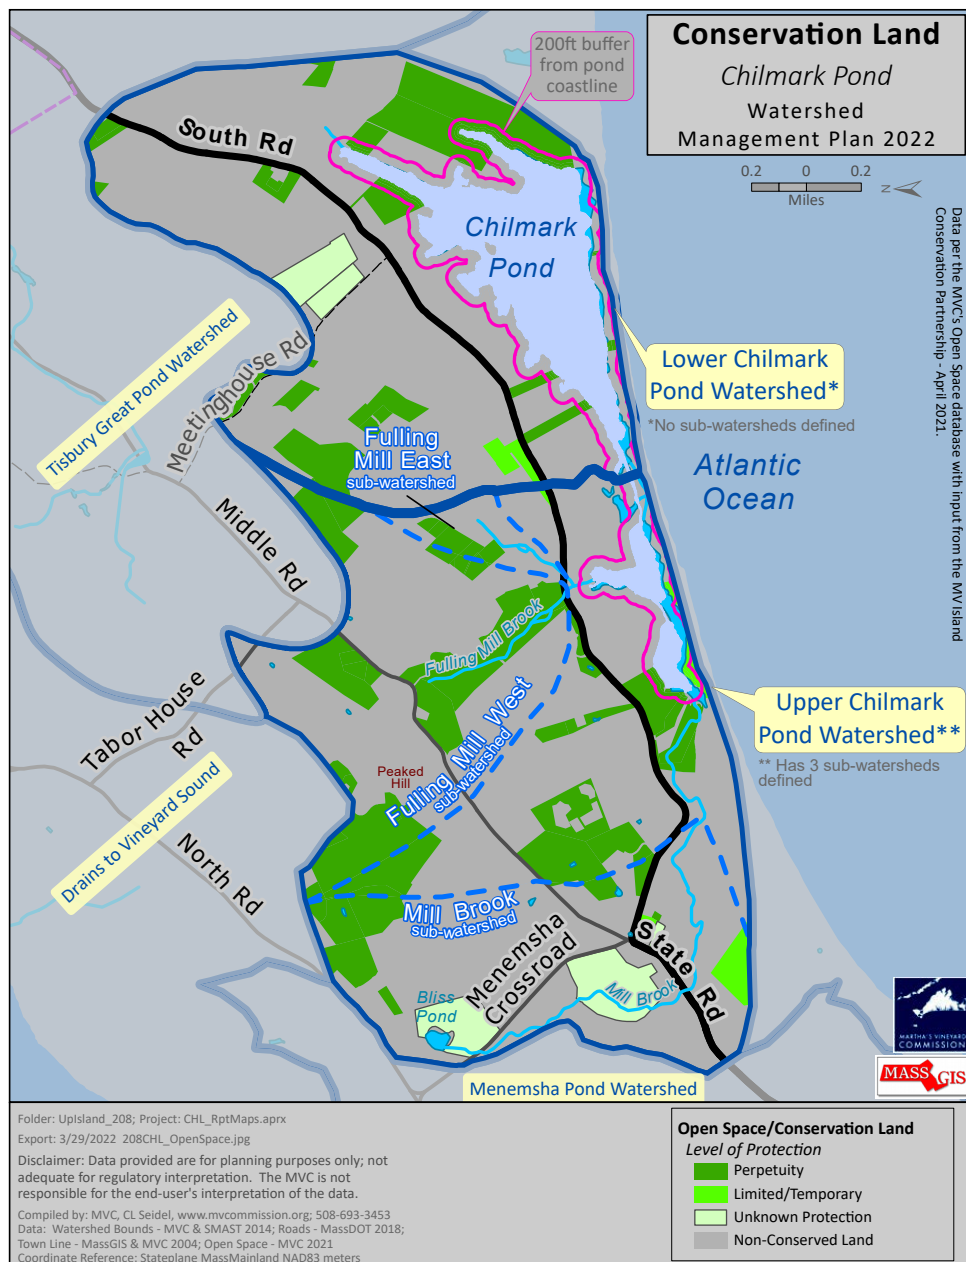
Figure 35. Chilmark Pond Watershed Conservation Land Map

Approximately 22% (745 acres) of the Chilmark Pond Watershed is conserved with some type of legal protection in place. Protections can be based on agricultural, conservation, or easement restrictions (Figure 35).
