JAMES POND

Individual System Assessment

Martha's Vineyard Commission

February 2023

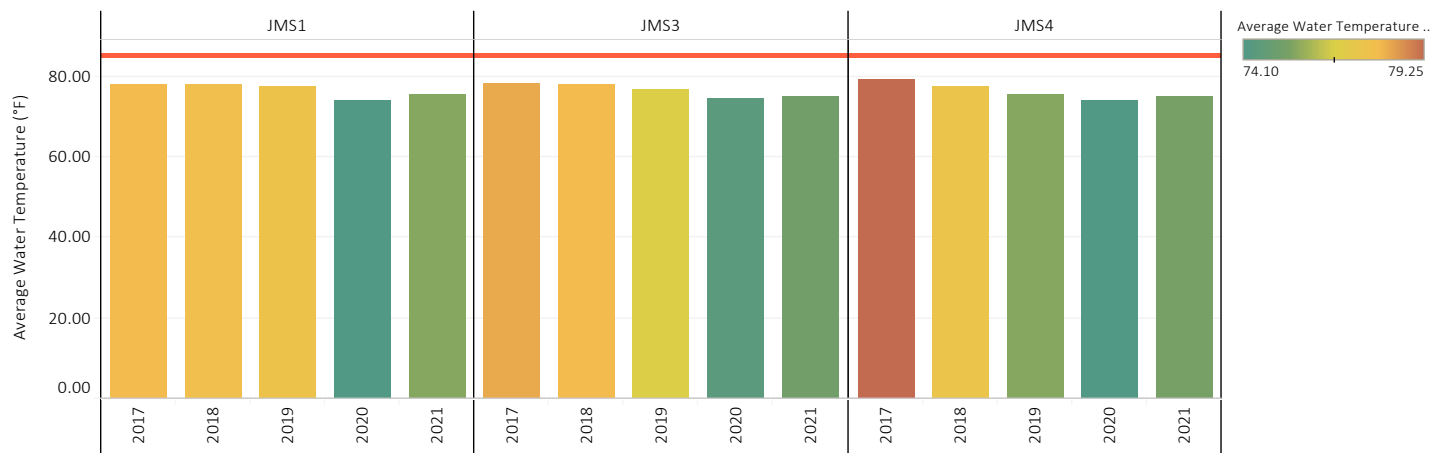
Figure 11. James Pond Temperature Data (2017-2021)

Massachusetts surface water quality standards state that coastal water temperature shall not exceed 85°F (29.4°C) nor a maximum daily mean of 80°F (26.7°C). The **RED LINE** indicates the 85°F (29.4°C) limit. <https://www.epa.gov/sites/default/files/2014-12/documents/mawqs-2006.pdf>

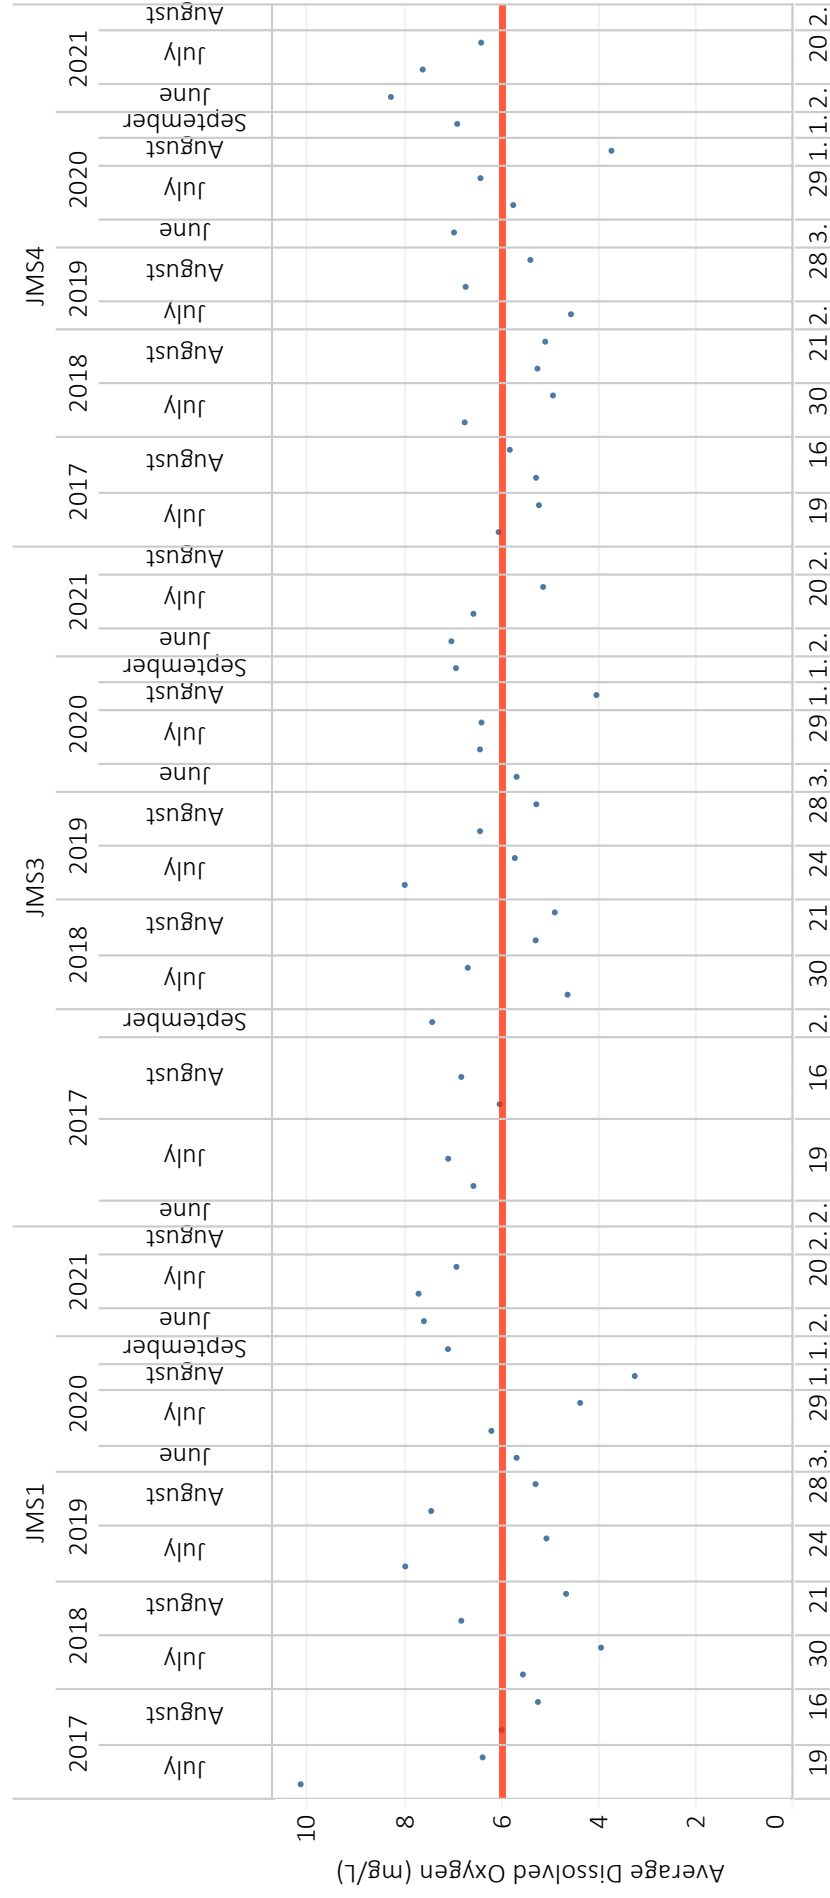
Figure 13. James Pond Dissolved Oxygen (2017-2021)

The frequency with which DO fell below 6mg/L at all James Pond sites indicates that DO is likely to fall below the recommended stress threshold at night during summer months, especially at JMS1 and JMS4 where the DO was measured above 6mg/L nearly as often as it was below. Consequently, one could expect the benthic communities in these areas to exist in stressful habitat conditions²⁶(Figure 13).

The **RED LINE** indicates the threshold dissolved oxygen level, values below this line are associated with stressful conditions in which aquatic species fail to thrive.

*All values represent dissolved oxygen levels taken at the BOTTOM surface of the pond.
