MEMORANDUM

TO: Martha's Vineyard Commission
FROM: Eric Dray, Preservation Consultant
DATE: October 4, 2022
RE: Architectural Peer Review - DRI #736, 43 Look Street, Vineyard Haven

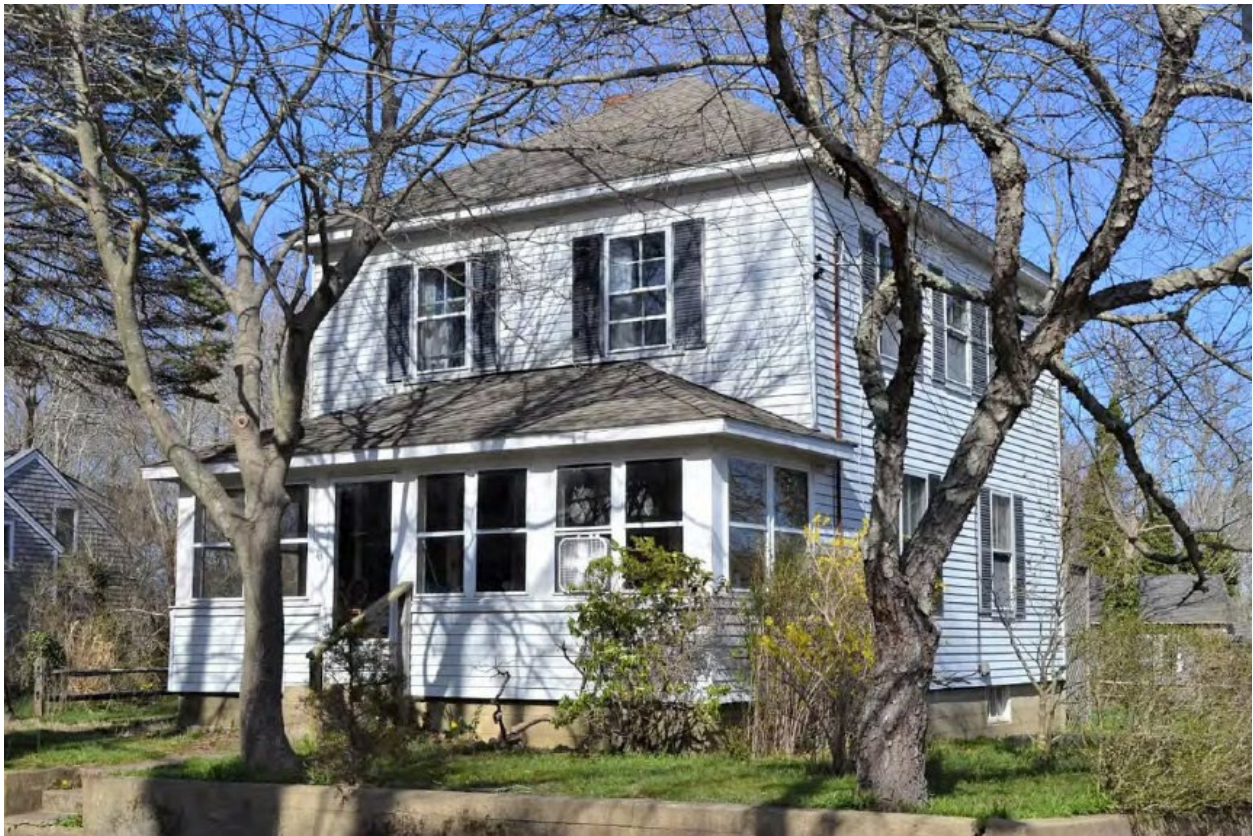
View of 43 Look Street, looking northeast.

43 Look Street has all the hallmarks of a Four Square design: boxy shape, 2 ½-stories with hip roof, two-bays wide by two-bays deep, mostly symmetrical fenestration on each elevation, a front porch spanning the front elevation, and four rooms to a floor. The house does not have any architectural embellishments that connect it to a specific style.

The house rests on a concrete block foundation, including the front porch. The elevations have been clad in aluminum siding. The original siding may lie beneath. The wood trim of the projecting box roof cornice remains exposed. The house retains what may be original or early wood 2/2 double-hung sash. The open porch has been enclosed, but within the porch is a wood paneled door with large lite that may be an early or original front door.

Despite these alterations, the house retains its integrity as an example of an American Four Square house. The overall form, window openings, possibly the windows themselves, the front door, and some of the exposed wood trim all appear to be original. A review of floor plans and interior photographs included with the DRI application show that the floor plan is typical of Four Square houses - four rooms per floor - at it remains largely intact.

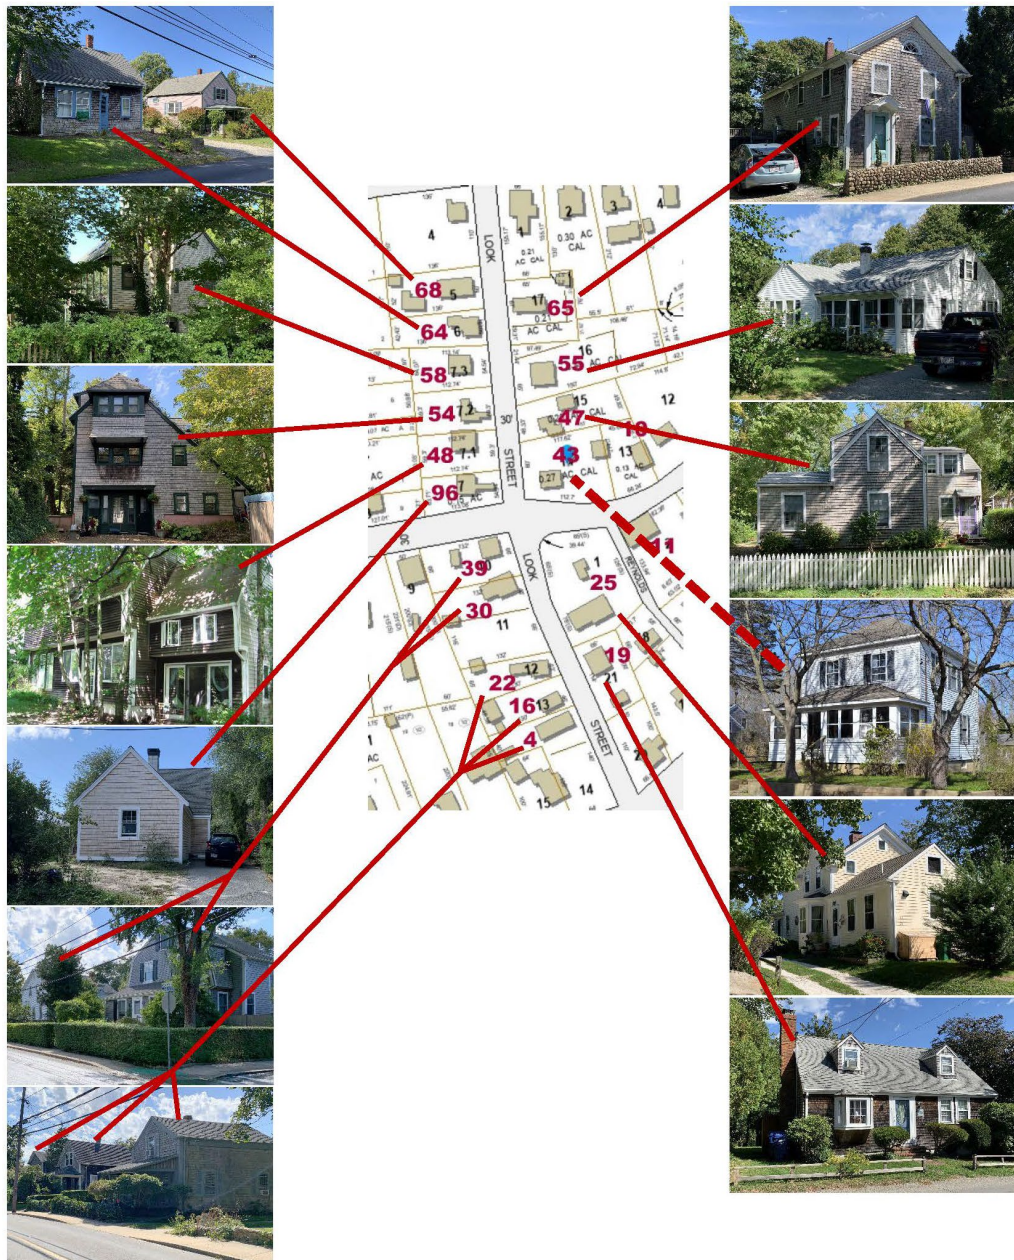
Figure 1. Diagram of Look Street corridor.

I believe the relevant context for assessing relationships to neighboring properties consists of houses along Look Street between State Road and Spring Street (see Figure 1 below).

- Look Street rises up from State Road to the south, and drops back down to Spring Street to the north. This change in topography, and the fact that properties at the intersections with State Road and Spring Street are oriented to those other streets, creates a developmental and visual separation.
- Properties that extend down William Street to the east are of a different character and development period, and the change in topography and road direction creates a visual separation.
- There are some late-19th and early-20th century resources along West William Street, similar to those found along Look Street, but they are not visually connected to the Look Street corridor.

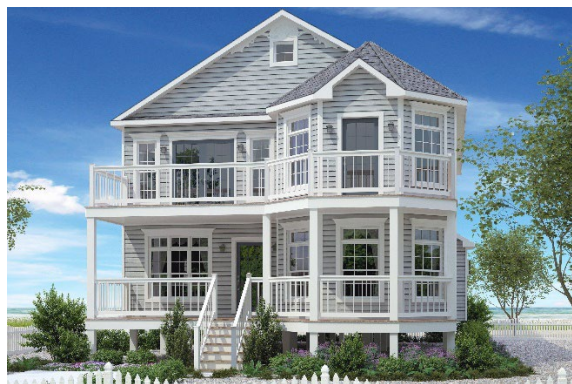
Figure 4. New house at 43 Look Street.

Style and Form: The proposed house has a design that could be characterized as a modern interpretation of the Queen Anne style which was popular from ca. 1880-1910. The Queen Anne style employed different roof shapes, including corner turrets like that found here, to animate the building's form (see Figures 4 and 5). There is no precedent for this more elaborate Victorian-era house style and form on Look Street.

Windows and Doors: In comparison to other houses along Look Street, this house has far more fenestration on the front elevation. The front elevation is particularly problematic because it not only has extensive, large-scaled windows, but also has three other doors that are fully fenestrated - the second story has a multi-lite single door and multi-lite paired (French or sliding) doors (Figure 4). This is also the only house on Look Street with more than one door on the front elevation – in this case a total of four.

Porches: There is no precedent for double-height porch/decks along Look Street. A number of houses do have covered one-story front porches, but they all employ shed or hip roofs to cover those spaces. Those roofs have the effect of incorporating the porches into the main body of the house. With the flat roof required for a second story deck, this (metal?) structure would appear tacked onto the body of the house in a way not found along Look Street.

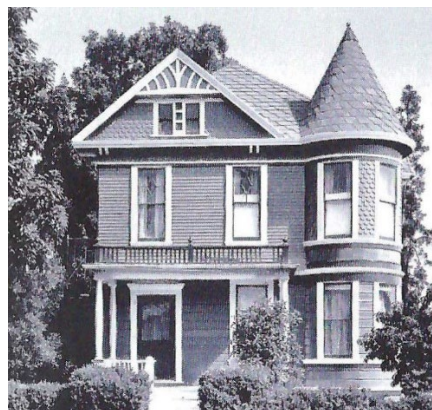
Figure 5. Late-19th c. Queen Anne-style house (Source: MacAlester, *Field Guide*).
