Informational Screening for Regional Impact Review of Proposed Demolition

Historic/Cultural Significance: The structure located at 97 Iroquois Ave, Tisbury (West Chop) was built in 1897/1898.

The Proposed Plans

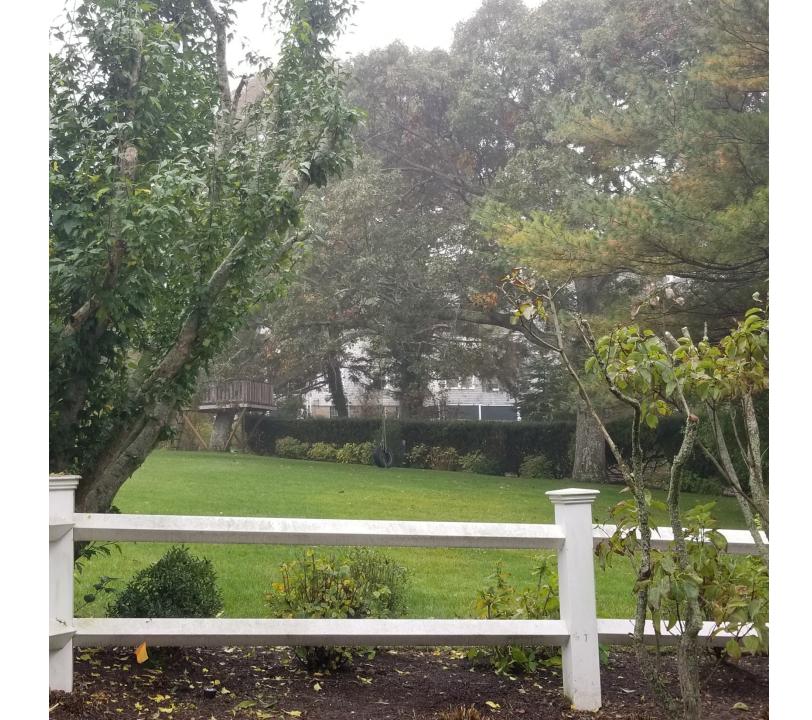
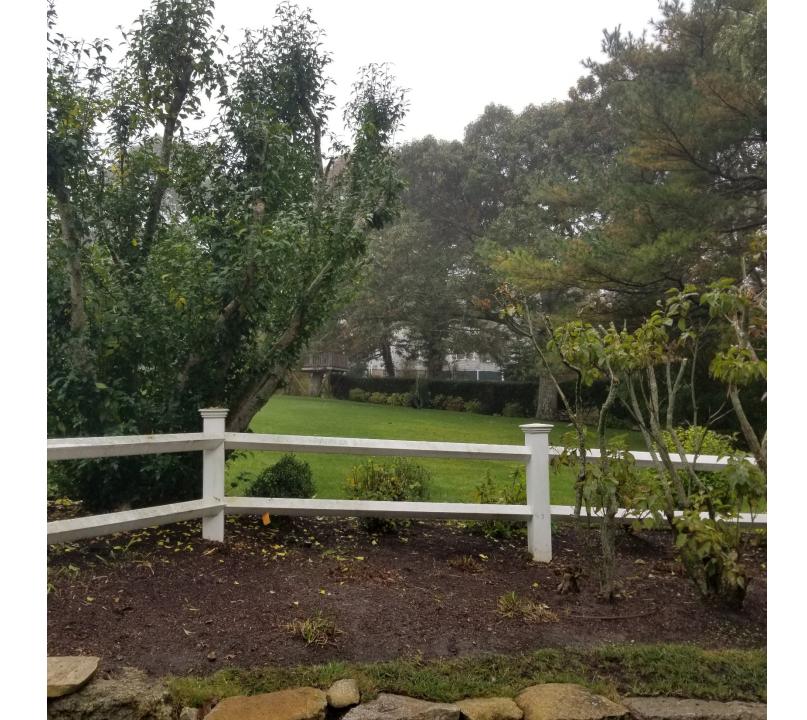
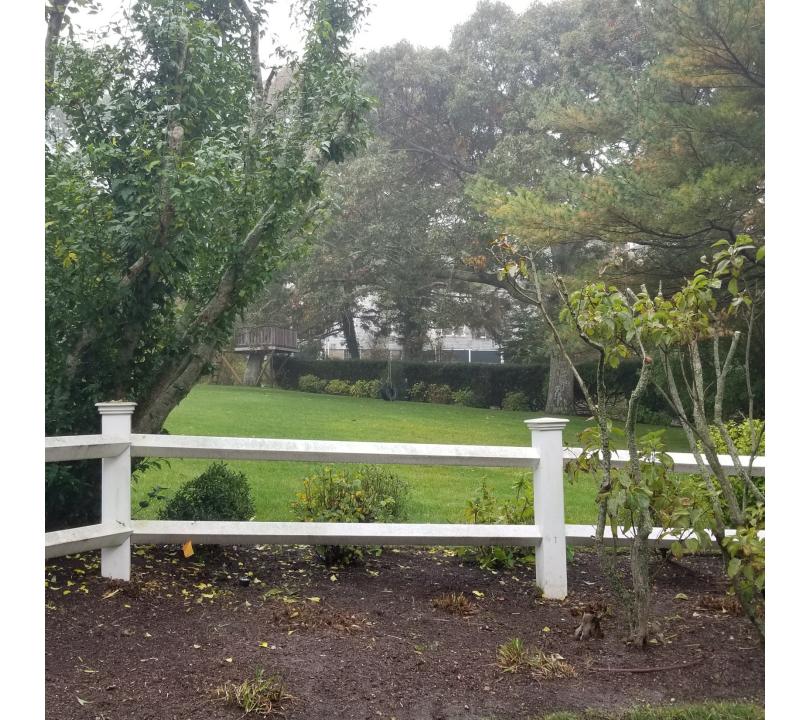
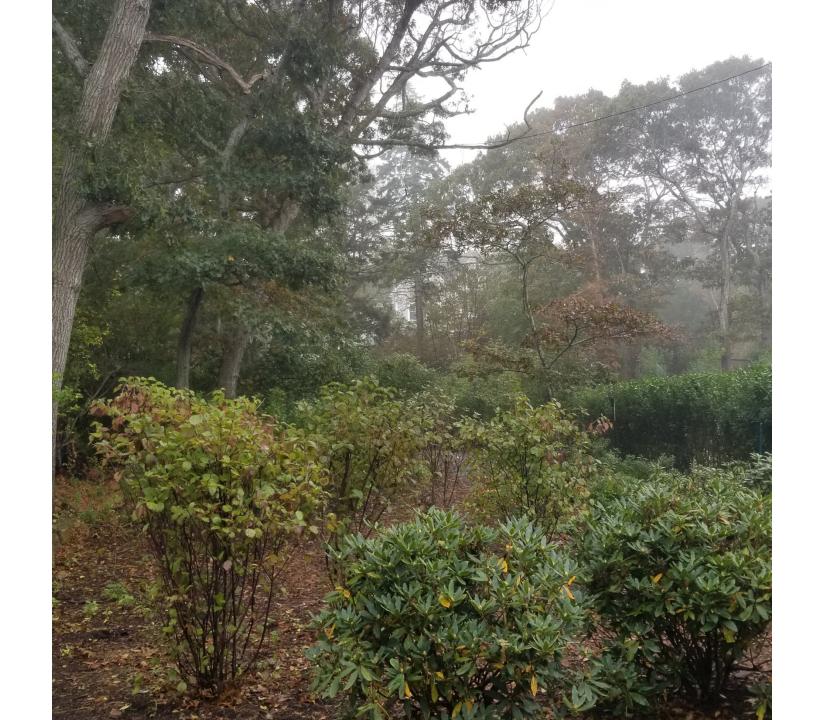
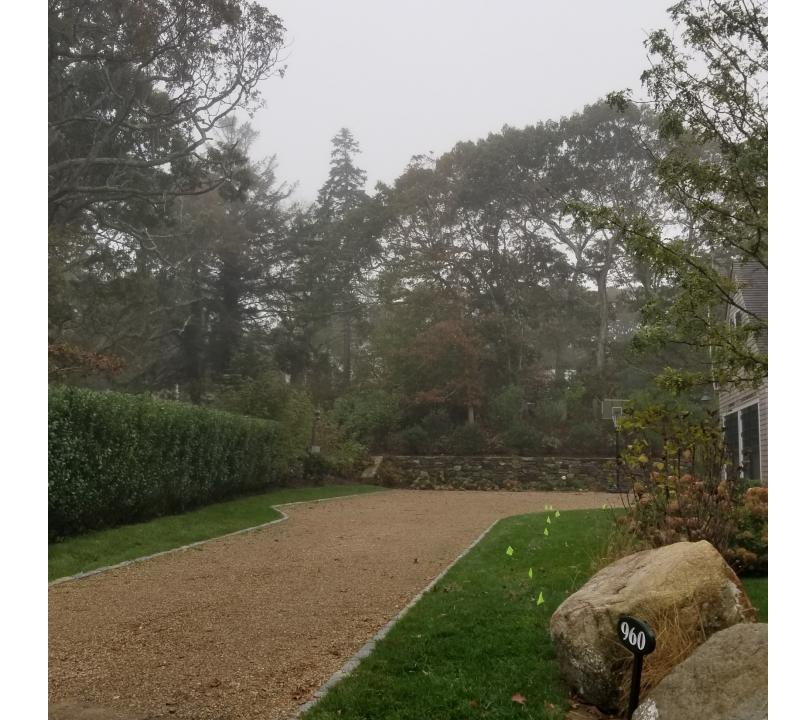
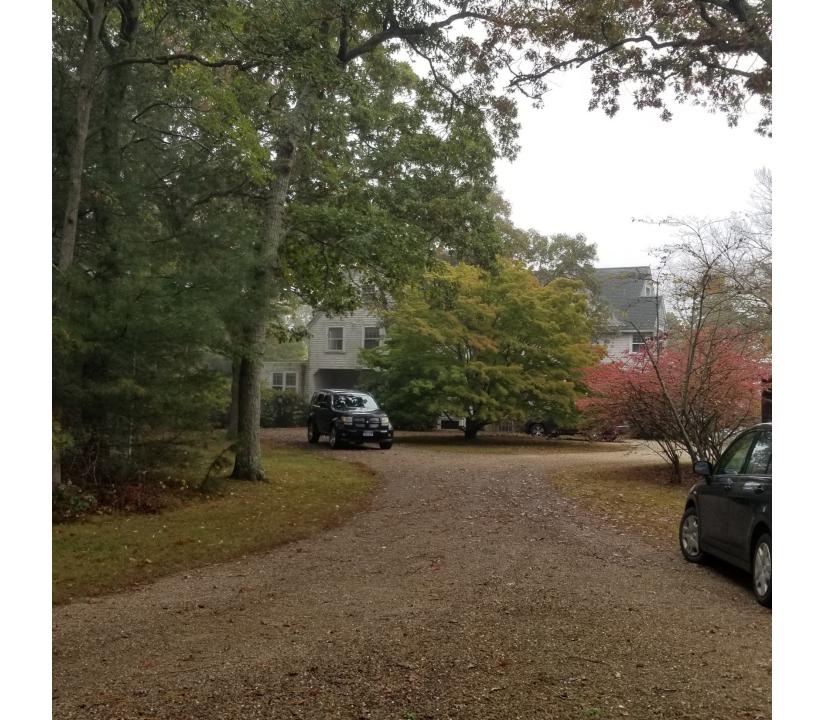
Views From the Public Way

Contribution to Context: The north side of the structure is visible from Main Street as part of the neighborhood and the south side is visible from Iroquois Ave.

Integrity: The house retains essential character-defining features of construction of the late 19th century but has been altered in the way of an added porch on the north side of the structure.

Condition: The home is in good condition except for the foundation and porch.

(Page 6): Continuing north along Main Street, north of its intersection with Iroquois Avenue, stands the Jolliffe House at 97 Iroquois Avenue (MHC 148). a 2'Z-story, gable-roof building sheathed in wood shingles with lattice underpinning along the foundation line. The building sits back from the road at the end of a dirt drive (identified as "Brud Warner Circle") leading off of Iroquois Avenue. The building's primary entrance is located on its southeast elevation within a 1-story, hip-roof, screened-in porch. A secondary entrance is located within a 1-story, integral porch with square posts on the southwest elevation. A ramp with iron rail leads up from the driveway to this porch. Oversized gable-roof dormers are located on both roof slopes. Fenestration consists of 12/12 and 9/2 double-hung sash windows within molded surrounds. The building features three interior, brick chimneys: one on the building's north roof slope, an other near the ridge, and the third at the south end of the building. A 1/2-story, side-gable, concrete block outbuilding features 6/6 double-hung sash windows. To the southeast of the south of the house. The outbuilding features 6/6 double-hung sash windows. To the southeast of the outbuilding stands a 1 V^-story, gable-roof garage (MHC 150) sheathed in wood shingles and set on a concrete foundation. The second outbuilding features a small, 1-story, shed-roof ell on its southeast elevation and 4/4 and 1/1 double-hung sash.

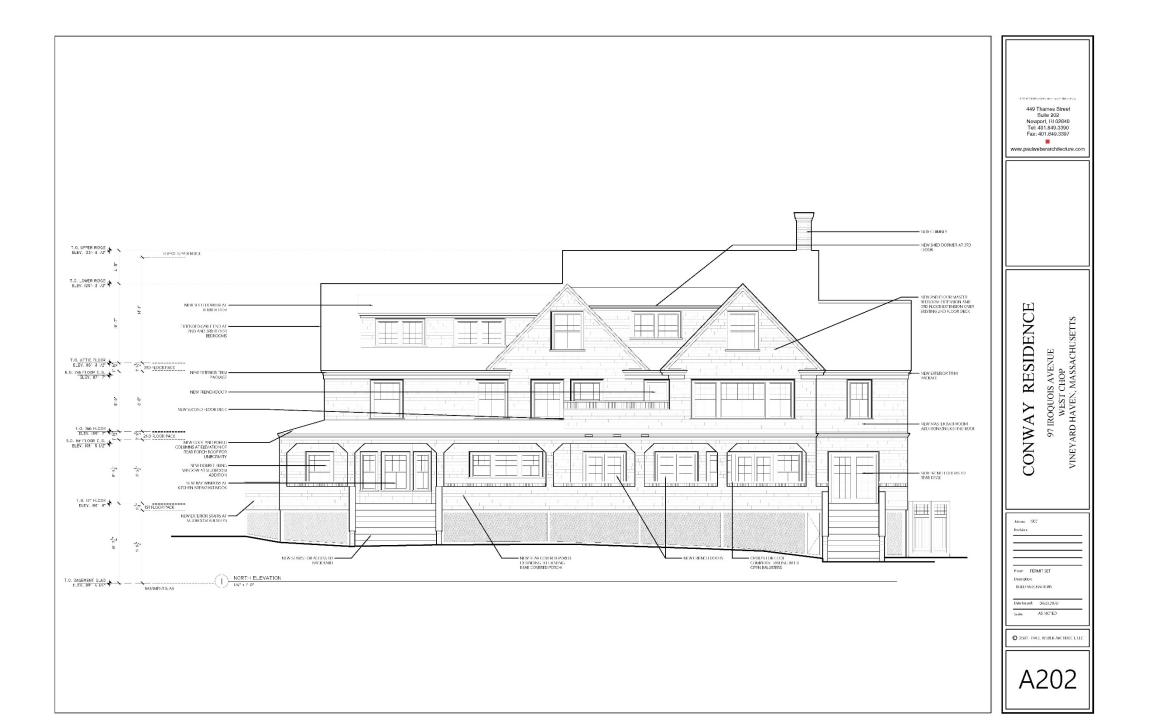
Replacement Program: Proposed plans have been submitted for a new foundation and additions to be made to the north side of the house.

- 1. Side wall shingles will be white cedar.
- 2. Roof shingles will be an architectural grade asphalt shingle to match existing.
- 3. Windows will be Marvin ultimate clad windows with 7/8" SDL muntins. Windows will match existing light cuts, 9/2, 12/2, etc.
- 4. Window and door exterior trim will match existing with $5/4 \times 4$ trim with a back band.
- New exterior rake and eave trim will also match existing trim profiles.
 New lattice at foundation will match existing lattice.
- 7. New copper flashing will be 16oz bright copper.
- 8. New brick chimney will match existing brick chimneys.
