MEMORANDUM

RE: DRI #718, 7 Arlington Avenue, Oak Bluffs - Demolition

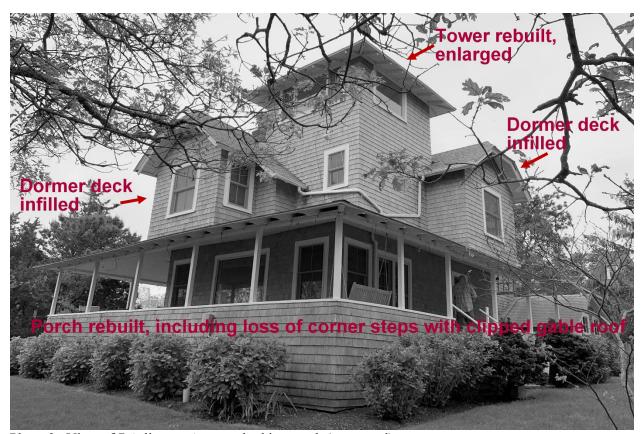
Photo 2. View of 7 Arlington Avenue, looking south (annotated).

Alterations include the following (see Photos 1 and 2 for further reference):

- Removal of all ornamental trim. The house in its original form was highly ornamented, including vergebaords, roof-top finials and cresting, patterned roofing (presumably slate), and turned porch posts with ornamental brackets.

- Replacement of corner turret with larger tower.
- Replacement of wrap-around porch. This was likely done when the house was moved in 1917. The replacement porch has no ornamental details, and the corner steps with clipped-gable roof were not replicated.

- Infilling of dormer decks.
- It is unclear if the rear ell is original to the house. The ell appears to have a similar roof height, but in the original location, the second story appears to have been stepped back, which is no longer the case.

- Window replacement and resizing. None of the windows appear to be original or historically significant. The majority of the windows appear to originally have been wood, 2/2 double-hung sash. These windows have all been replaced with modern, thermal 2/2 windows and large fixed sash.

Conclusions: In its current form, 7 Arlington Street retains some of the Queen Anne-style irregular massing of the original 1875 villa, most notably the roof forms with clipped-gable dormers on both sides of the corner tower. However, the house has lost all ornamental trim that animated the elevations and roof; and the primary reference to the Second Empire style – the Mansard-roofed turret – was replaced by a larger, astylistic corner tower with shallow hip roof.¹

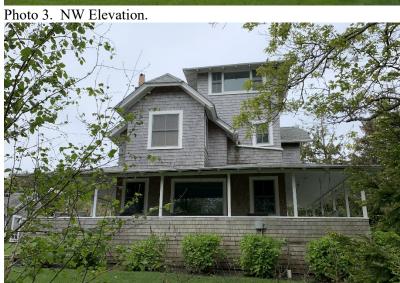
Photo 4. NE Elevation.

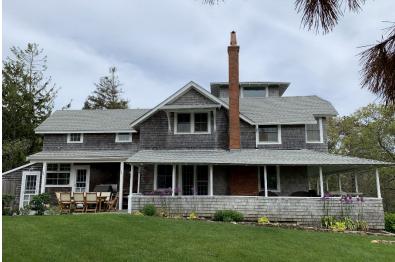
Photo 5. SE Elevation.

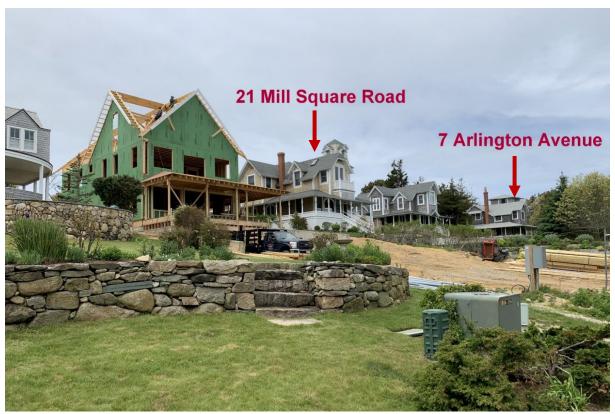
Photo 6. View looking north from East Chop Drive (annotated).

Observations: 7 Arlington Avenue is aligned with, but slightly separated from the row of cottages on the ridge above East Chop Drive (see Photo 6). The four most adjacent houses date(d) to the late-1800s, but 19 Mill Square Road has been demolished and a new house is under construction. The remaining 19th century cottages are similar in scale and siting.

The row of cottages is of a heterogeneous mix of styles. The cottage at 21 Mill Square Road is most similar in style and form to 7 and 11 Arlington Drive. The 1978 MHC Building Form for 21 Mill Square Road also identified its architectural style as Expansive Campground.² Both Palmer Villa and 21 Mill Square Road were moved here from elsewhere in Oak Bluffs, and they were built in their original locations within a year of each other (1875 and 1874 respectively). 21 Mill Square Road was originally located on Ocean Park. It was moved to this location in 1891. Palmer Villa was moved here and divided into two cottages in 1917. Unlike 7 Arlington Street, 21 Mill Square Road has retained its Mansard-roofed corner turret, and retained or replaced-in-kind a fair amount of the ornamental detail.

Conclusion: It was likely intended that 7 Arlington Avenue be located in a manner that continued the row of summer cottages on the ridge overlooking Vineyard Sound. Although somewhat altered, 7 Arlington Avenue does provide the north terminus to a distinct row of late-19th century cottages.
