Chilmark Planning;  
Menemsha Corridor Plan for Improvement

**[Analysis + Recommendations]**

Prepared for the:  
Martha's Vineyard Commission and the Town of Chilmark, MA

October 30, 2017

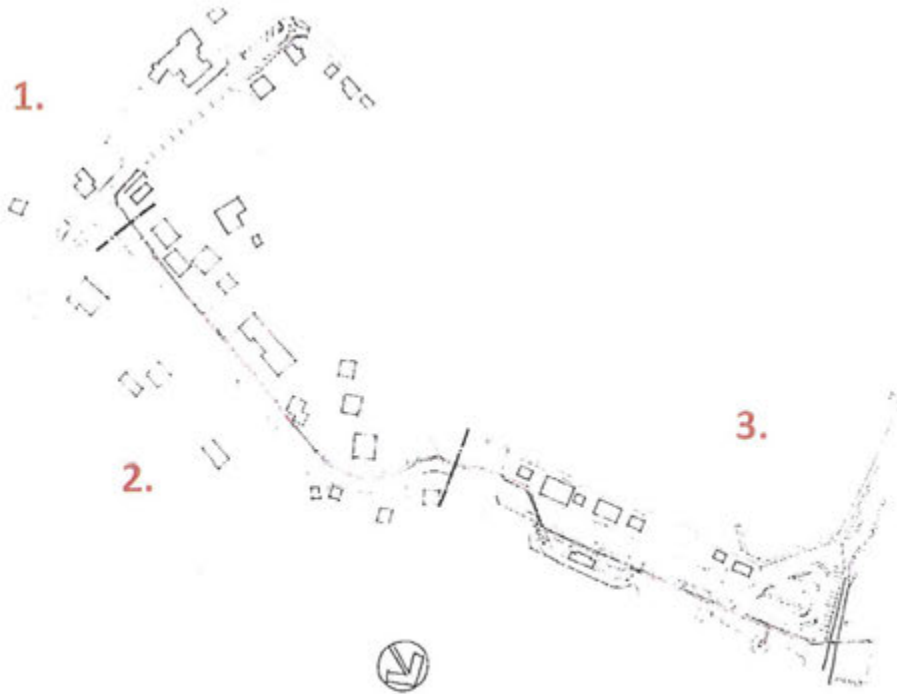
Above: Project extents.

The following represents our review of the existing conditions in the Village of Menemsha. For ease of description, the project has been divided into 3 parts:

1. North Road from the intersection of Basin Road to Boat House Road.
2. Basin Road from Dutcher Dock to the intersection of North Road.
3. Menemsha Beach to Dutcher Dock.

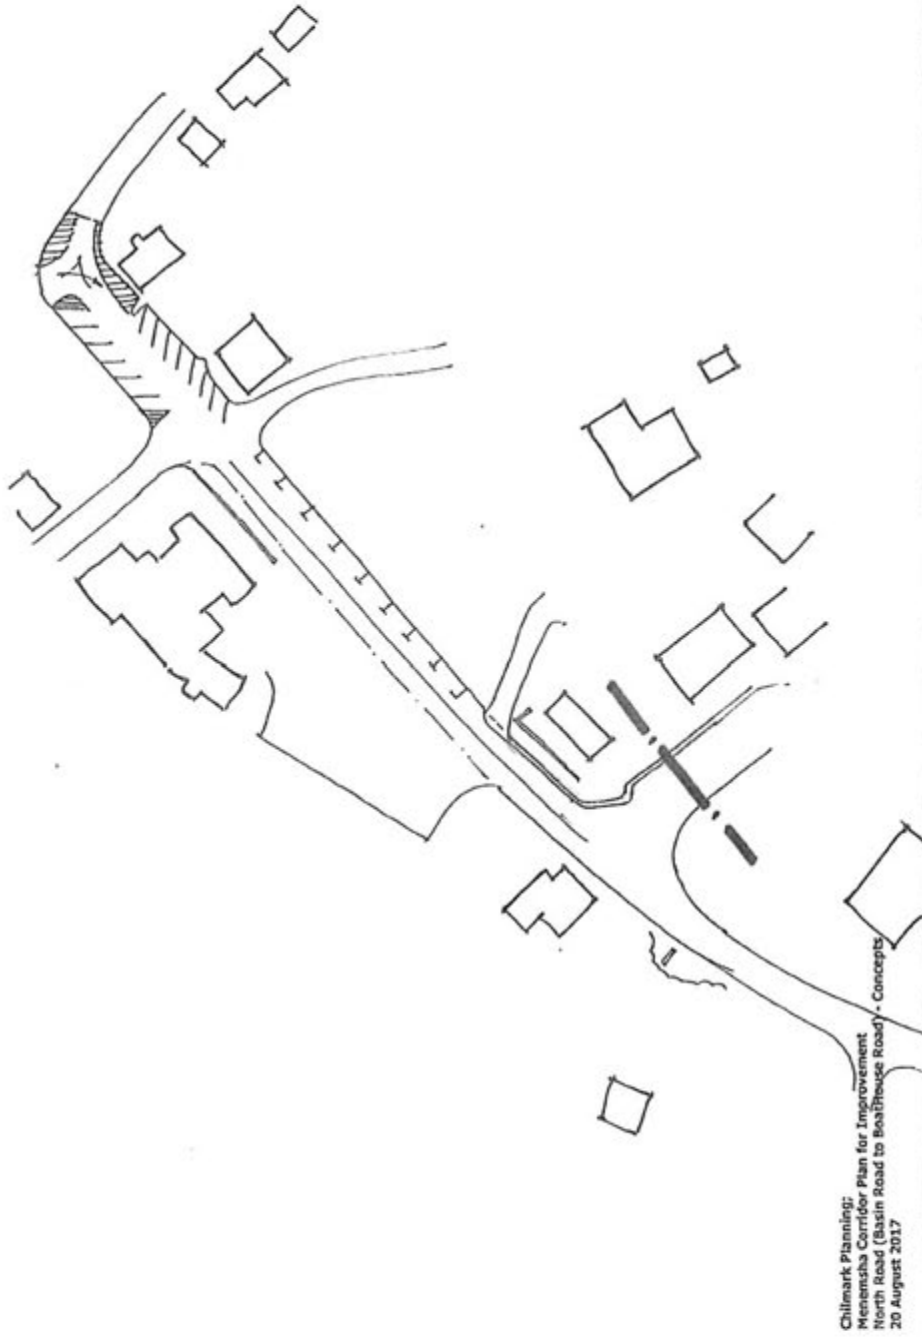
**North Road (Basin Road to Boat House Road)**

Chilmark Planning:  
Menemsha Corridor Plan for Improvement  
North Road (Basin Road to Boat House Road) - Concepts  
20 August 2017

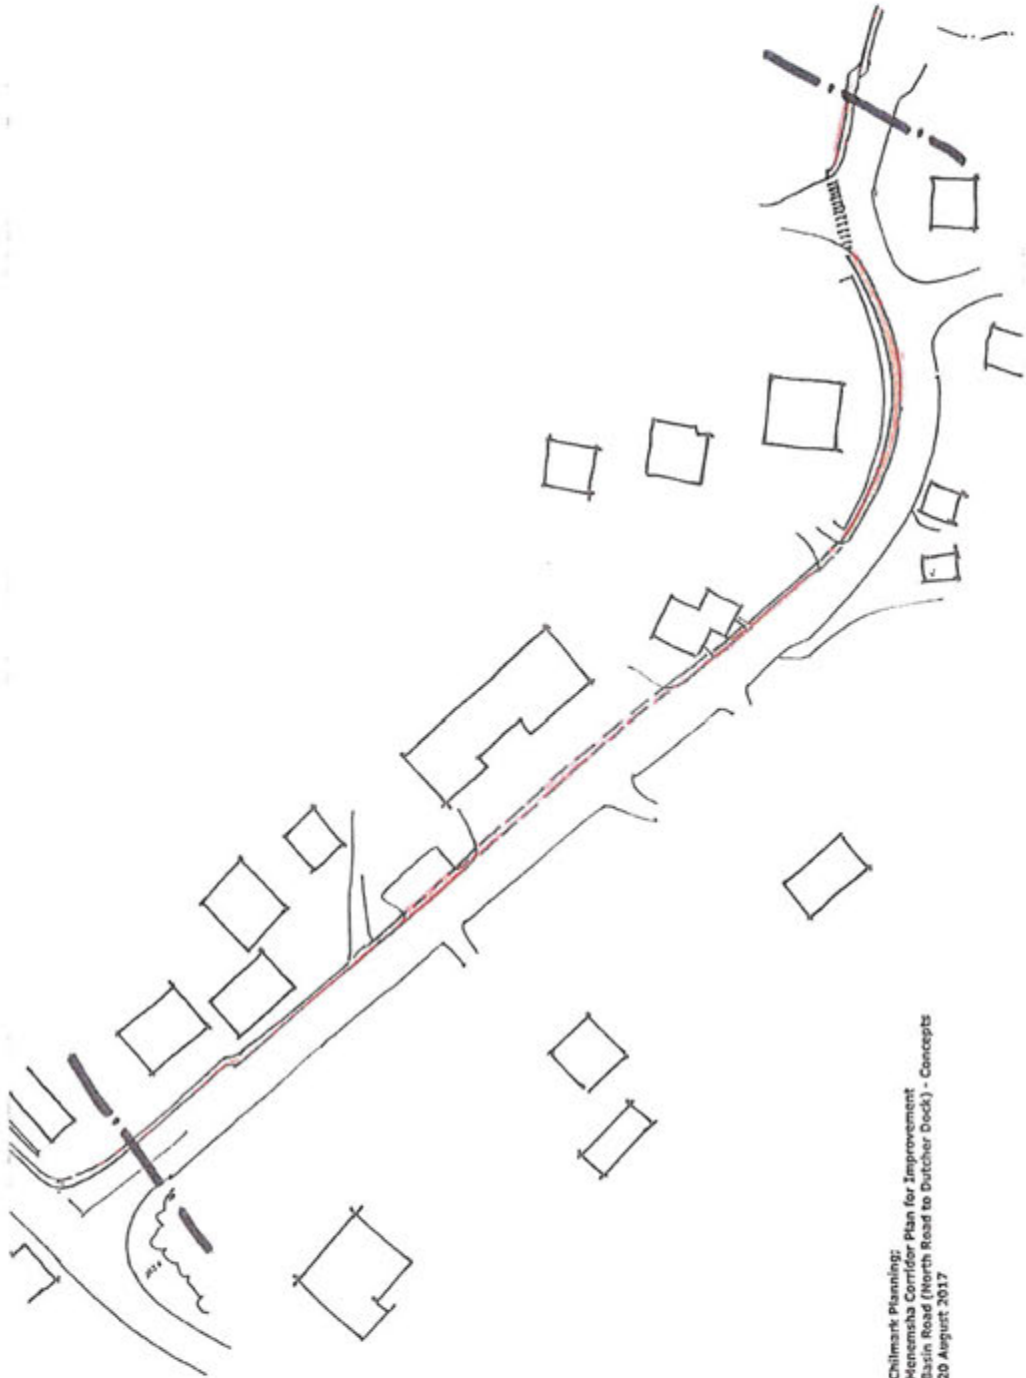
11x17 Basin Road to Dutcher Dock

Chilmark Planning:  
Menemsha Corridor Plan for Improvement  
Basin Road (North Road to Dutcher Dock) - Concepts  
20 August 2017

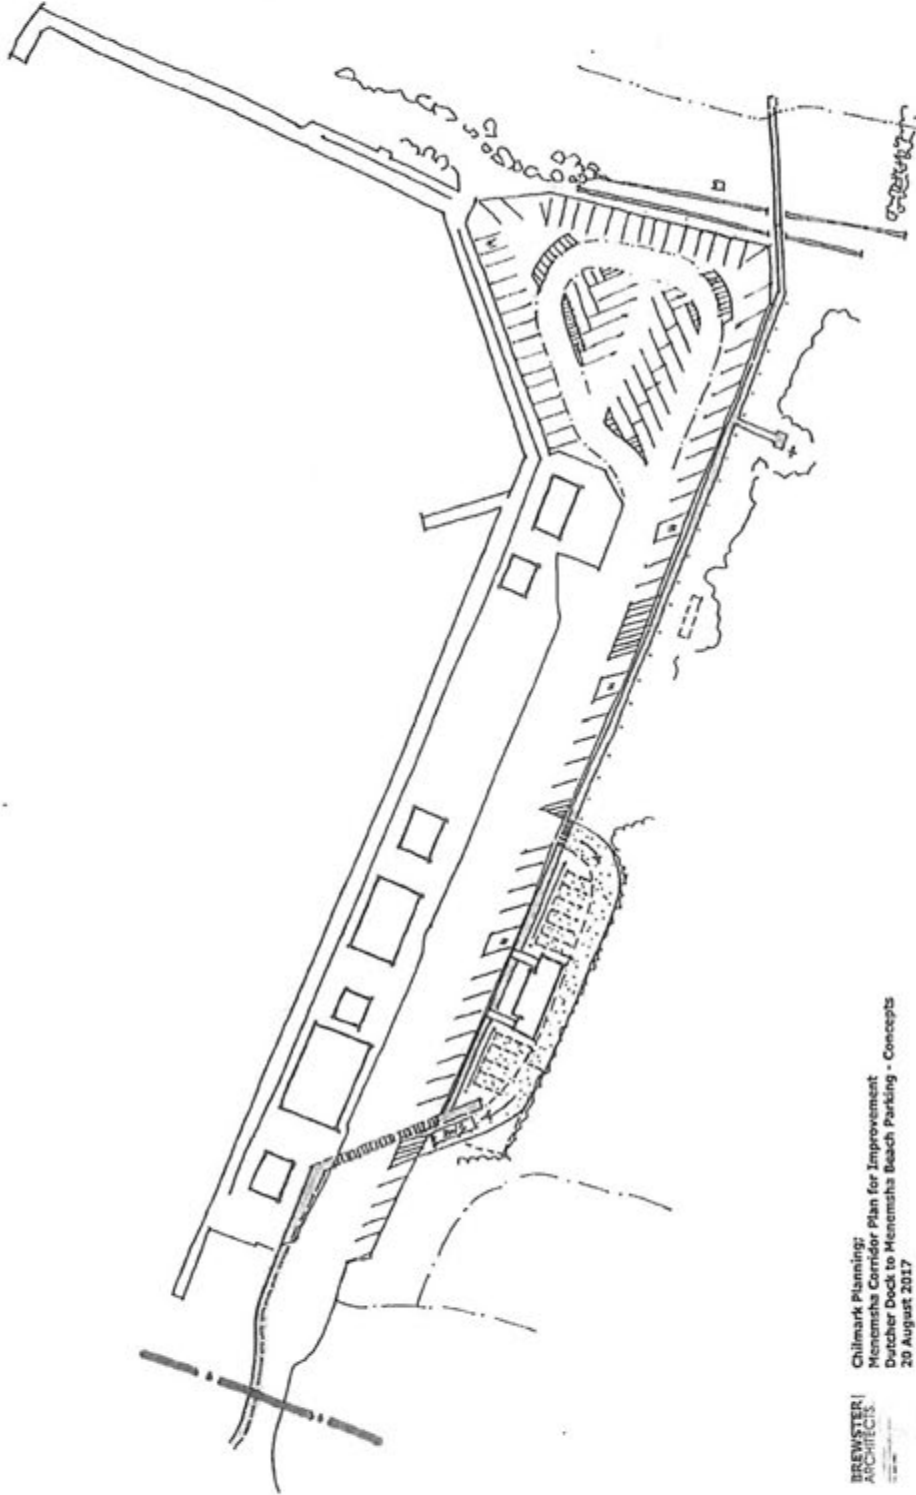
BREWSTER  
ARCHITECTS  
Chilmark Planning  
Menemsha Corridor Plan for Improvement  
Dutcher Dock to Menemsha Beach Parking - Concepts  
20 August 2017

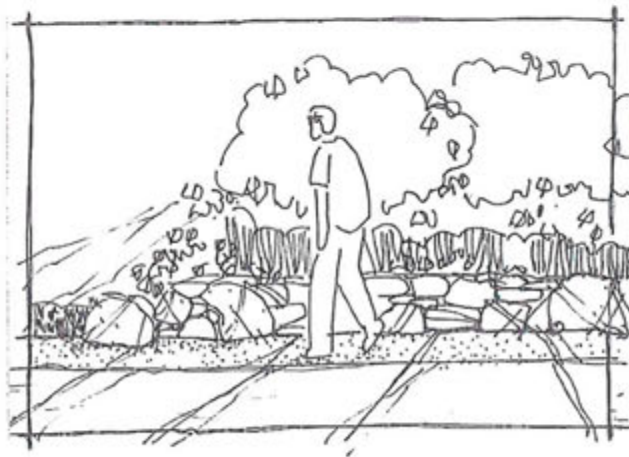
Right: Retaining wall, plantings and shell/crushed stone path.

Basin Road from the intersection of North Road offers a simple path along the business fronts on the east side of the street. A crushed stone and shell path approx. 36-48 inches wide located at the immediate edge of the road pavement is simply installed in place of gravel and turf. Where the path crosses existing paved drives and parking, a marked path can be provided. A couple of areas require the relocation of business' landscaping out of the ROW to accommodate the new path.

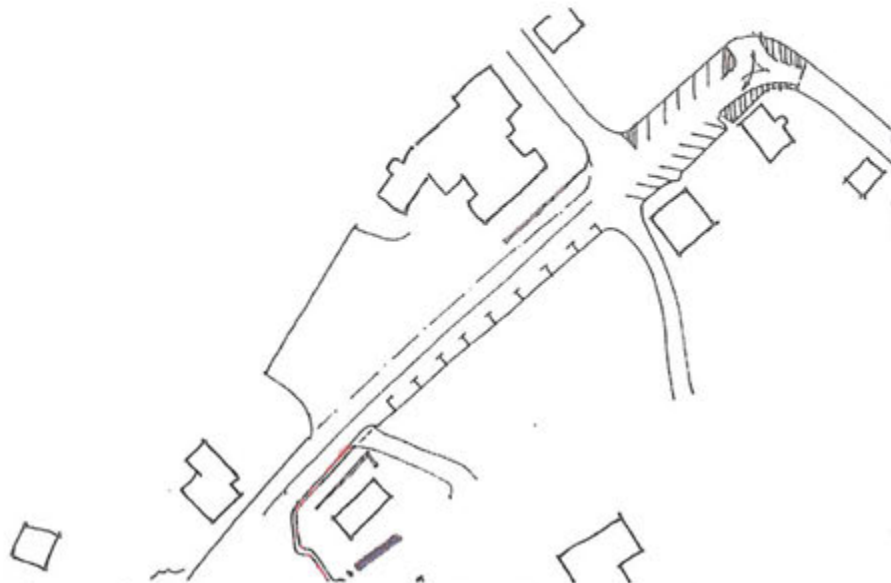
Above: Proposed parallel parking across from the Homeport and pavement markings at intersection of Boathouse Road.

The existing parallel parking on the north side of the street is the best option available due to the narrowness of the street. New pavement markings should be placed to maximize the number of vehicles. Existing vegetation should be trimmed back to the pavement edge and the existing signage replaced indicating parking time limits.

Additional signage indicating 'No Outlet' should be placed near the intersection of the Coast Guard drive. Pavement markings near the intersection of Boat House Road can be used to indicate a 'T-type' turnaround, pedestrian areas in front of the Galley, possible bicycle parking, etc. Additional bollards or obstructions are recommended in front of the Galley to protect/separate customers from traffic.

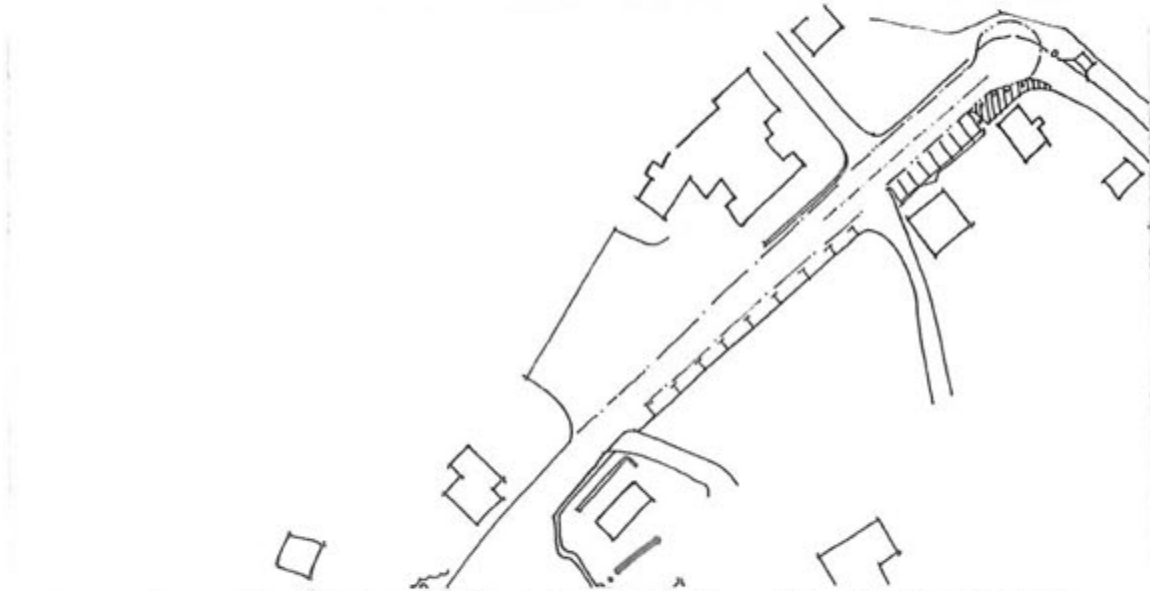
Above: Alternate proposed parallel parking across from the Homeport and cul-de-sac at intersection of Boathouse Road.<sup>2</sup>

*As a result of discussions with the Committee regarding the draft presentation of this report, a revised sketch showing the approximate turning radius for a passenger vehicle is provided. This would entail realignment of the road centerline beginning prior to Edy's Island Road. If maintaining the existing road edge along the south side (split-rail fence and roses) of the street and using two 10-12 foot wide travel lanes would eliminate the existing diagonal parking across from the Galley and would require the reconfiguration of the spaces in front of the Market as 90 degree spaces, resulting in approximately one-*

half the existing number at this location. Additionally, pending final layout and in order to provide a sufficient safety zone in front of the Galley, this cul-de-sac would project past the present edge of pavement and require extension of the stone retaining at the water's edge.<sup>2</sup>

3. Alternatively, re-align road centerline and provide a cul-de-sac at the intersection. This reduces existing parking, but creates a safer pedestrian zone. Determinations by Others as to possible extension town property lines to accommodate this and/or additional parking is required.<sup>2</sup>

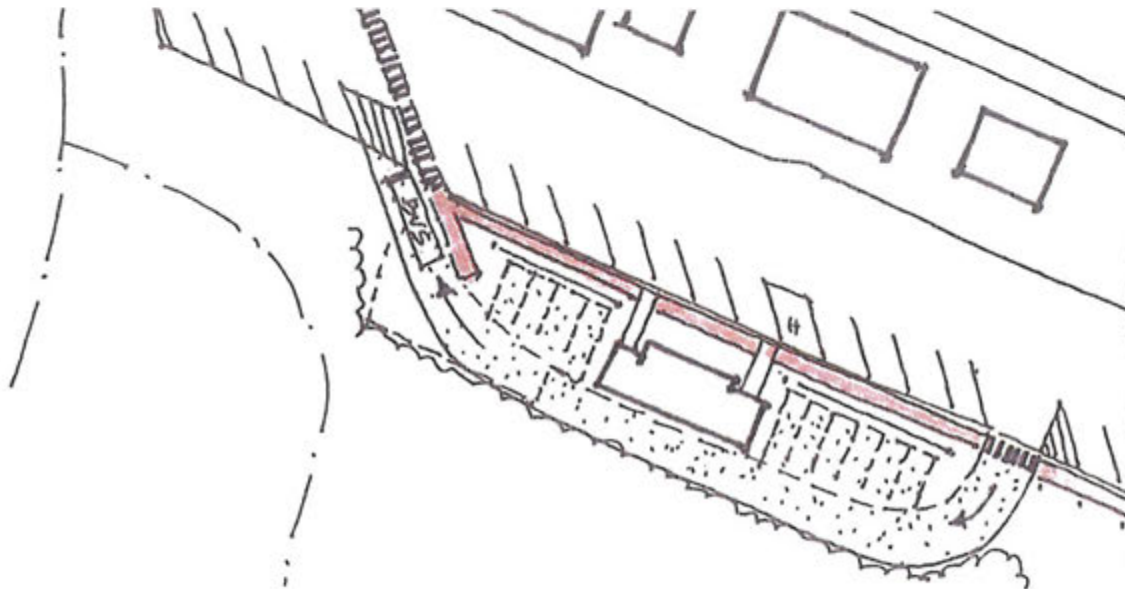
Above: Proposed Bus turn-around at Comfort Station, with additional Market Employee parking.

One proposed solution reconfigures the existing gravel lot to the south of the Comfort Station and reclaims the area to the north with a connector drive behind the building. This will certainly require permitting and may require a measure of remediation/dune replacement efforts to accomplish.

The scenario shown allows the bus to pass the Comfort Station and by coming around the back can stop against a passenger loading area at the street on the proper side of the bus. This solution reorganized the existing Market employee spaces toward the street and creates additional parking to the north as well. This concept takes advantage of the existing employee parking area, the previously disturbed/reclaimed area to the north to minimize impact on the adjacent marsh and dunes.

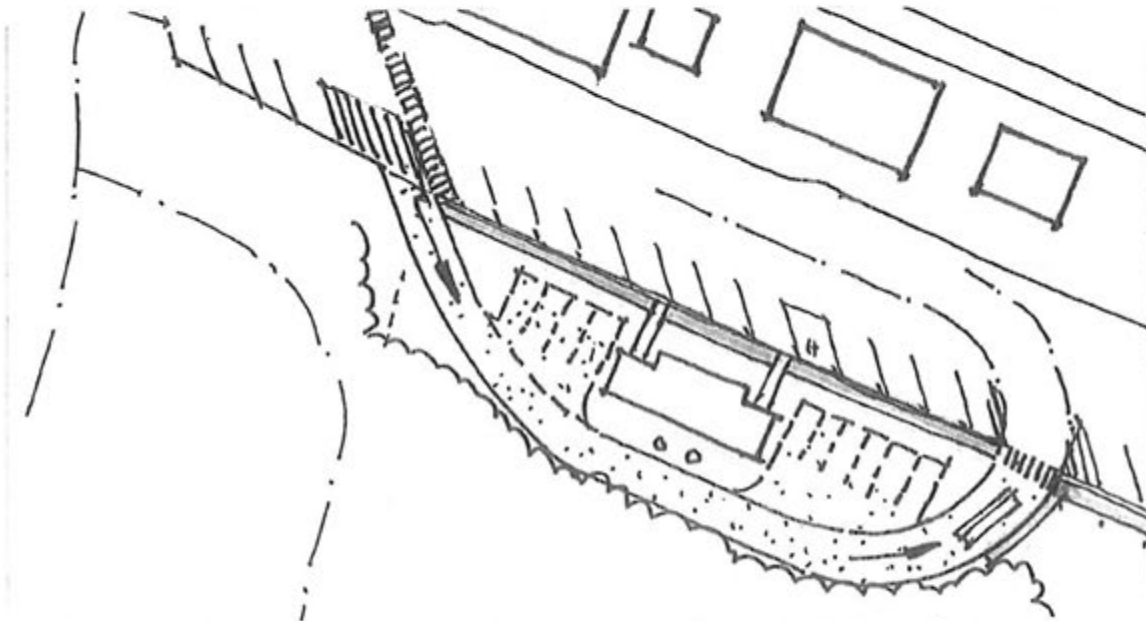
Above: Alternate proposed Bus turn-around at Comfort Station, with additional Market Employee parking.<sup>3</sup>

*As a result of discussions with the Committee regarding the draft presentation of this report, the loop was requested to be reversed such that a bus will enter before the Comfort Station and exit after. It was noted that an existing tank is buried behind the Comfort Station and will require a reinforced traffic covering, or slight relocation of the drive to avoid. Also Additional screening from the residential properties to the southeast is desirable.<sup>3</sup>*

3. Provide a minimal width connector drive behind the Comfort Station terminating at a passenger loading area (VTA Bus stop) the street. Coordinate final layout with Conservation Commission and existing buried infrastructure.<sup>3</sup>

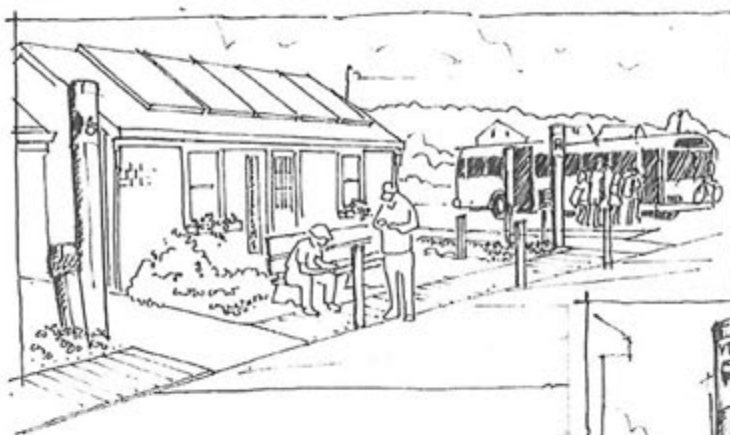
Above: Comfort Station with proposed Bus turn-around and pier-post signage.

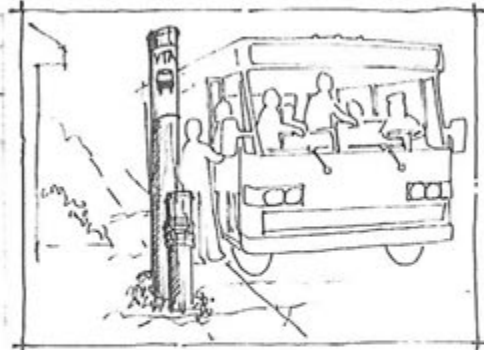
Right: Bus stop with pier-post signage.

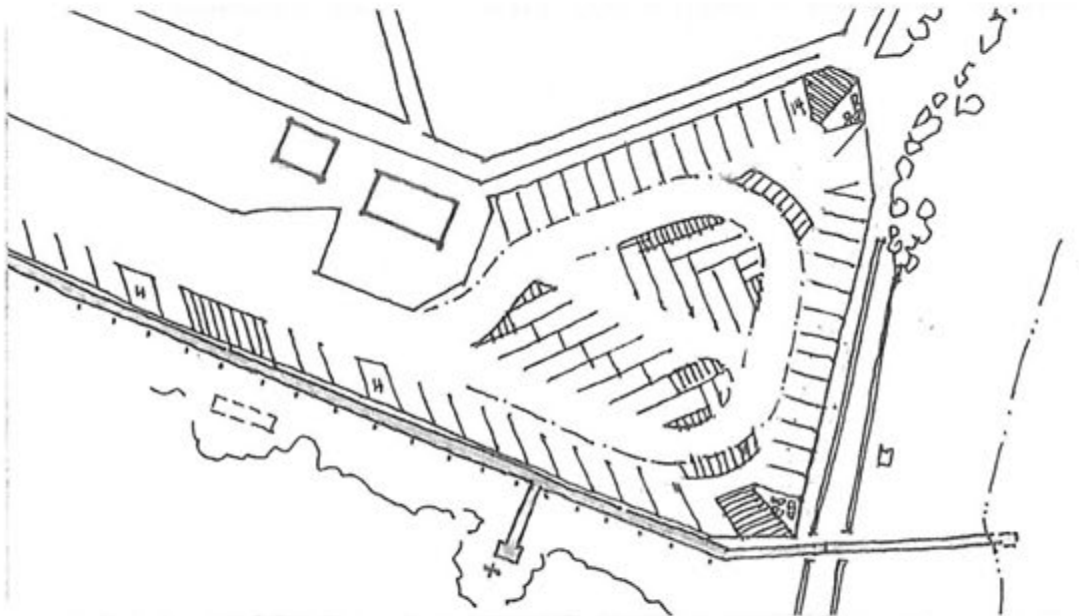
Above: Proposed beach parking with passenger drop-offs, trash and emergency access in the 'corners.'

- b. Reconfigure the center spaces. Revise turning radii and backing spaces meeting current engineering standards for one-way traffic where 45 and 90 degree parking spaces are provided. These standards vary for each of the specific combinations of parking and travel lanes. Turning radii should be designed to accommodate a VTA bus.

- c. Refer to Scenario A for additional recommendations.
3. Add directional arrows on paving, with turning lane markings around the center parking spaces. Provide marked drop-off spaces in the 'corners' along beach.

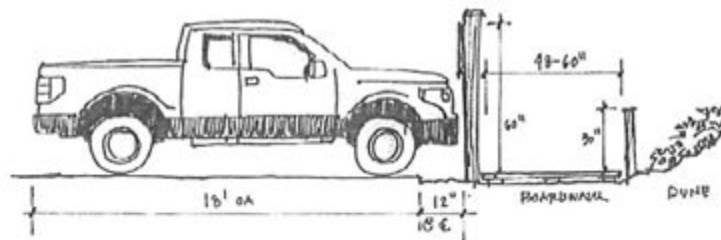
Above: Typical parking / path interface.

- i. The existing diagonal (45 degree) and 90 degree spaces are random width and do not meet the standard for standard vehicles, minimum 9 feet wide by 18 feet long. This causes the longer vehicles, such as pickup trucks to extend out into and reducing the traffic lane. Diagonal spaces require a longer space to accomplish this same standard.
- ii. The existing spaces include the front bumper overhanging past the precast concrete wheel stops. These wheel stops are not easily fixed to the ground since they sit diagonally on the edge of pavement and sand.
- iii. Along the eastern and beach edge, provide new round treated pier posts 6 inches in diameter x 72 inches above grade with chamfered tops placed at the centerline of each typical parking space in lieu of existing precast wheel stops. This would maintain the front line of parking, over the entire length.

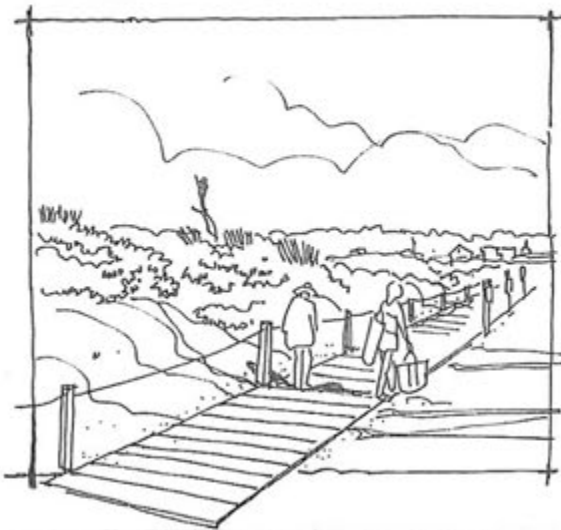
Above: Seasonal walkway, looking toward Comfort Station.

The existing slatted walkway is a modular slatted panel system comprised of hardwood slats with a cord connector with wide spaces between each board. These panels have a wide spacing between slats and are not connected to each other which allow some leading edge slats to rise up and become tripping hazards. Surface preparation is essential to the success of this particular modular panel, and requires some grooming prior to installation. Blowing sand covers portions of the walk at times; refer to other section of this report.

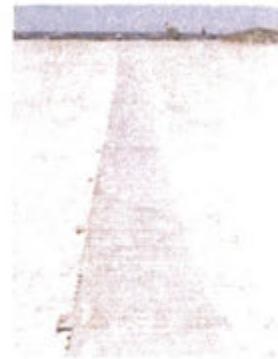
Left: Example of a 'roll-out' beach access mat.

1. Provide a 60 inch wide temporary path to the high tide water level from the public beach entrance. Beach wheelchairs are not a substitute for providing beach access routes, as they do not provide independent access. This can be accomplished with a 'roll-up' type mat in lengths as required, similar to 'Mobi-mat' which is a non-slip woven polyester mat, in choice of blue or brown color, with or without striping for the Visually Impaired.

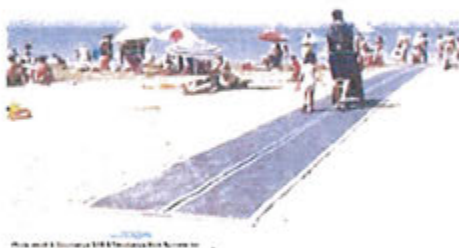
Above: example of an 'out-board connector' type walkway.

'Quick-deck' Rigid Modular Walkway Connection. Assembled with Bolts, with 'in-board' or 'out-board' connection points. 'Out-board' recommended for ease of Assembly.

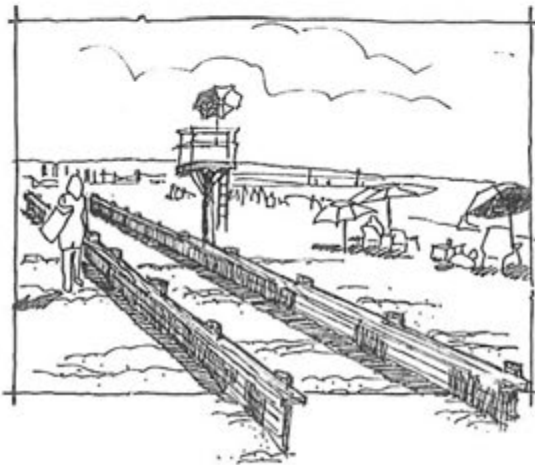
Above: Existing and proposed secondary 'bulkhead.'

Blowing sand covers portions of the parking lot and seasonal walkway at times. The existing bulkhead constructed along the beach parking lot is an ideal construction that accommodates both seating as well as a wind break. Based on wind energy diagrams, the bulkhead would be more efficient with the hollow space beneath the seat if it faced the water. This would trap the sand as opposed to creating the conditions which now redirect blow the sand over the top. The disadvantage of this mirrored construction would be the need to clean out the sand to maintain the pocket.

1. Reconstruct the existing bulkhead wind-break at the same bench height in its mirror image, with the pocket facing the water. Replace damaged components, and provide a new opening for access for mobility impaired visitors to gain access without having to go around.
2. Construct a secondary bulkhead, approx. 4 feet toward the parking lot to disrupt the wind-borne sand a second time before the parking lot edge. Use the similar materials, such as treated pier pilings (dock posts), 2x and 3x material.
  - a. Alternatively, a row of slatted 'sand-fence' can be an effective barrier to disrupt the wind energy. This is typically 48 inches high, comprised of wood slats, connector wires and wood posts.

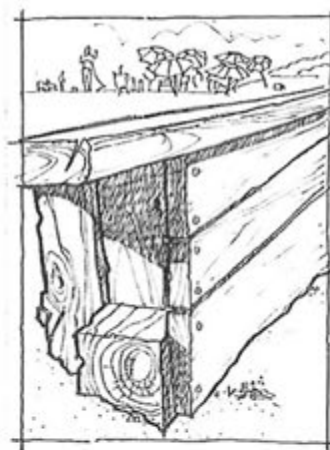
Right: Bulk-head detail with sand capture toward beach.

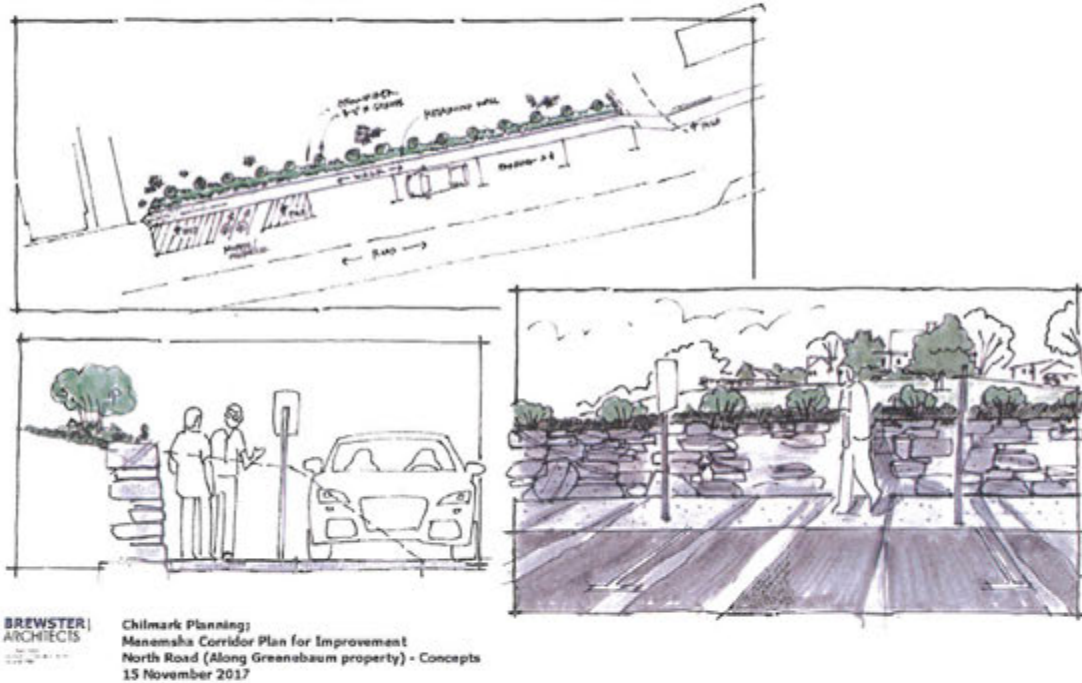
Above: Updated North Road parking along Greenebaum property.

- B.0 Develop drawings showing an overview, an elevation and a section of the North Road/Greenebaum lot area developed for an additional walkway.  
*Response: Additional views of the Greenebaum property have been provided.*

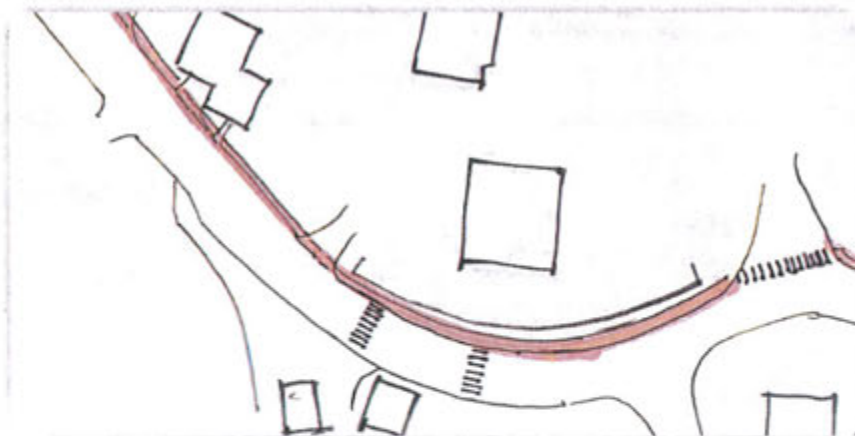
Above: Updated Basin Road (North Road to Dutcher Dock) Concepts drawing showing additional cross-walks at 'The Bite.'

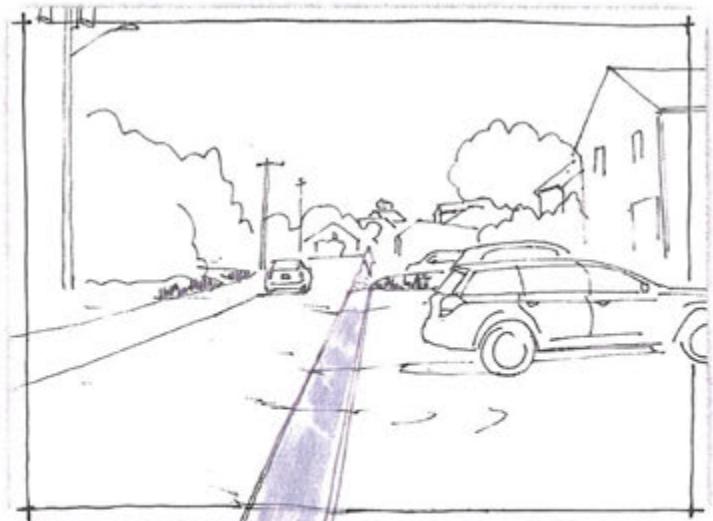
Above: Typical walkway with pavement marking.

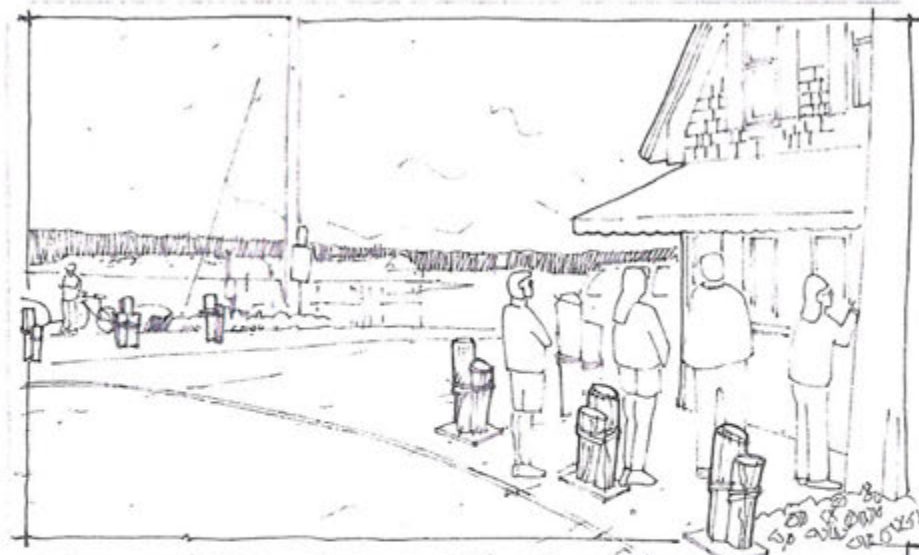
Above: Looking west toward The Galley.

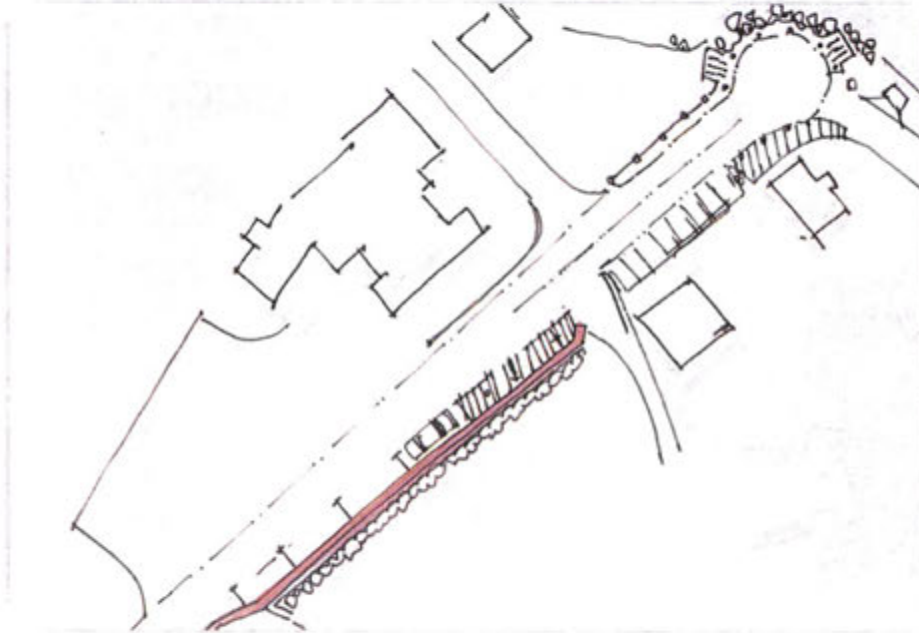
Above: Updated vehicle and moped parking near Greenebaum parcel and bicycle racks at the Galley cul-de-sac.

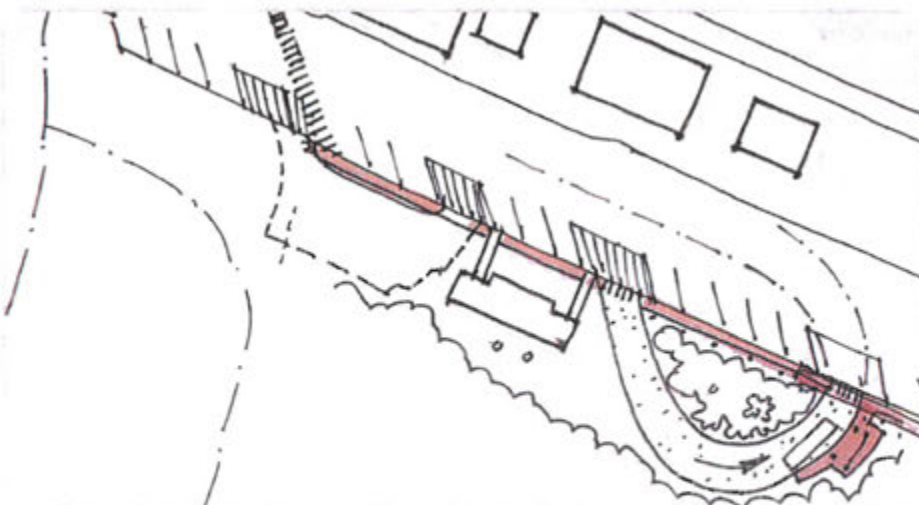
Above: Alternative Bus Turn-around beyond the Comfort Station, with Bus Shelter on north side.

- B3.1 Provide sketch at turnaround after the comfort station, on pages 13-15, that the first south side "shell lot" remains and an additional "shell lot" is to be added on the north side of the Comfort Station with a passenger drop-off and embarkation site on that north side.

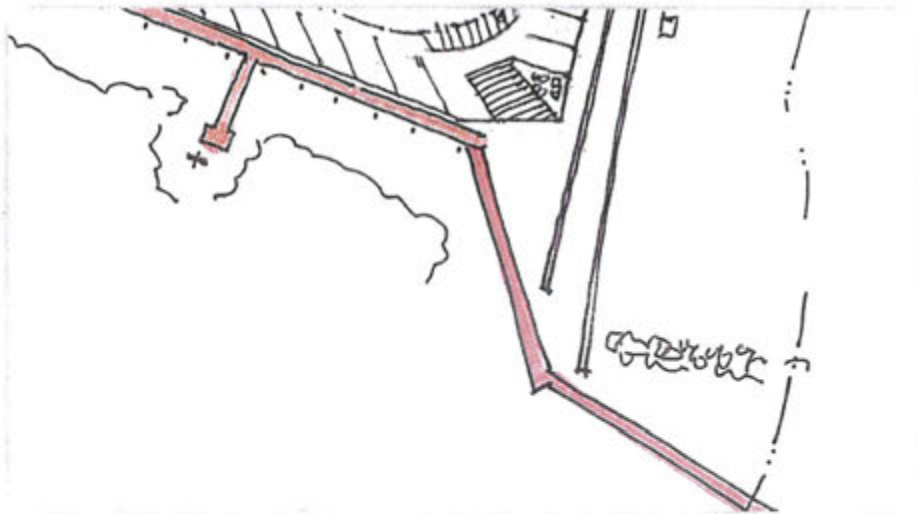
Above: Alternative beach access on north side of headwall and break-water.

- B4.1 Provide an illustration of how a person using a wheelchair or walker or other type of access vehicles would access the beach from the parking lot.  
*Response: Drawing (p. 8) Dutcher Dock to Menemsha Beach Parking shows the proposed beach access through the new and existing headwall for a fairly direct route to the waterline. Alternatively, the path can be flipped such that the bulkhead can remain as it presently is, and the path configured to the north of the breakwater to the highwater line.*
