# Martha's Vineyard Commission

## DRI 279-M Stillpoint Meadows

### MVC Staff Traffic Report – 2022-11-16

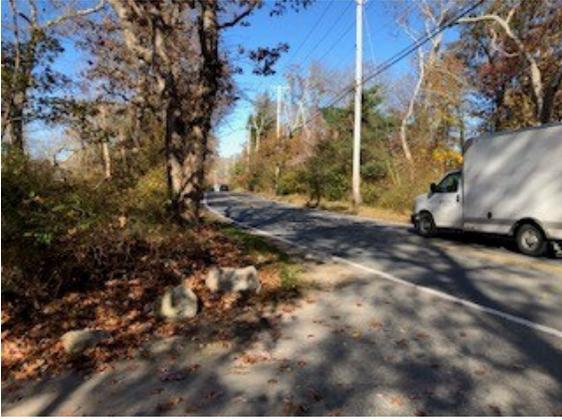
Looking northbound and southbound from the site driveway, the sight distances are adequate for the posted speed limit of 35mph. Staff also confirms the sight distances as presented in their traffic impact report, submitted on June 3, 2022.

**540 ft looking Northbound**

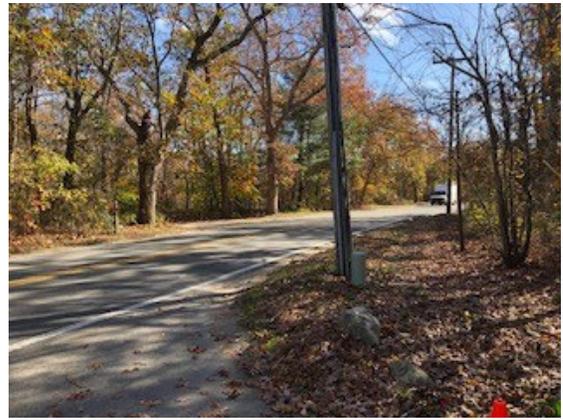
**300 ft looking Southbound**

It should be noted that the traffic impact report evaluated sight distances for a posted speed limit of 40mph. The applicant acknowledges in the report that the required sight distances for a 40mph roadway are not met in the southbound direction.

As recommended in the June 3, 2022, report, staff agrees that brush and trees along the horizontal curve to the south of the site driveway should be cleared to provide a much safer condition. Staff has estimated that cutting back roughly 10 ft will open an additional 115 ft of sight distance at the site driveway.
