DRI 665 – M.V. Museum Landscape Site Plan – Phase One

MARTHA'S VINEYARD MUSEUM SKIFF AVE TISBURY MA

PHASE 1 PLAN

DRI 665-M MV Museum Summary of proposed modifications

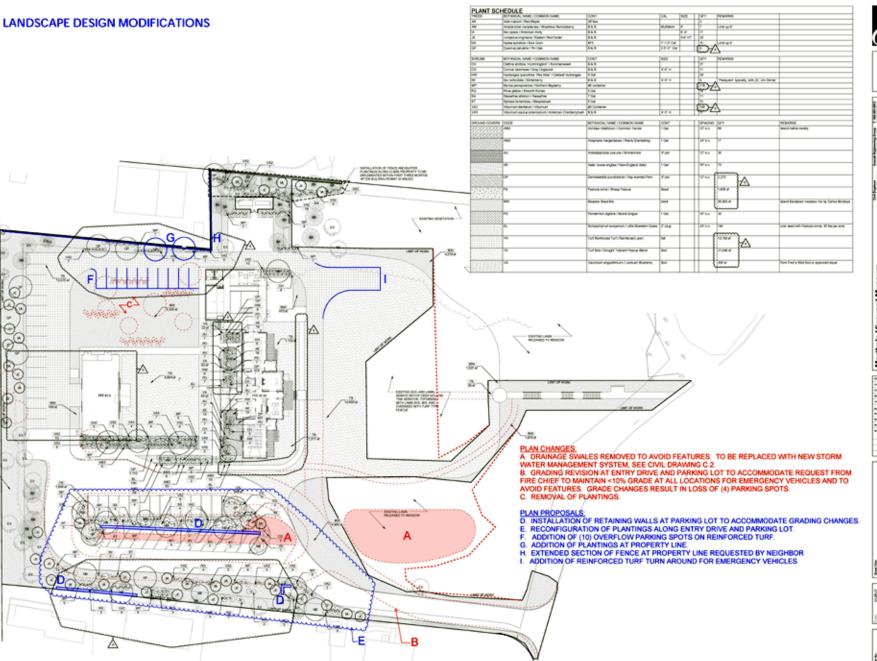
PLANTING PLAN

DESIGN DEVELOPMENT - 04 06 2017

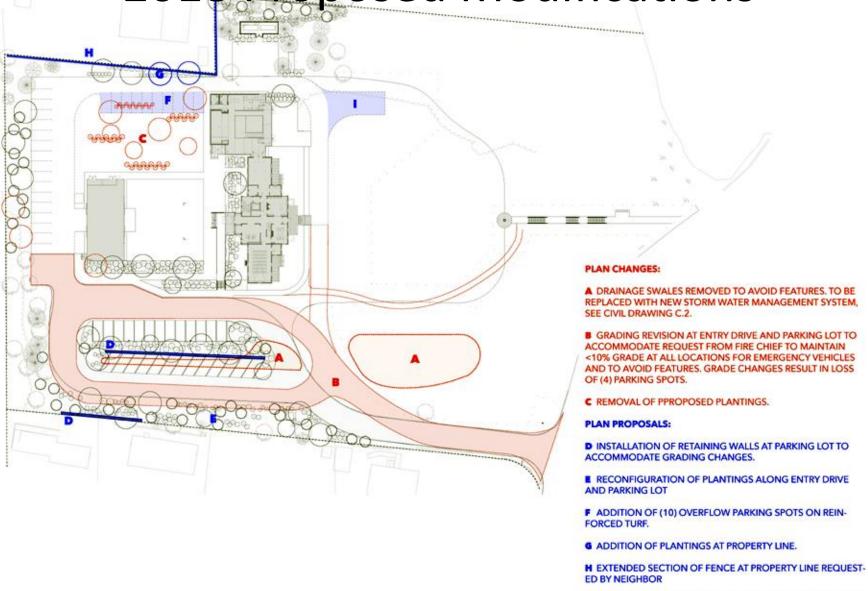
I ADDITION OF REINFORCED TURF TURN AROUND FOR EMER-

GENCY VEHICLES

PLAN CHANGES:

A DRAINAGE SWALES REMOVED TO AVOID FEATURES. TO BE REPLACED WITH NEW STORM WATER MANAGEMENT SYSTEM, SEE CIVIL DRAWING C.2.

- B GRADING REVISION AT ENTRY DRIVE AND PARKING LOT TO ACCOMMODATE REQUEST FROM FIRE CHIEF TO MAINTAIN <10% GRADE AT ALL LOCATIONS FOR EMERGENCY VEHICLES AND TO AVOID FEATURES. GRADE CHANGES RESULT IN LOSS OF (4) PARKING SPOTS.
- REMOVAL OF PPROPOSED PLANTINGS.

PLAN PROPOSALS:

- INSTALLATION OF RETAINING WALLS AT PARKING LOT TO ACCOMMODATE GRADING CHANGES.
- RECONFIGURATION OF PLANTINGS ALONG ENTRY DRIVE AND PARKING LOT
- ADDITION OF (10) OVERFLOW PARKING SPOTS ON REIN-FORCED TURF.
- G ADDITION OF PLANTINGS AT PROPERTY LINE.
- H EXTENDED SECTION OF FENCE AT PROPERTY LINE REQUEST-ED BY NEIGHBOR
- ADDITION OF REINFORCED TURF TURN AROUND FOR EMER-GENCY VEHICLES

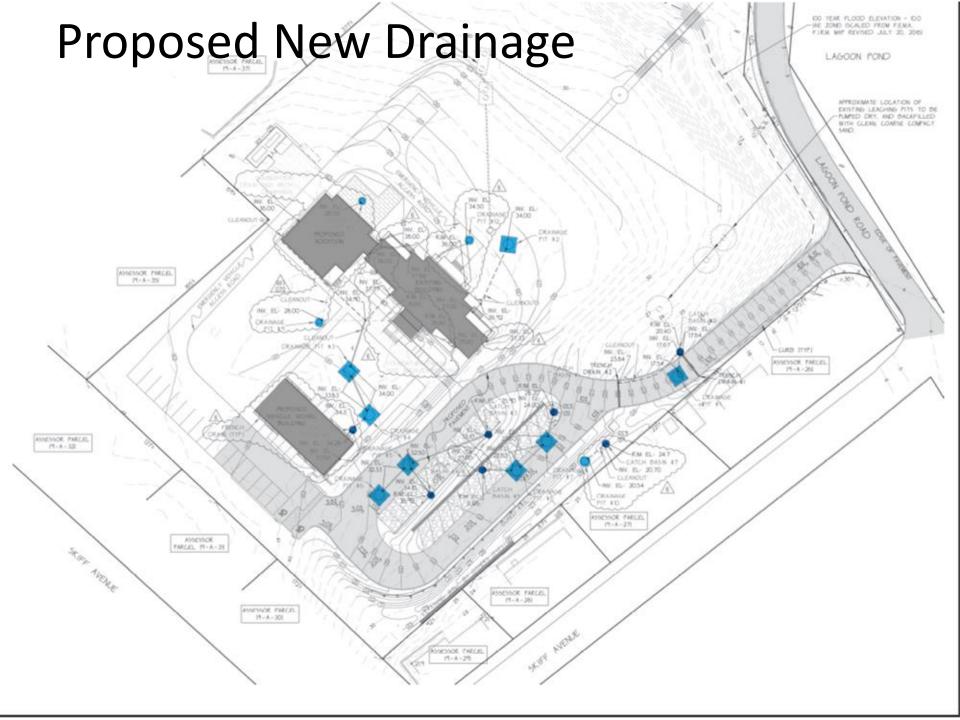
The driveway drainage system:

- 5 non-leaching catch basins equipped with an oil and debris trap;
- 2 trench drains in the in the driveway;
- 5 drainage pits.

The roof runoff:

- French Drain at Vehicle and Vessel building;
- 1 non leaching catch basin at Vehicle and Vessel building;
- 3 drainage pits.

Area south of the driveway:

- Swale;
- 1 non leaching catch basin;
- 1 drainage pit.

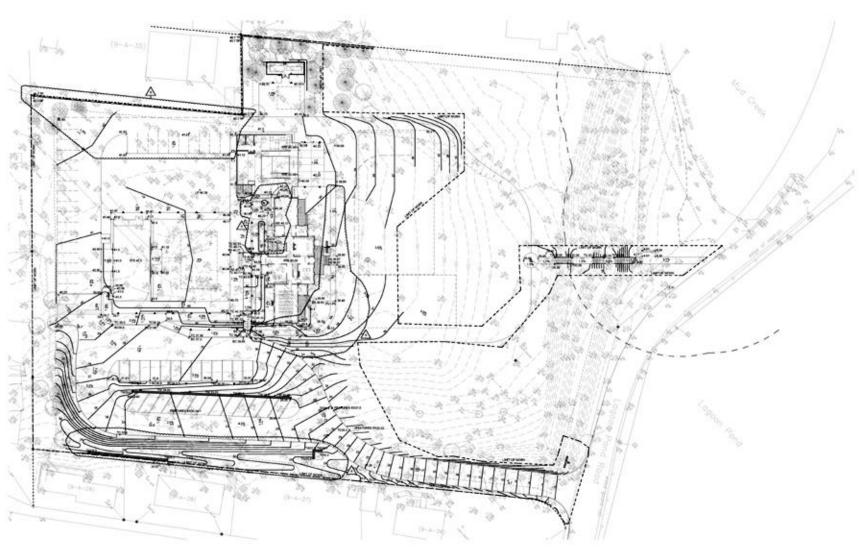
GRADING LEGEND

GRADING NOTES

for it' everage depth of topsof screened for bean even, and 12" depth of planting even, except on otherwise indicated on the drawings.

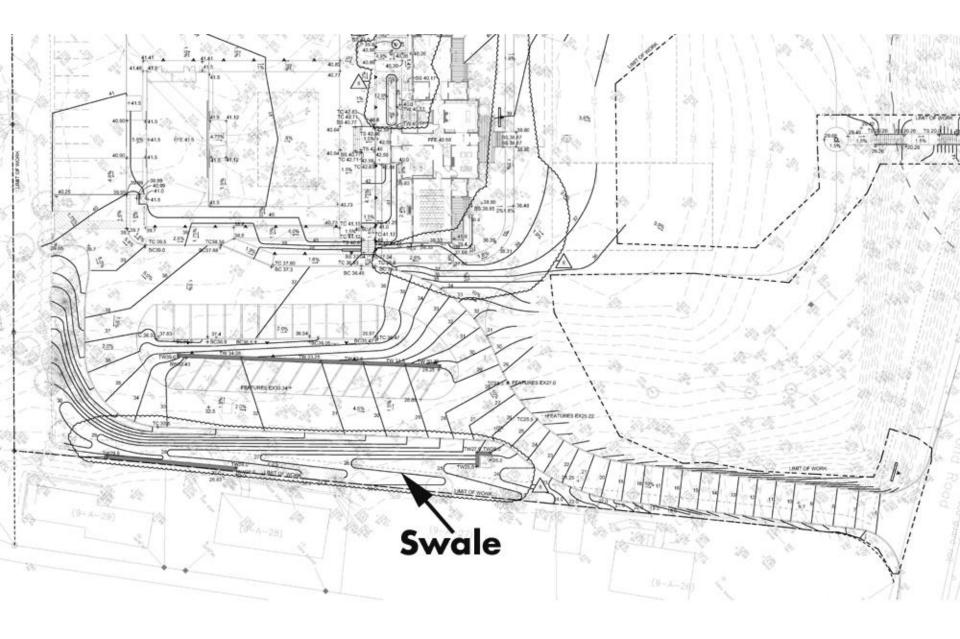
RADING LEGEND

Install staked haybale sitation fence at edge of proposed grading as shown. Maintain haybale fence in good condition throughout project.

Promptly notify the Landscape Architect of unexpected sub-surface conditions. Confractor to set grade stakes showing lines and elevations for for 6" average depth of topsoil screened for lawn areas, and 12" depth at planting areas, except as otherwise indicated on the drawings.

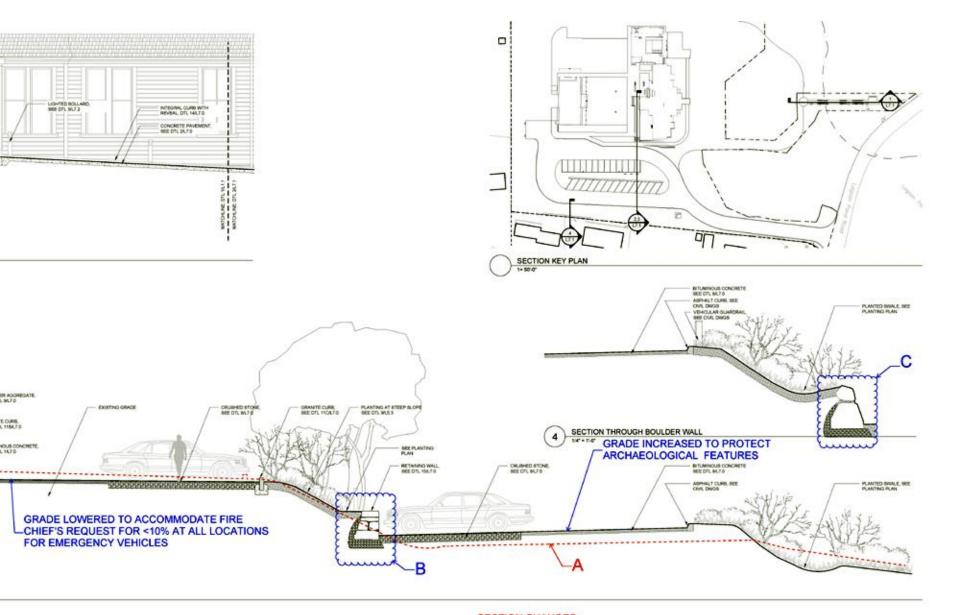
SECTION THROUGH STAIRS BELOW FLAGPOLE

SECTION CHANGES:

A. DASH INDICATES PREVIOUS GRADING AT SECTION THROUGH PARKING LOT

SECTION ADDITIONS:

- B. RETAINING WALL BETWEEN UPPER AND LOWER PARKING LOTS.
- C. RETAINING WALL AT LOWER PARKING LOT.

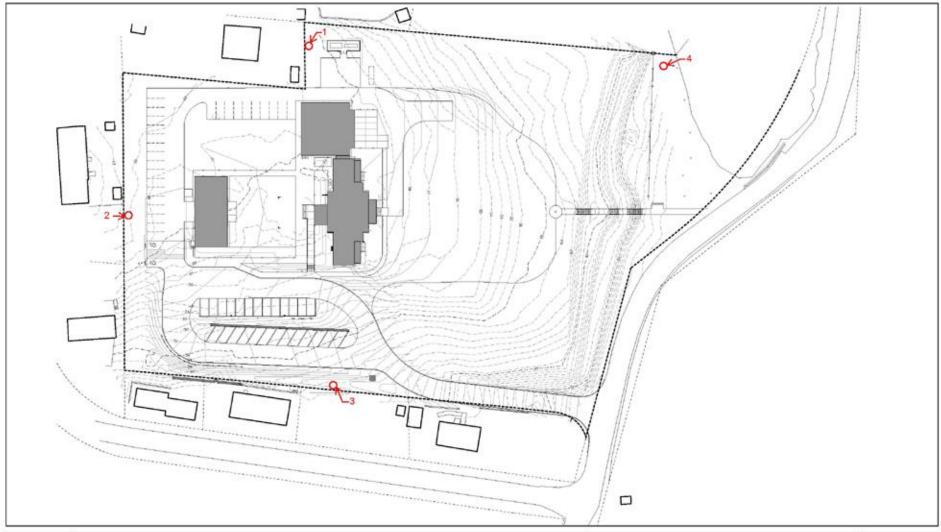
Proposed Acoustic Ambient Monitoring Locations

Proposed Site Plan - Acoustic Monitoring Locations			Sheet No.:
Date:	6/11/18	Drawn: ALL	Dwg Ref.:
Scale:	N.I.S.	Checked: CE	1000
Document Bat - N/A			_

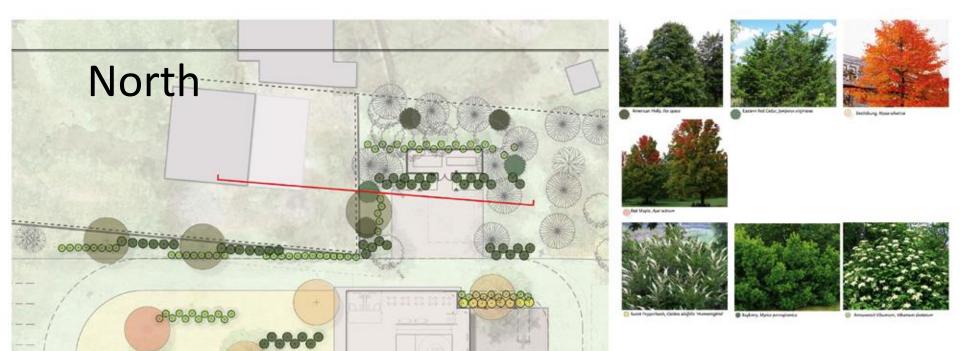
PLAN, 1" = 10'-0"

NORTH SCREEN PLANTING

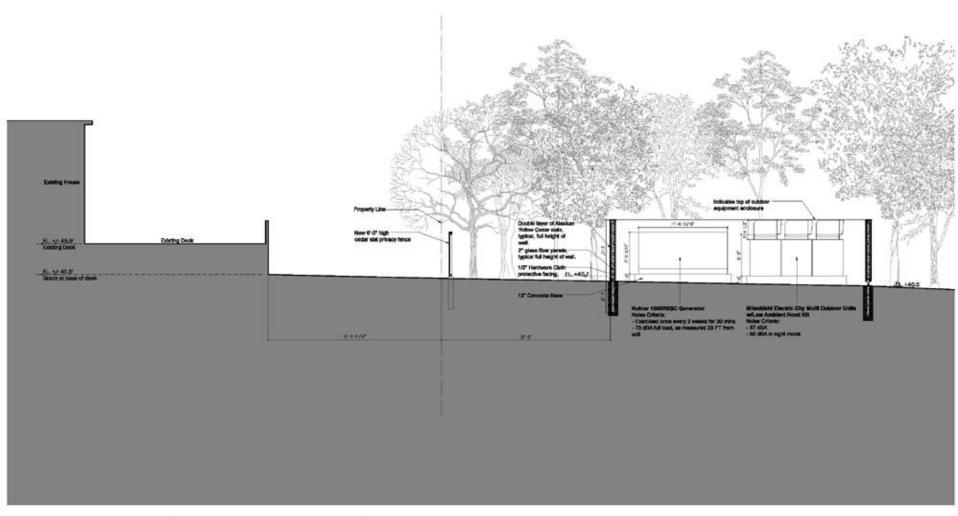
Section through Emergency Generator & Condensing Units

Martha's Vineyard Museum - Outdoor Equipment Enclosure Section Detail
March 30, 2017
Oudens Ello Architecture
